INFORMATION HANDOUT

**For Contract No. 07-3X8704
At 07-LA-105, 405-R2.5, 20.5/R21.1**

Subject: FOUNDATION REPORT FOR RETAINING WALL NO. 95 NEAR ROUTE 405 AND ROUTE 105 CONNECTOR

Subject: REVISED GEOTECHNICAL DESIGN REPORT (GDR) FOR NB 405 TO E/B AND W/B 105
CONNECTORS – APPROACH, DEPARTURE, AND GENERAL EMBANKMENT
ROADWAY DISTRESS REPAIR

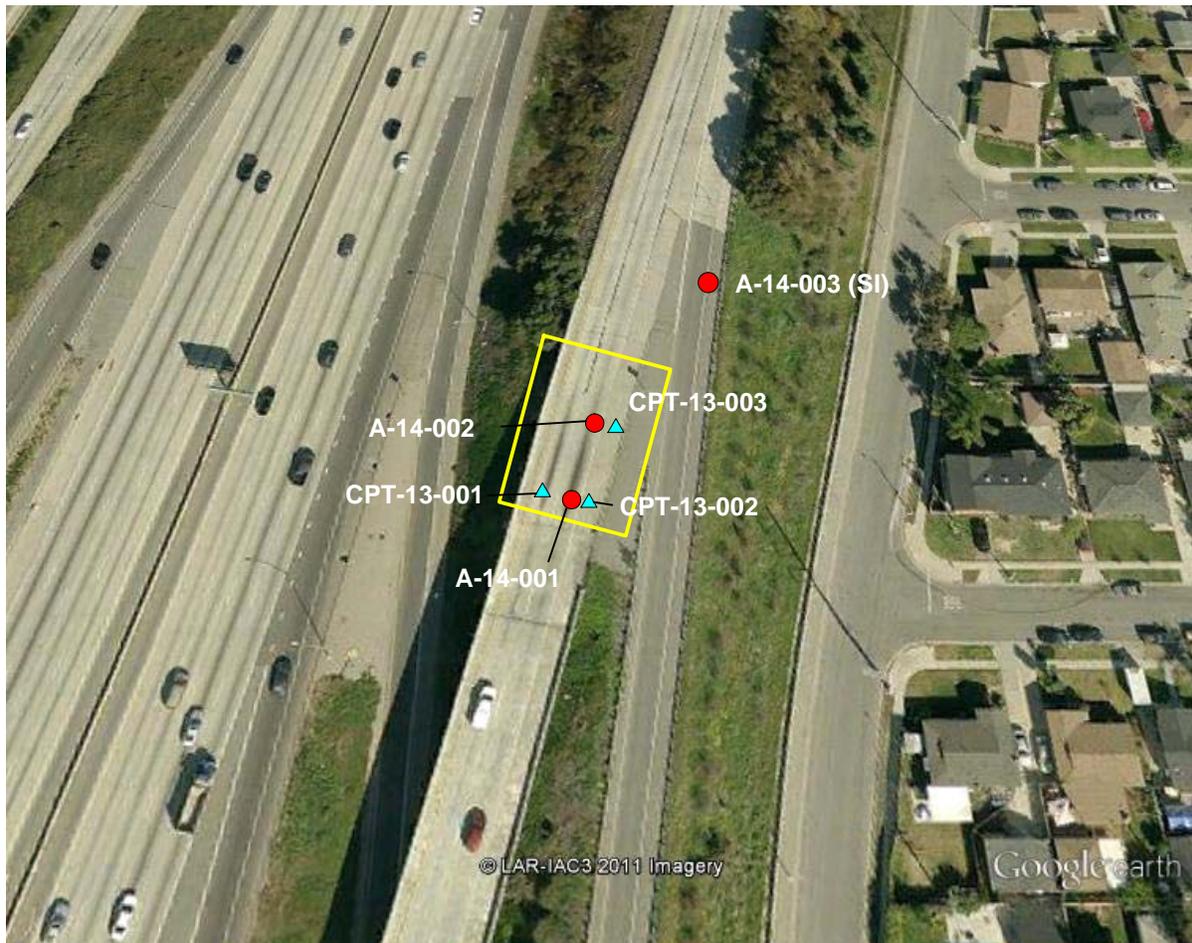
**Location 1 - Investigation Plan
N/B 405 to 105 Connector at 53-1238G St Bridge**

1-2 inches of settlement was observed on the departure slab within both lanes at this location. Guard rails of the wing walls were also observed to have settled by 1-2 inches relative to the bridge structure. The departure slab is about 30 feet in length. Evidence of ponding of water around the inlet drain on the right shoulder indicates improper drainage (likely a result of settlement of the slab).

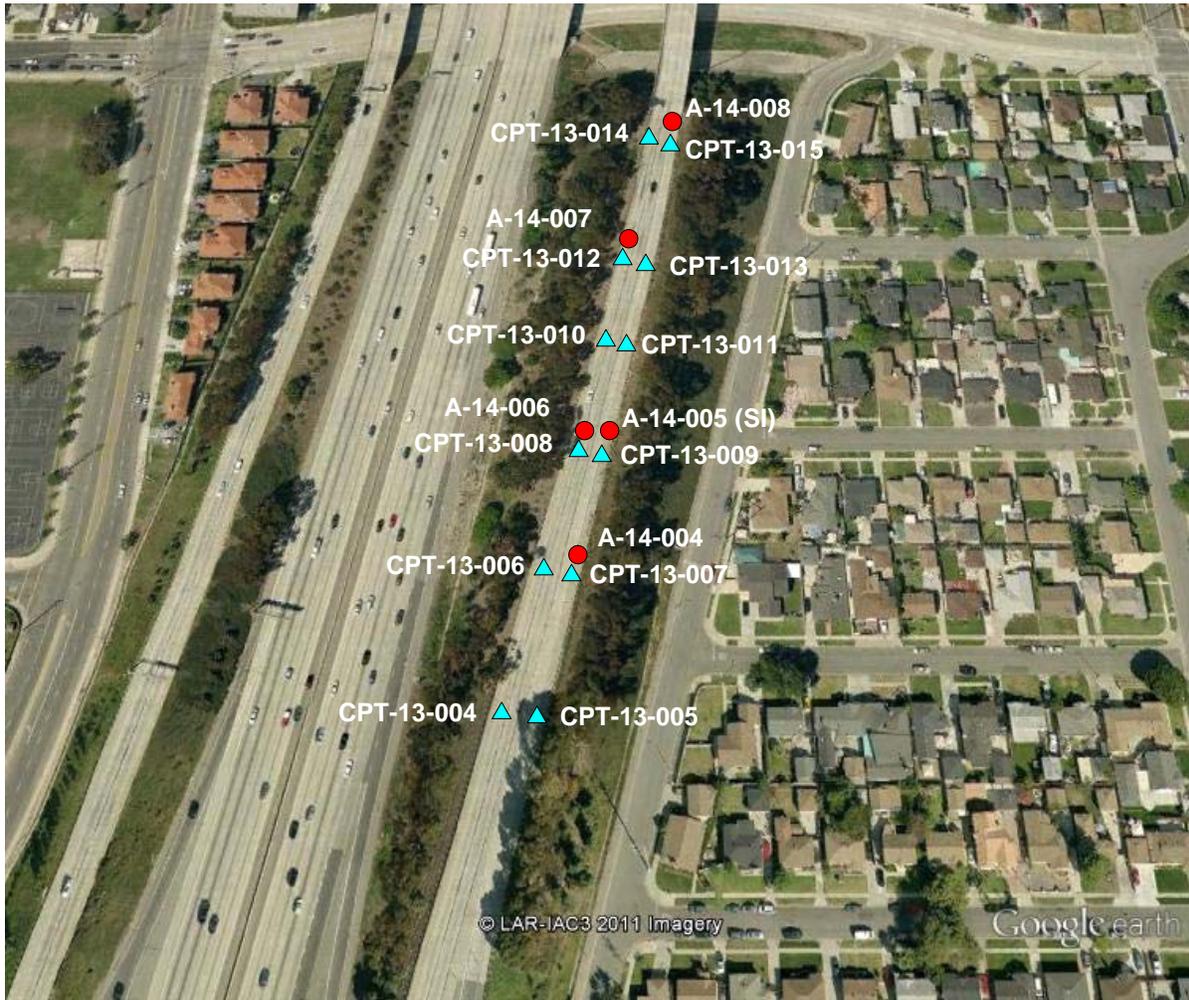
Location 2 - Investigation Plan (N/B 405 to 105 Connector)

Settlement of about 1-inch of the right shoulder and Number 2 lane was observed at this location. Settlement was observed to be intermittent between Stations 374+00 to about 385+70 (end of 120th Street Approach slab). Settlement also appears to have affected the grade of the connector where runoff appears to be re-directed over east facing embankment slope face. About 257 feet south of the 120th street bridge abutment runoff appears to be flowing over the right shoulder and causing erosion of the slope face, which was documented in the Preliminary Assessment Report dated

Additionally, at Station 374+70 (per the 405-105 Connector Alignment), tension cracks were observed in the right shoulder area, about 60 feet in length. The tension cracks were indicative of slope distress. Some minor bulging was observed on the slope face just below the tension cracks as well. An SI was installed within the tension cracks zone to monitor slope movement (See Section 4.1 for a discussion on slope inclinometer results).

At Station 374+70, where evidence of slope distress was observed, hollow stem auger boring A-14-003 revealed about 40 feet of fill composed of 13 feet of very stiff clay overlying 11 feet of medium dense sands and 16 feet of medium stiff to stiff clayey soils. This fill is underlain by stiff to very stiff clayey soils of alluvial origin.

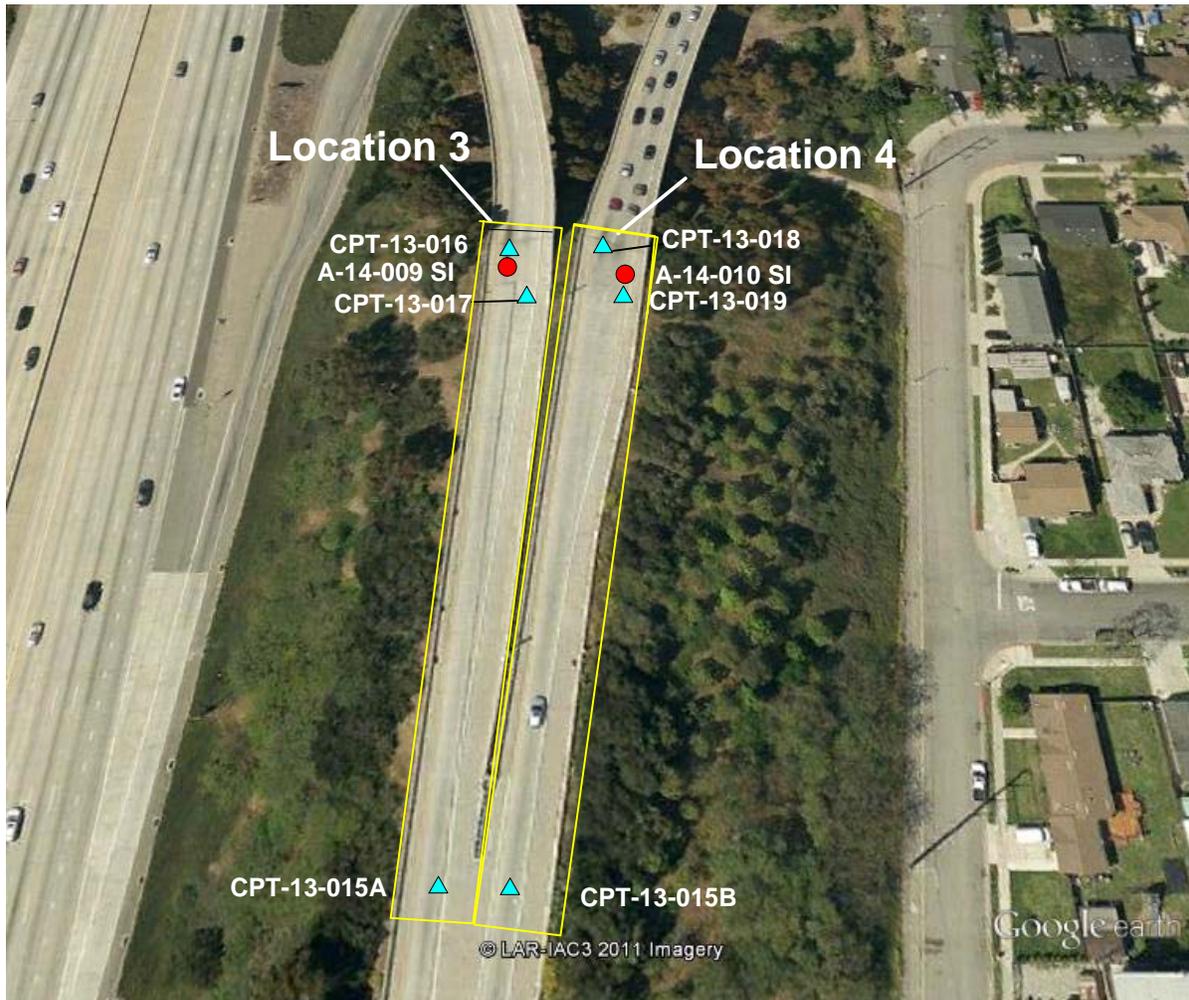
**Location 3 and 4 - Investigation Plan
N/B 405 to W/B and E/B 105 Connector Approach**

Observed distress in this location consisted of settlement of 1-2 inches of the approach slab (for the N/B 405 to 105 W/B Connector Bridge) on both travel lanes. Some cracking was observed on the approach slab as well. Settlement of 1-2 inches of was observed on the guard rail top of the wing-wall relative to the bridge deck guard rail. Cavities below the guard rail and slab were also observed, on the outside of the slab area on the west side. As mentioned previously, this area was filled with injection foam from the slab-jacking operation performed in June 2013.

1-2 inches of settlement was also observed in the approach slab at this location. Similar to Location 3, the settlement was observed to involve both travel lanes with some cracking of the approach slab. Some horizontal separation (about 1-2 inches) of the guard rails was also observed. No vertical settlement of the barrier guard rails was observed here. As in Location 3, this slab area was also injected with foam for a slab-jacking operation performed in 2013.

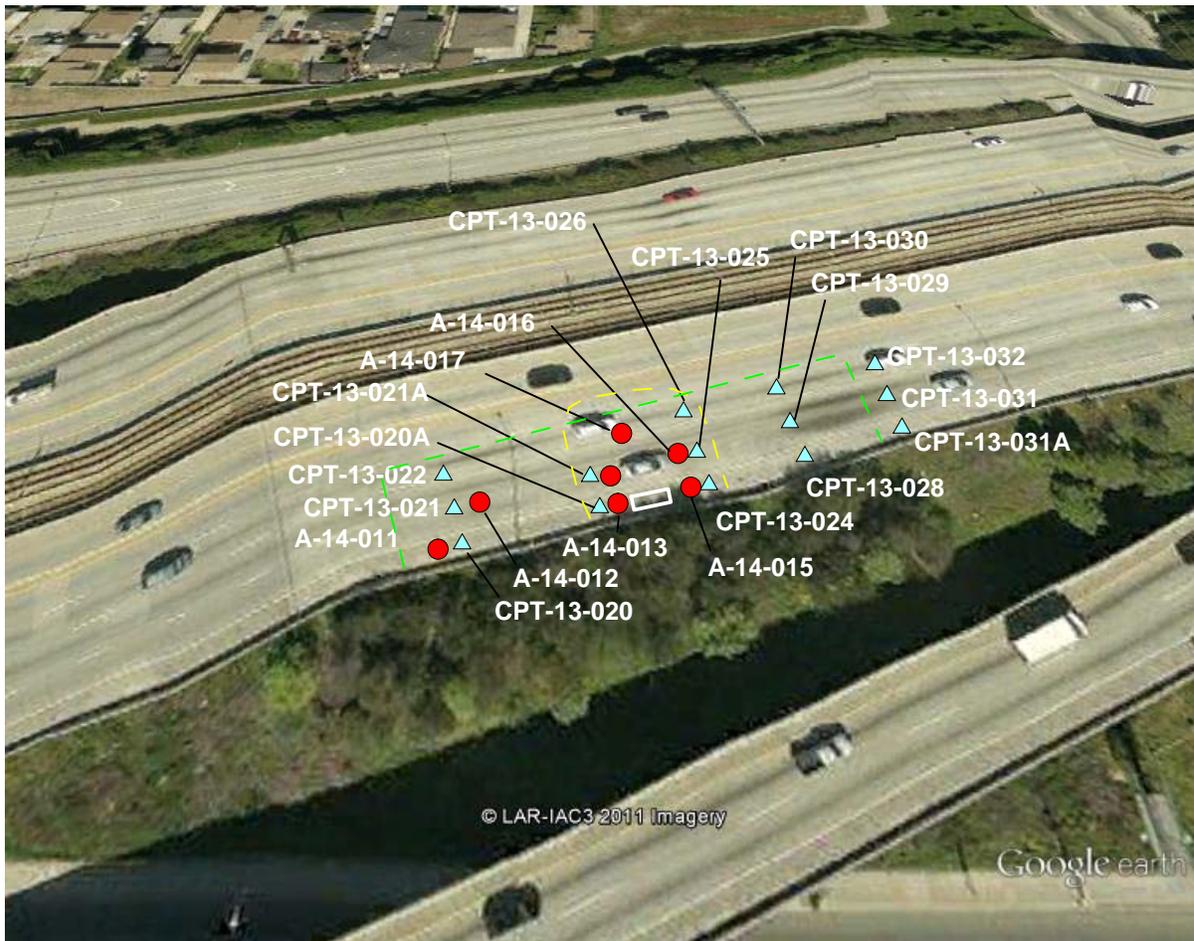
**Location 5 - Investigation Plan
N/B 405 to E/B 105 Connector
Departure (Right shoulder and
Adjacent two lanes to be drilled).**

This Location was observed to have significant settlement of about 2-4 inches for about a 25 foot width within the EB 105 right shoulder and adjacent Number 3 and 4 lanes, with less settlement observed in Lanes 1 and 2 and the HOV Lane. It was noted that this depression area is adjacent to an inlet drain located on the right shoulder. This depression area is located at about Station 122+50 (per the 105 alignment). In addition, severe signs of erosion were observed adjacent to the right shoulder area from about Station 122+37 to 122+62. The depth of erosion was observed to be about up to 6-8 feet deep. A detached 4-inch PVC pipe was observed coming out of the structural section just above the cavity area with the remainder of the PVC adjacent to the shoulder area. In November 2013, Maintenance had this cavity area filled with loose aggregate base material.

- ▲ CPT-13-020 (14 CPT's)
- A-14-013 (6 Borings)
- Area of Roadway Settlement:
approximately 25 ft wide
(Adjacent to Inlet Drain - Marked by white box)
- Approximate Limits of Distress
(250 feet long by 30 ft wide)
