FOR CONTRACT NO.: 07-4L2204

ROUTE: 07-LA-1-KP 82.8/83.3 (PM 51.0/52.0)

File: 07-LA-01-PM51.6/KP83.07
EA 07-4L2201
Escondido Beach Landslide

Subject: Geotechnical Design Report

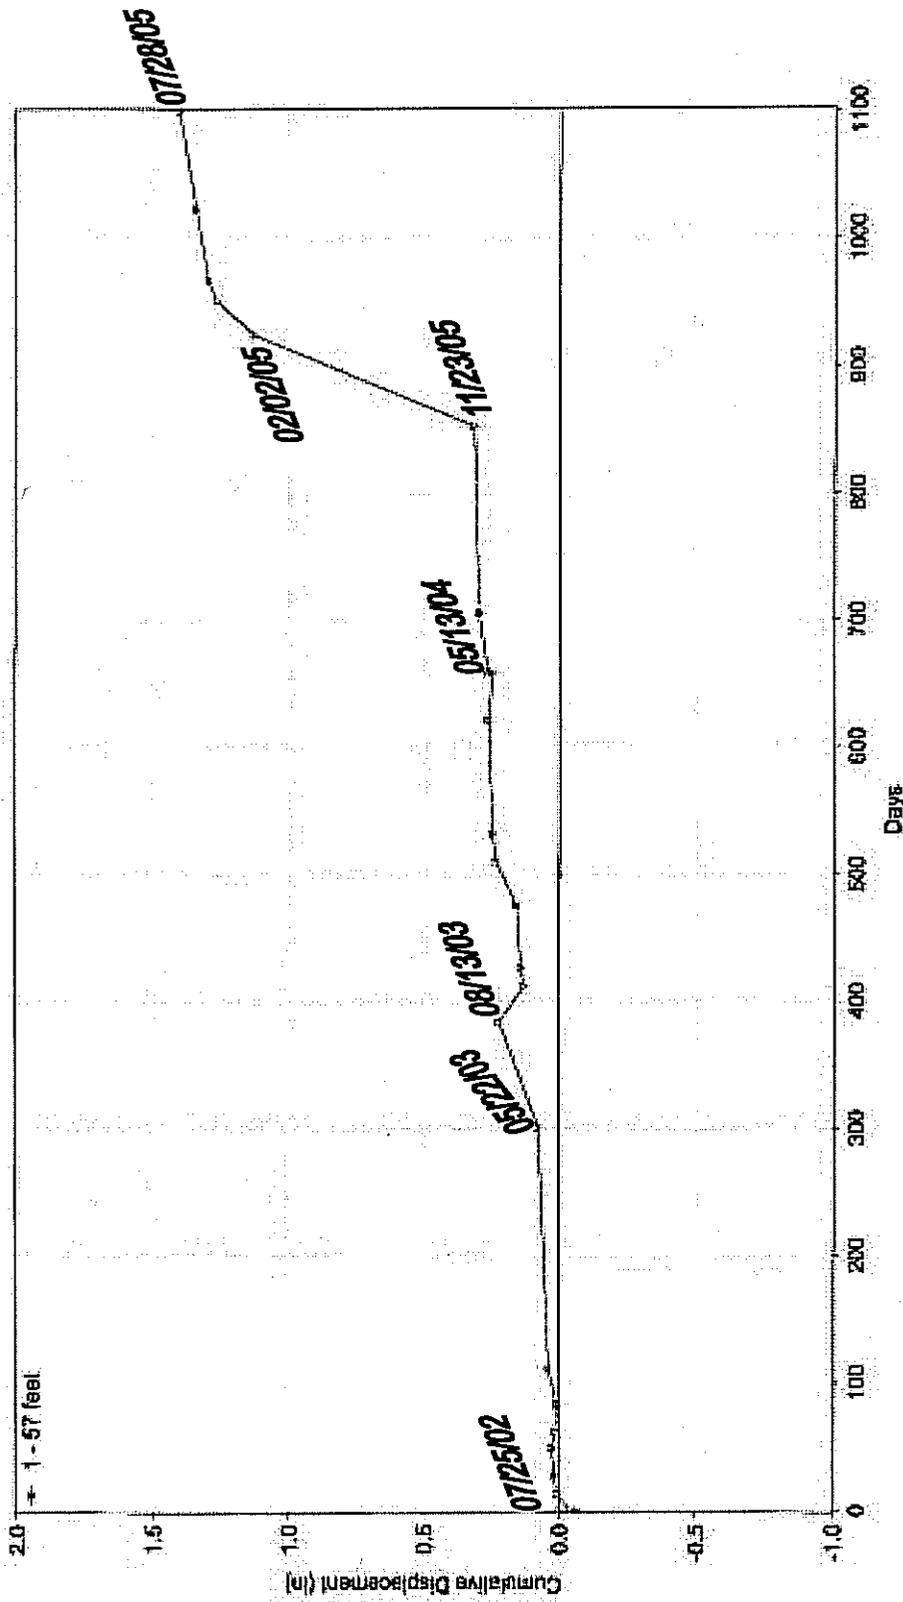
Figure 8: Time Series plot for Inclinometer SI_07_02

Slope Indicator Data Analysis prior to December 2004: Based on the available data from SI_07_02 and SI_08_02 it appeared that movement was occurring along a planar surface with a steep head scarp at or just below the highway elevation (Figure 6a). The slope inclinometer data did not suggest deep-seated movement. The highway fill constructed during the emergency repair of March-April 1978 moved down and outwards along with the highly disturbed Modelo Formation materials on the down-slope side. Instability at the interface of the weathered and unweathered Modelo Formation due to groundwater seepage may also have contributed to the observed movements. The location where the slide surface daylights cannot be determined, due to Right-of-Way restrictions and dense vegetation on the slope.

Approximately 20 mm additional movement along the shallow shear zone was observed due to the rainstorm, which resulted in a cumulative movement of 47 mm since the installation of the slope indicator. This shallow shear zone is affecting primarily the eastbound lanes and reflects the widening of the pre-existing pavement cracks (Figure 3a), and subsidence of eastbound lane No.2.

The deep-seated movement with shear zone at 13.5 m below the roadway surface, caused uniform movement of 5 mm at both slope indicators, SI's 0702 and 0802, after the rainstorm. The deep-seated shear zone was ascertained by the consistent displacement profiles of both SI's 07_02 and 08_02 at the depths near 13.5 m. This deep seated movement will affect the entire highway section and the slopes above and below the highway.

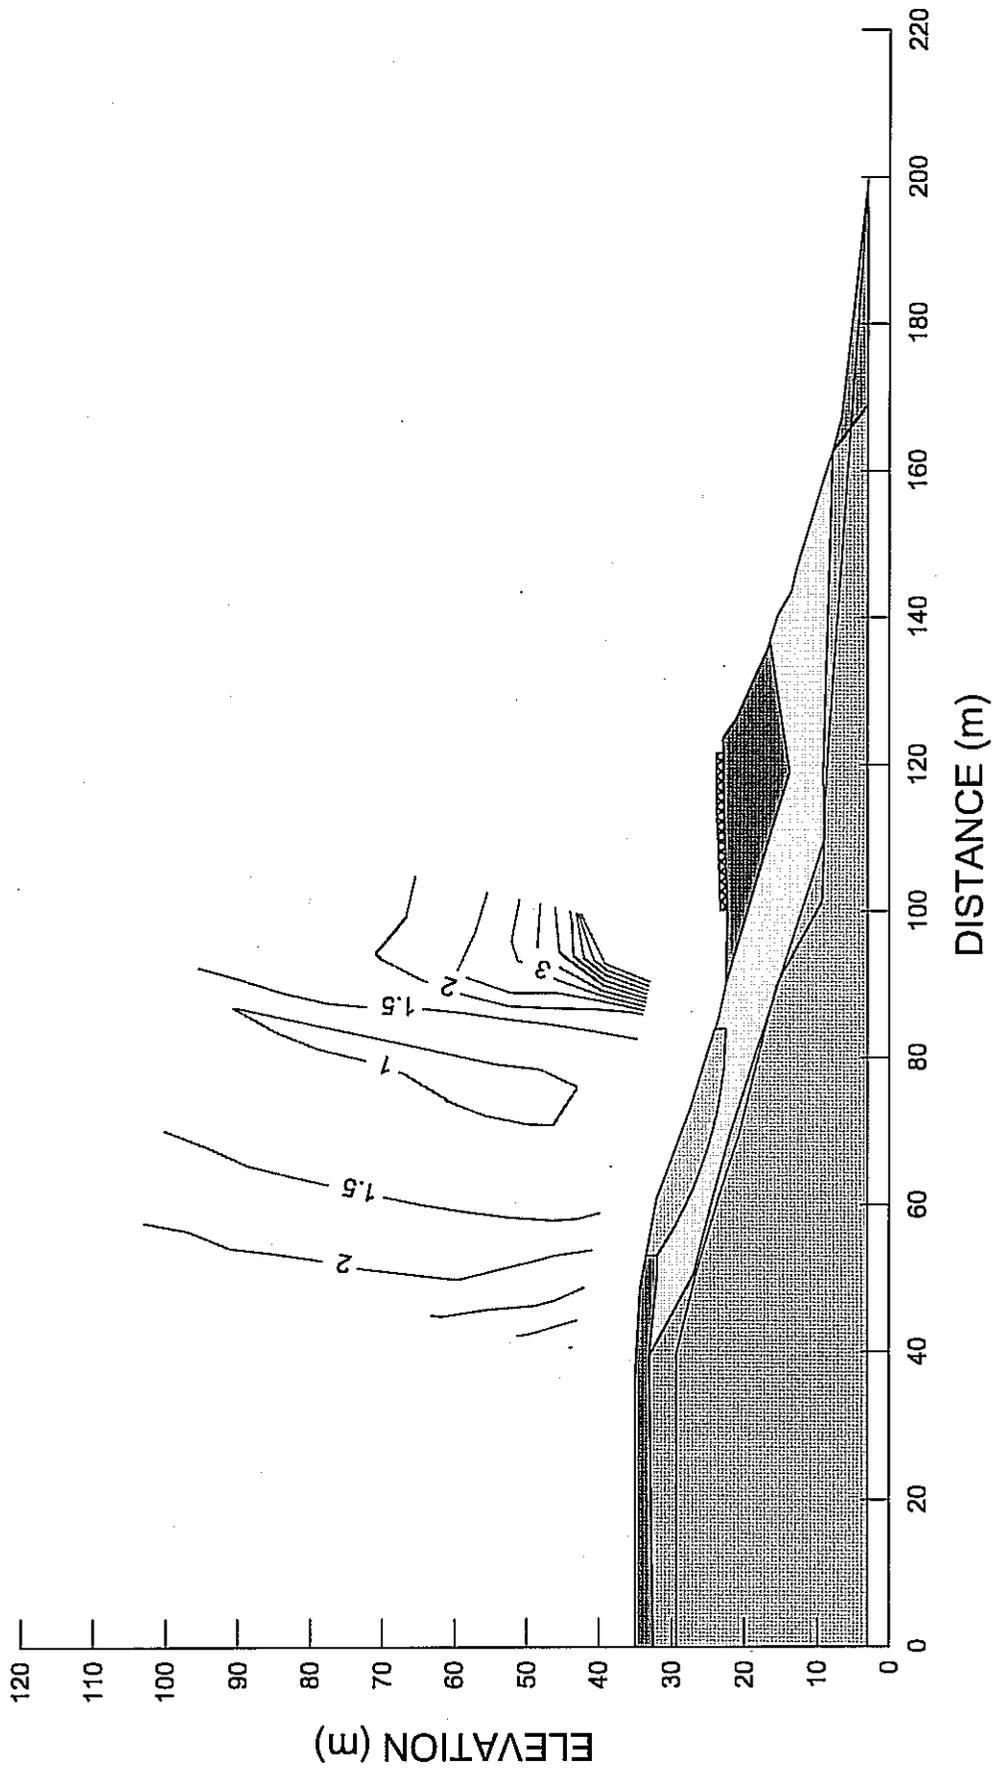
Figure 11: Stability Analyses of Upper Slope

A series of stability analyses were performed to model the observed slope distress on both sides of the highway (Table 3, Case 1 and 2). A separate analysis was also run to analyze stability of the entire slope encompassing the affected area on either side of the highway (Case 3). These analyses were performed using the SLOPE/W software (Geoslope Inc.). The first two runs (Case 1 and 2) were performed to back calculate soil properties with incipient failure (Factor of Safety (FOS) ≤ 1 , along a failure surface defined approximately on the basis of the observed depths of movement and visible cracking on the eastbound and westbound sides of the highway (Figure 3a, 3b). Case 3 models the recent movement observed in SI_0802 at a depth of 13.5 m, using the back calculated soil properties from Case 1 and 2. A piezometric surface was entered into the models based on observed ground water table and data from previous explorations [6]. Case 3 indicates that the entire slope has a Factor of Safety close to unity.
