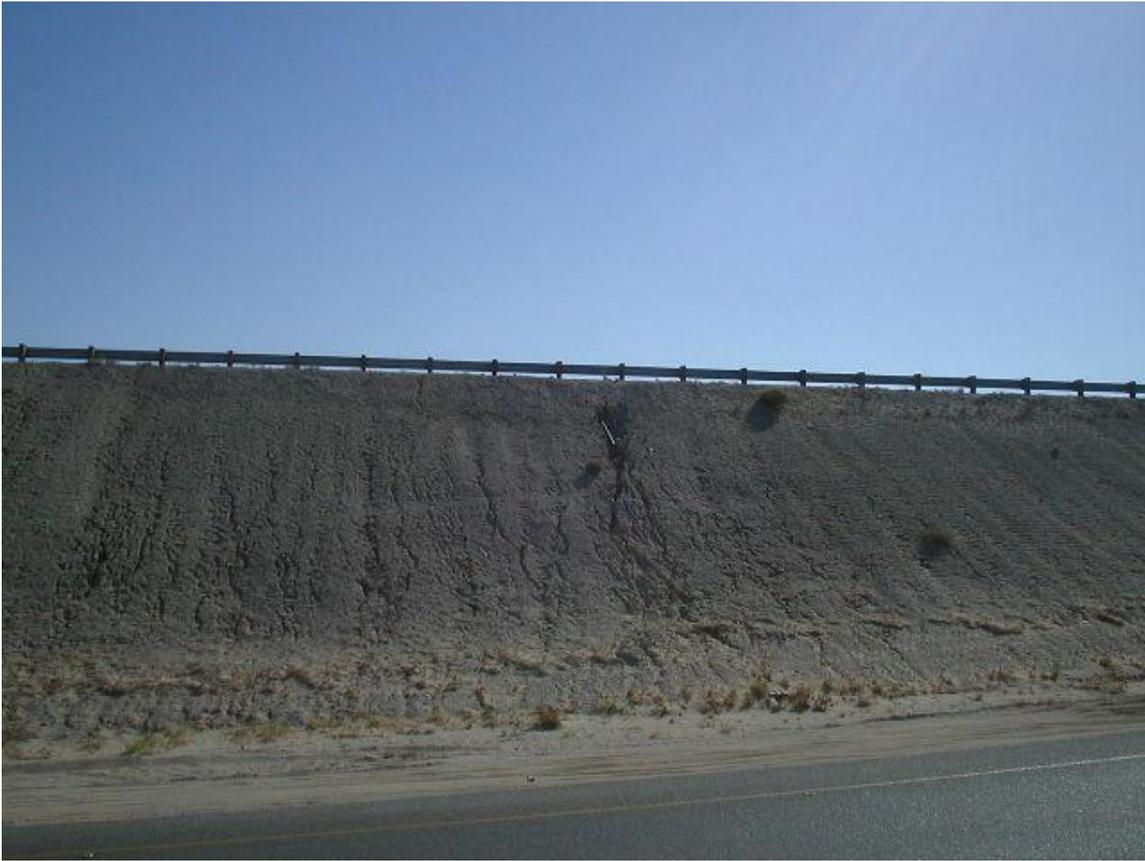
Figure 7A: Erosion rills formed on 1:2 (V:H) embankment at intersection of Ca 58 and East Main Street, Barstow.

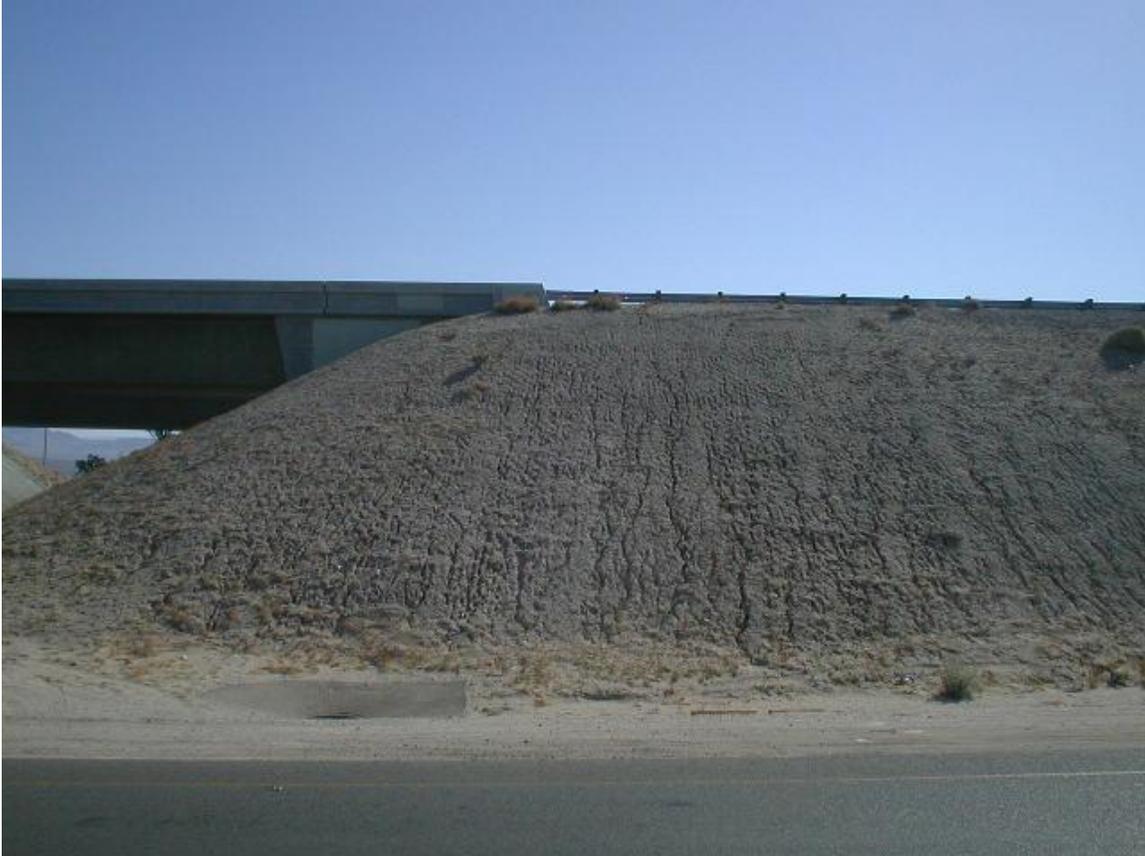
Figure 7B: Erosion rills formed on 1:2 bridge approach embankment at intersection of Ca 58 and East Main Street, Barstow.

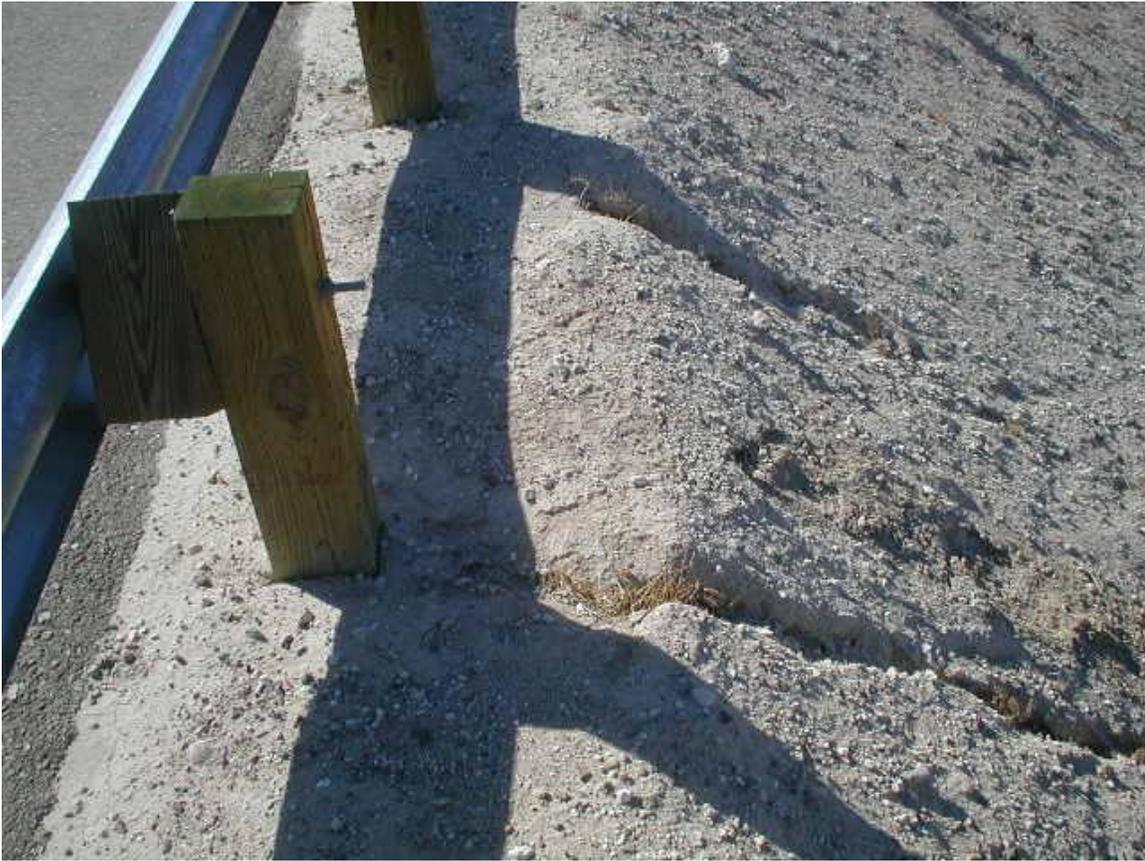
Figure 7C: Erosion rills formed on 1:2 embankment consequent to depressions created by installation of guard rail supports at Ca 58.

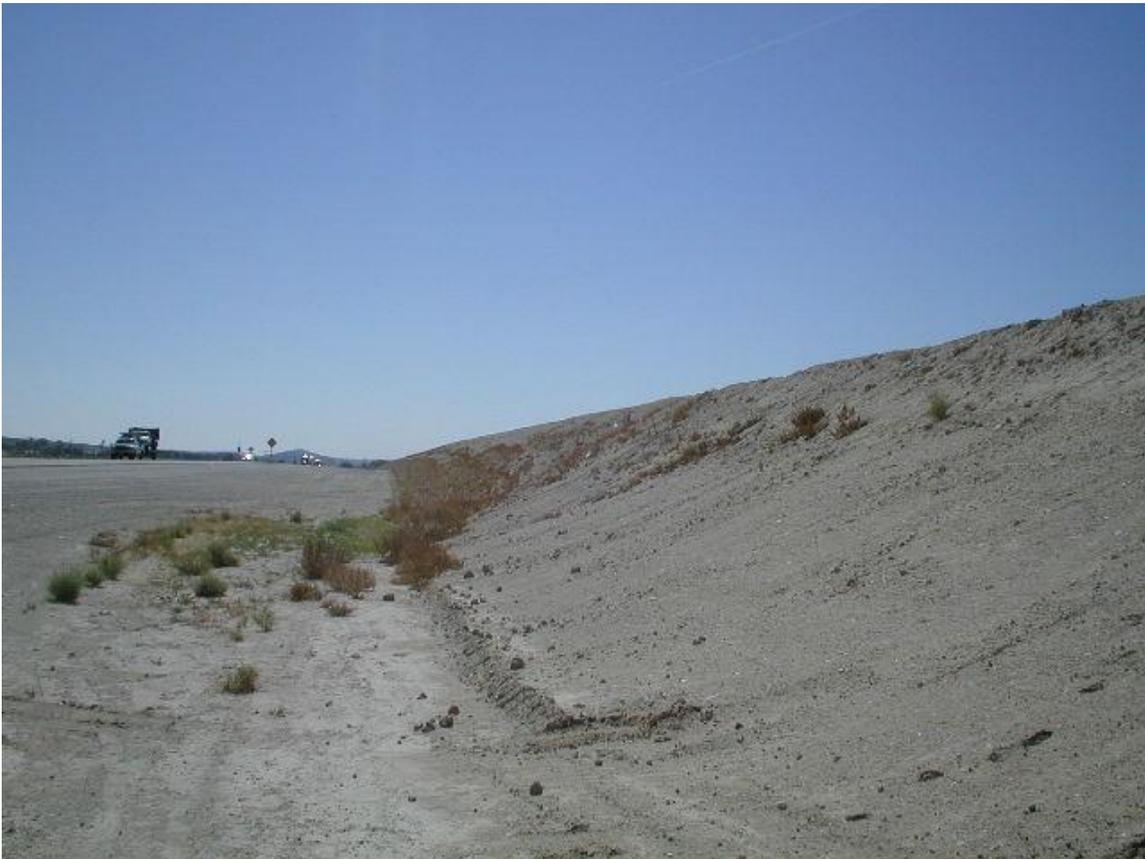
Figure 7D: Uncompact soil stockpile standing at 1:2 (V:H) slope, exhibiting no failures and only moderate erosion.

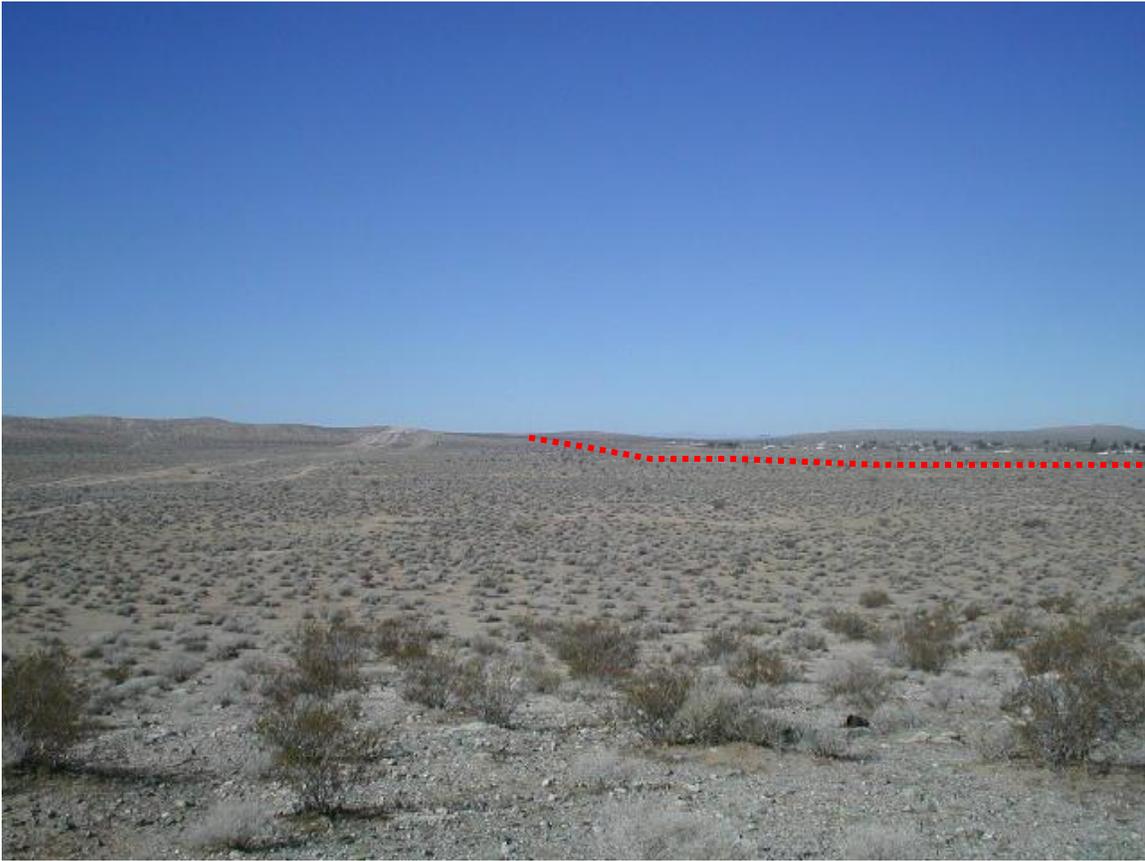
Figure 7E: Trend of proposed realignment. View looking west toward hills where cut section will be excavated.

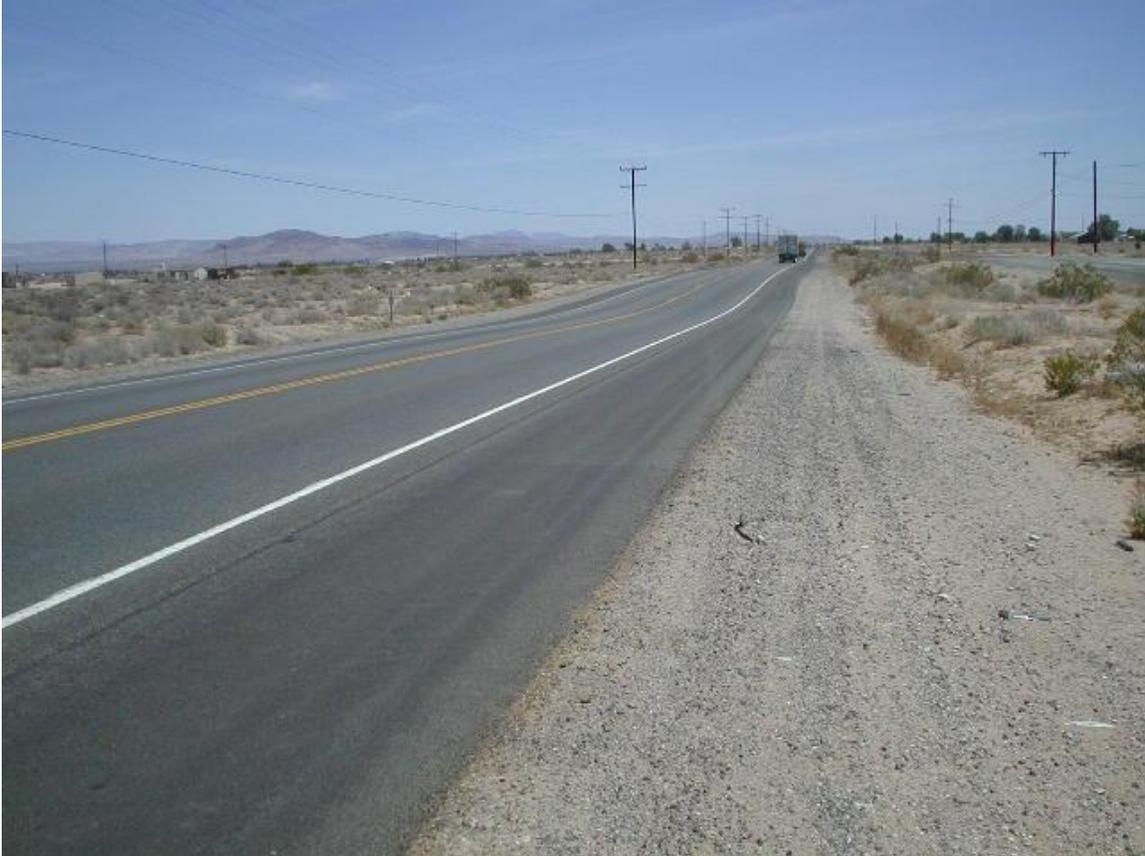
Figure 7F: View east toward small drainage dip in the existing Ca 58 at Valley View Road.

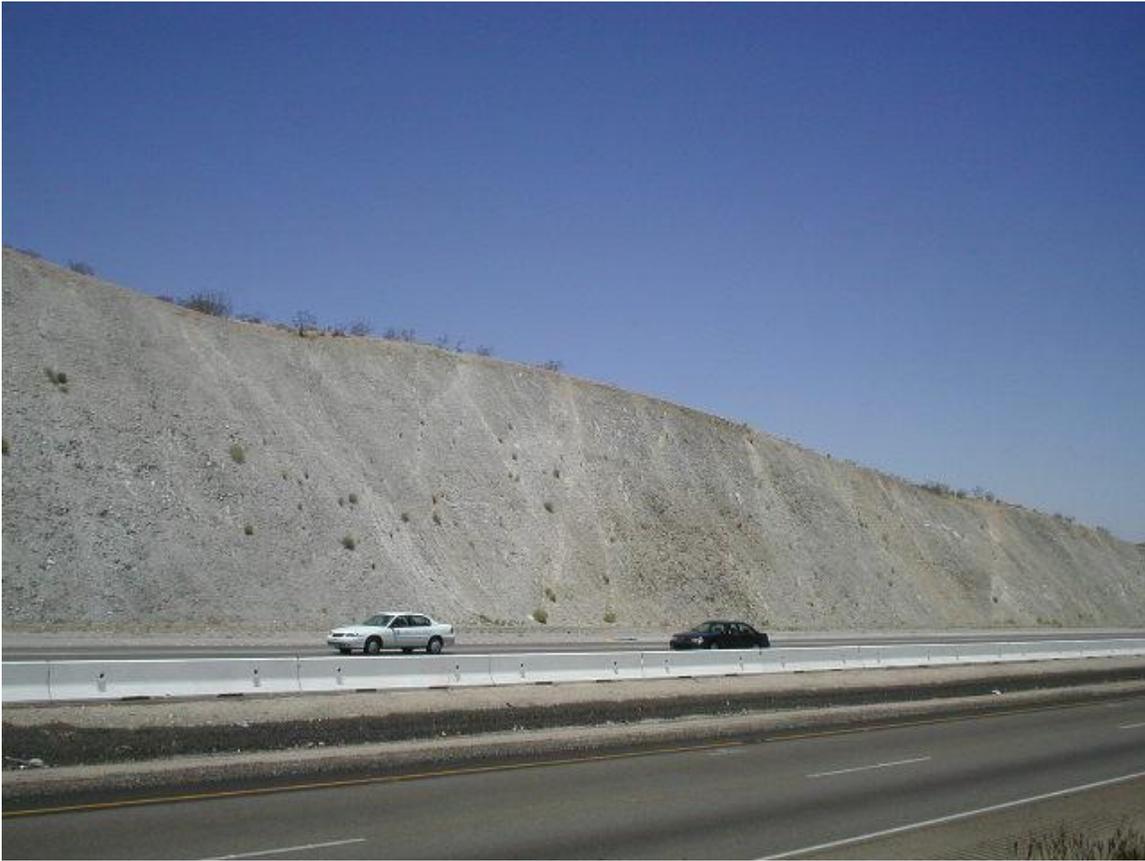
Figure 7G: View west toward 1:1 (V:H) cut in rock on Route 15 southbound. Only minor raveling occurring on slope.

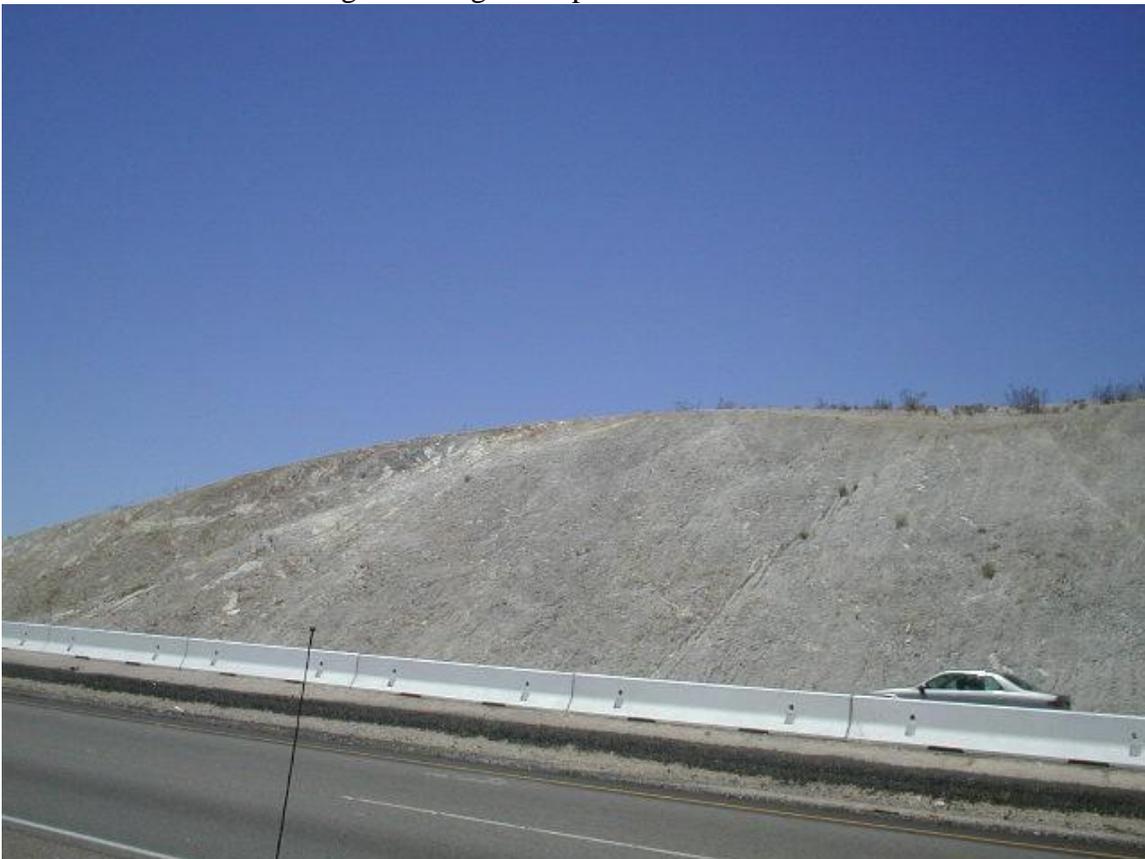
Figure 7H: View south toward cut in rock on Route 15 southbound. Intensely fractured cut face remaining relatively stable 1-year after excavation.
