**For Contract No. 08-0G8404
At 08-SBd,Sac-5,15-23.3,107.3**

**ASBESTOS AND LEAD BASED PAINT
SURVEY REPORT
C.V. Kane Safety Roadside Rest Area (SRRA)
San Bernardino County, California**

**Prepared for:
California Department of Transportation, District 8
Task Order No. 08
Contract No. 08A1542
EA No.: 0G8400**

August 5, 2008

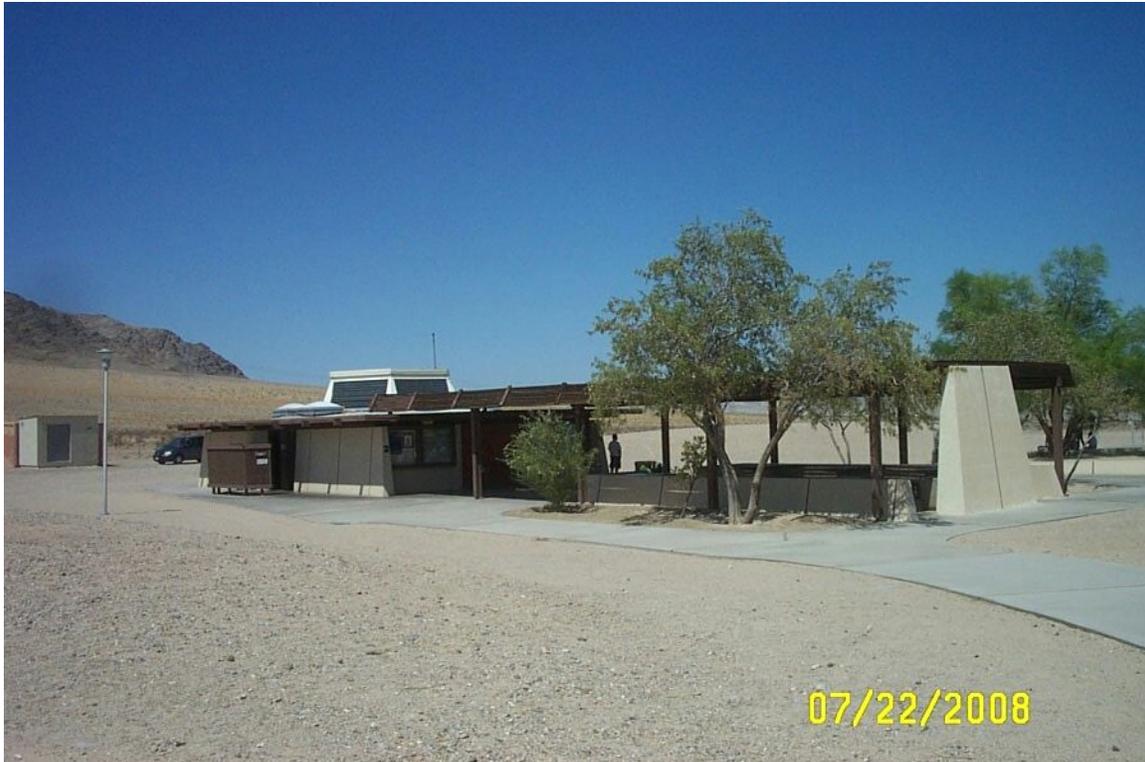
Photograph No. 1
View of Northbound Facility C.V. Kane Safety Roadside Rest Area (SRRA)

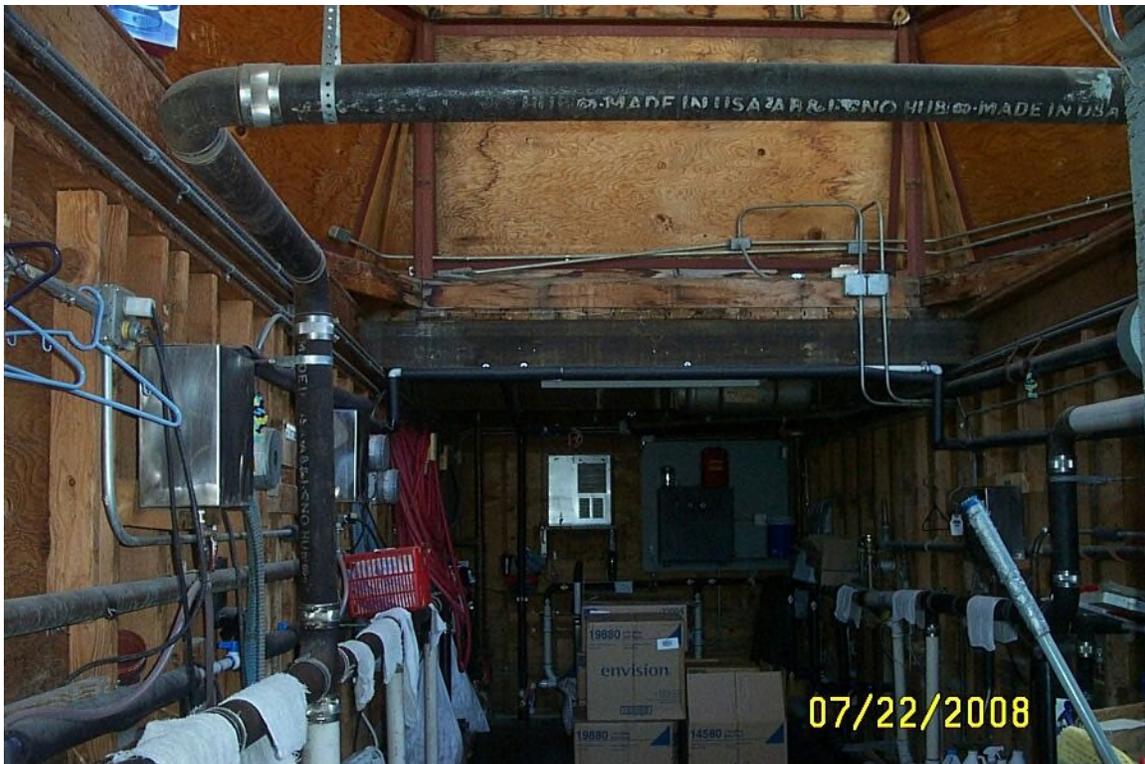
Photograph No. 2
View of Northbound Facility – Maintenance Crew Room.

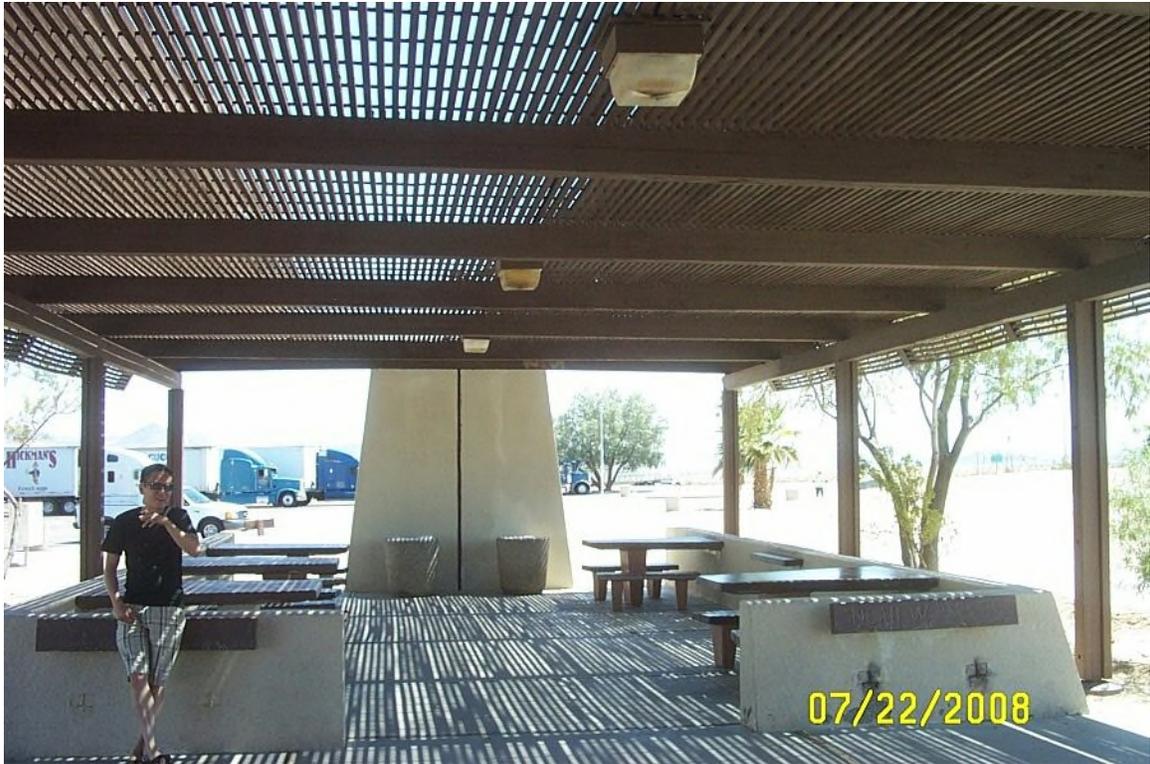
Photograph No. 3
View of Northbound Facility Picnic Shelter Area.

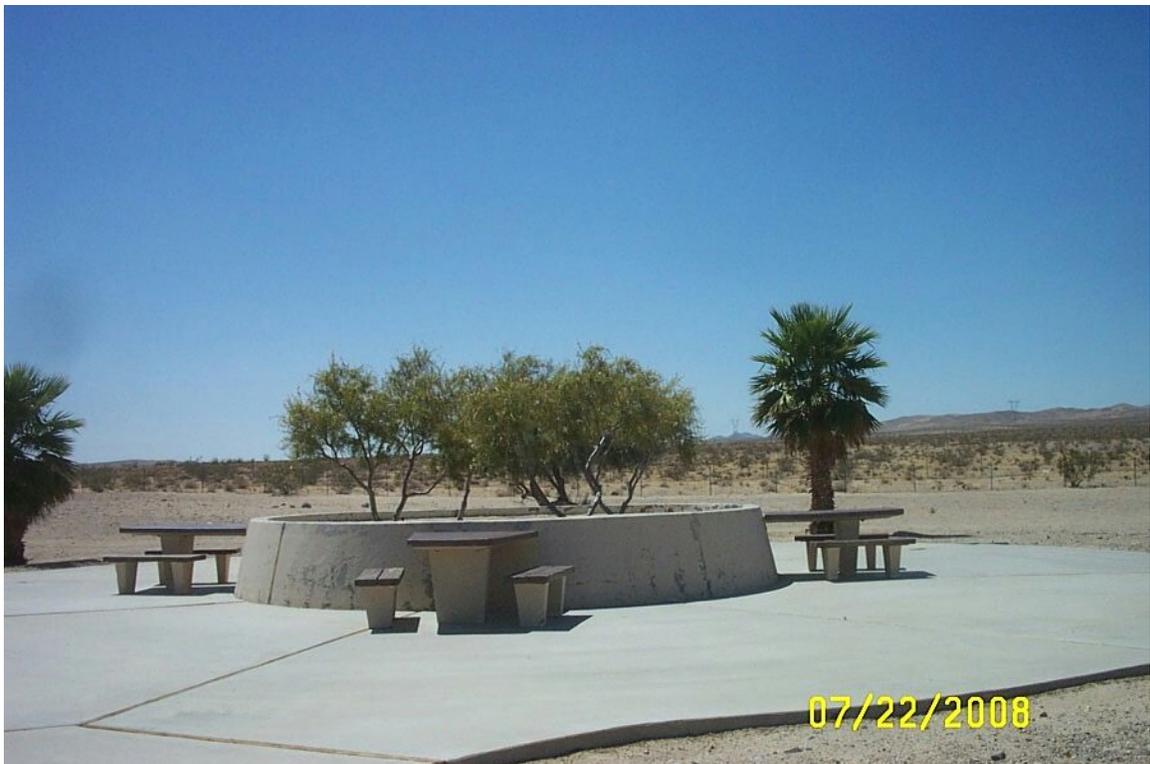
Photograph No. 4
View of Northbound Facility Picnic/Planter Area.

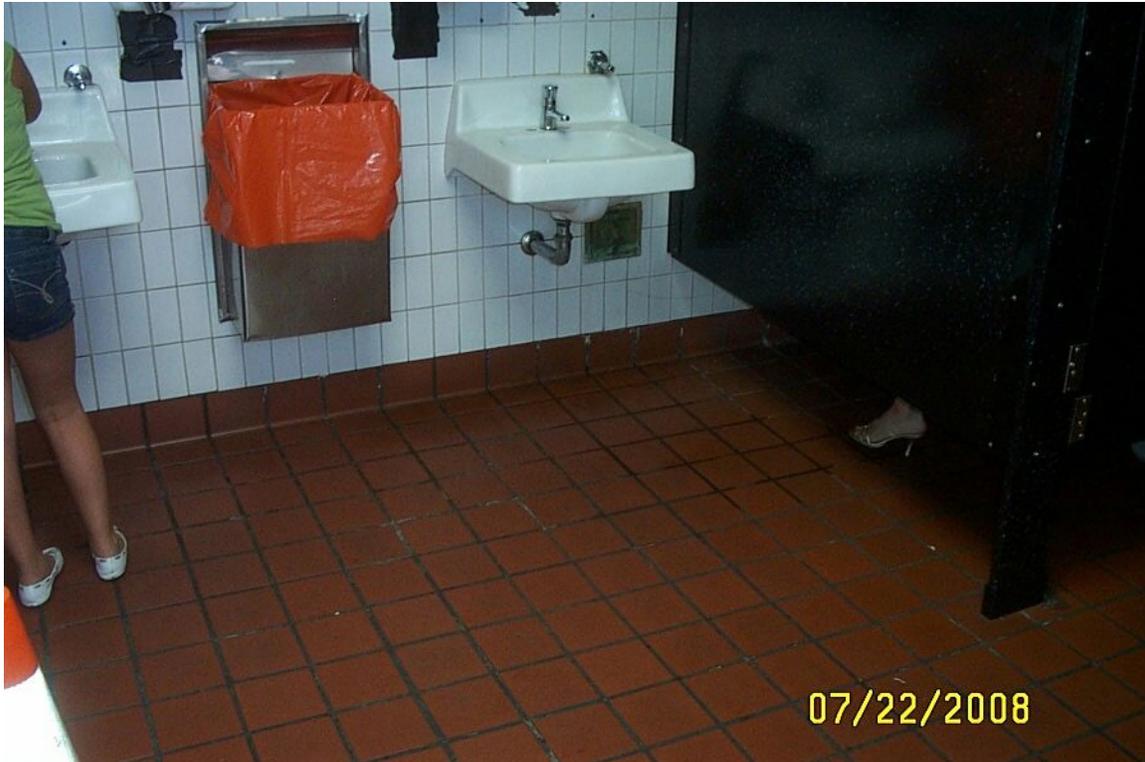
Photograph No. 5
Representative view of Northbound Facility Restroom.

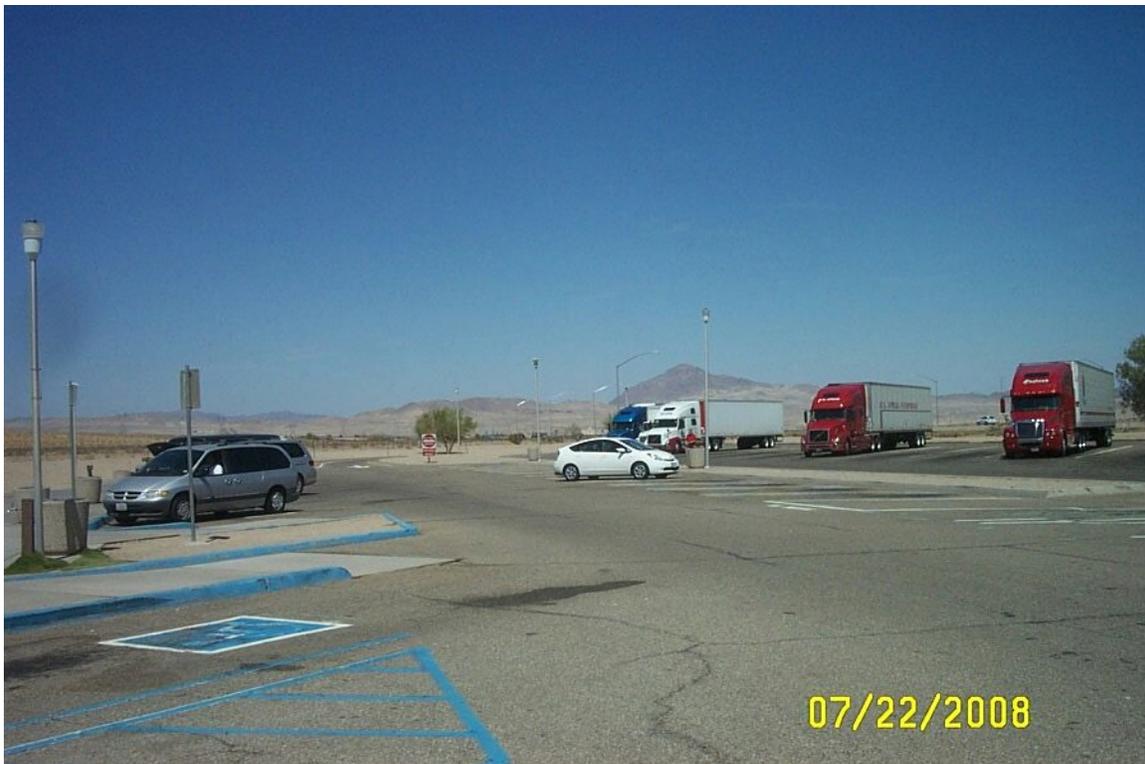
Photograph No. 6
Representative view of Northbound Facility Parking Lot.

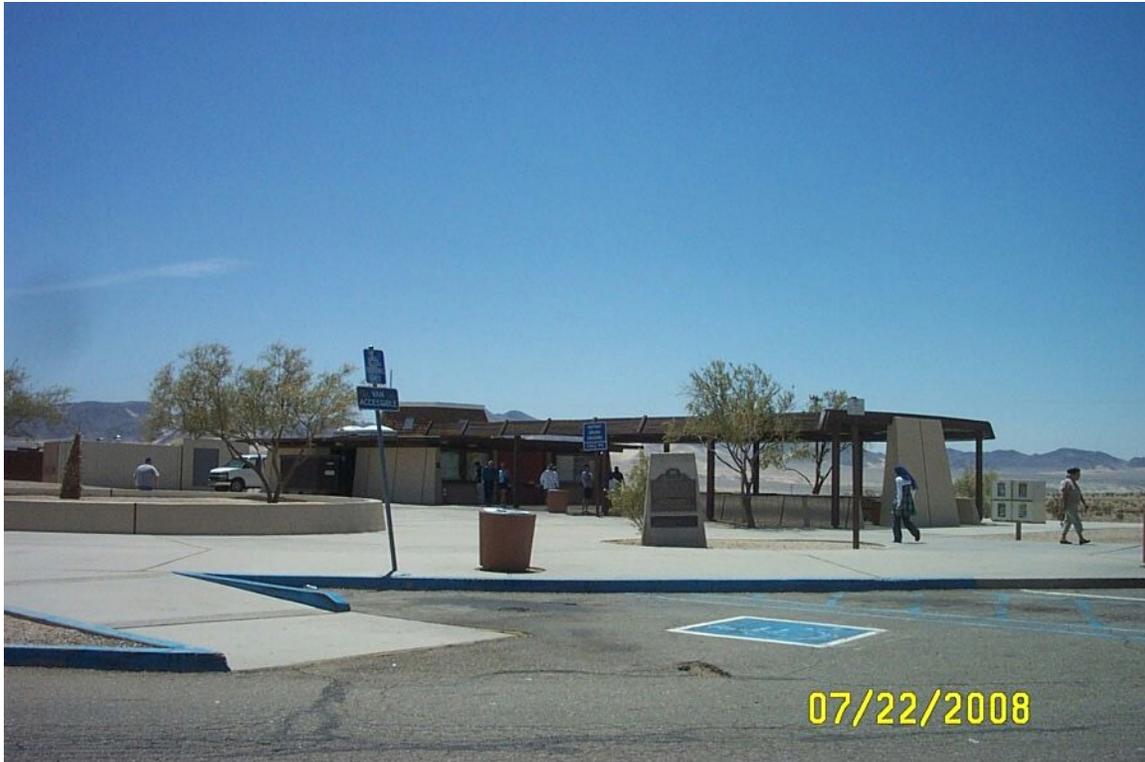
Photograph No. 7
View of Southbound Facility C.V. Kane Safety Roadside Rest Area (SRRA)

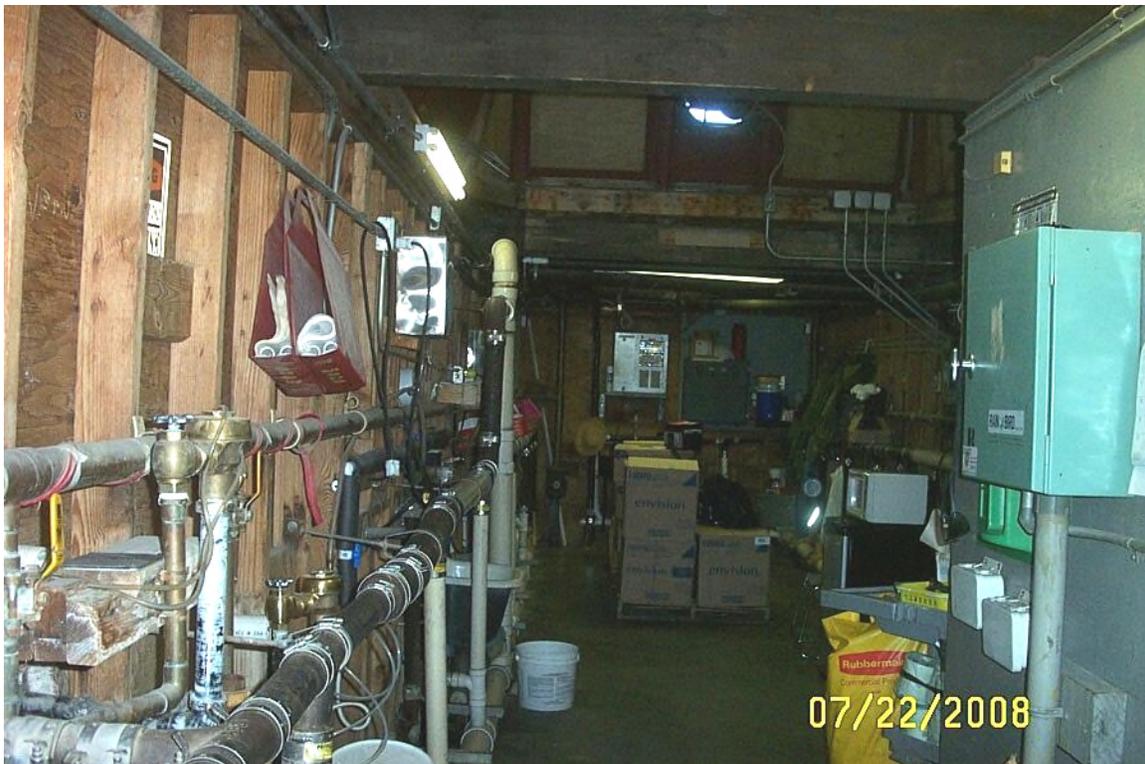
Photograph No. 8
View of Southbound Facility – Maintenance Crew Room.

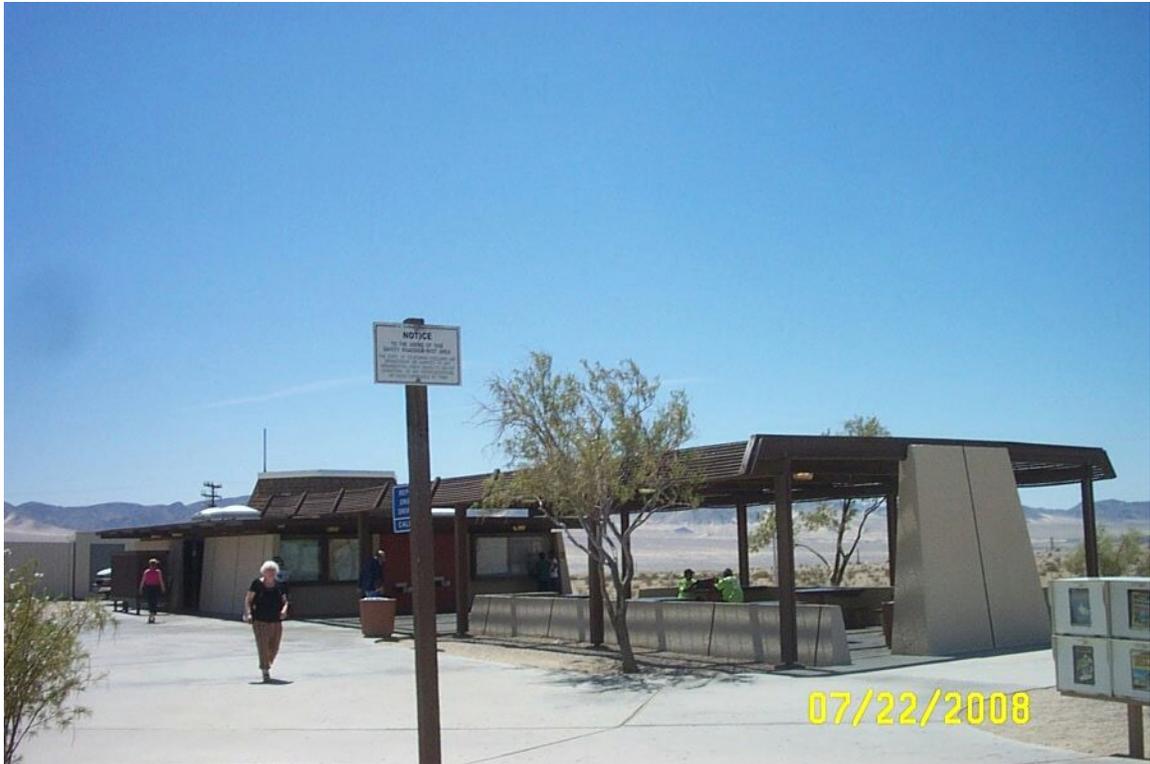
Photograph No. 9
View of Southbound Facility Picnic Shelter Area.

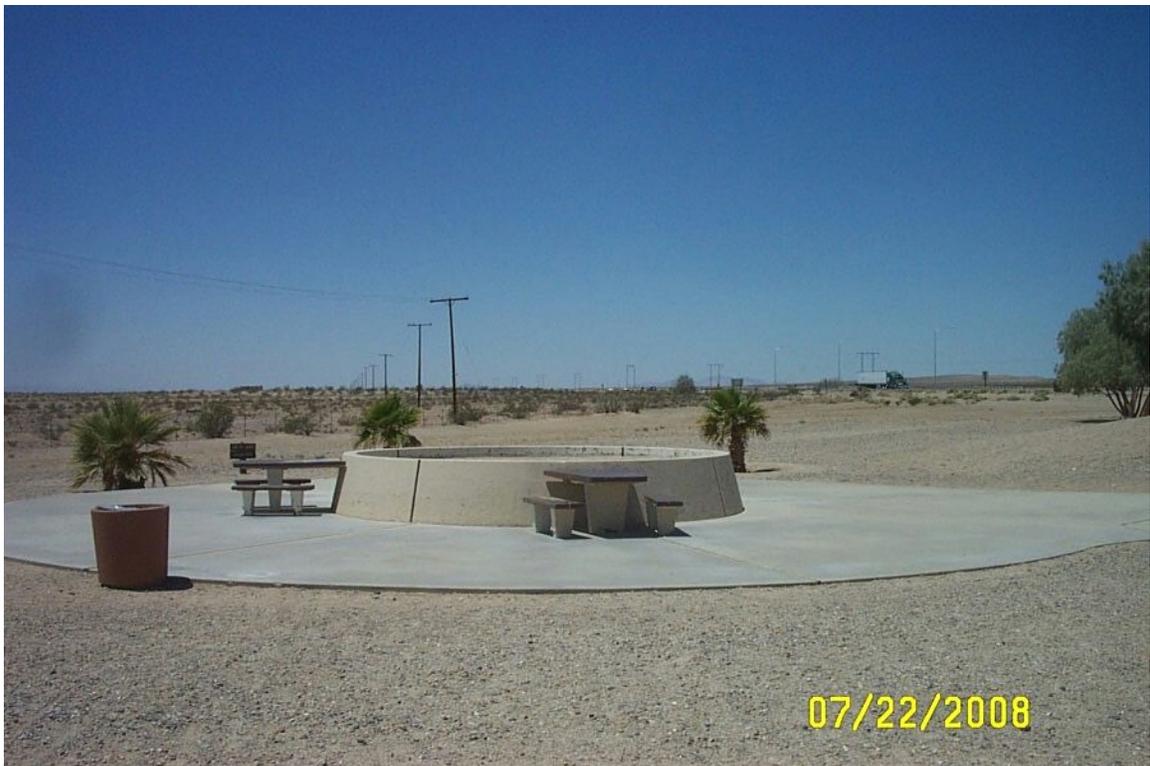
Photograph No. 10
View of Southbound Facility Picnic/Planter Area.

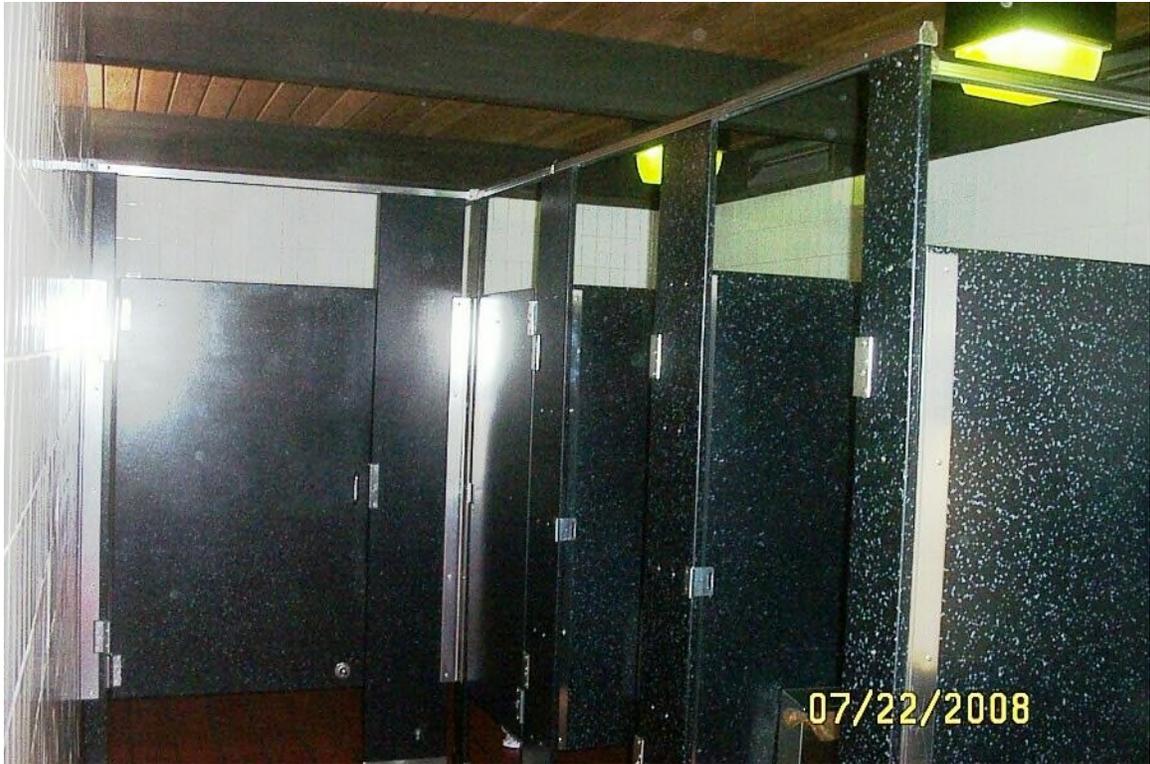
Photograph No. 11
Representative view of Southbound Facility Restroom.

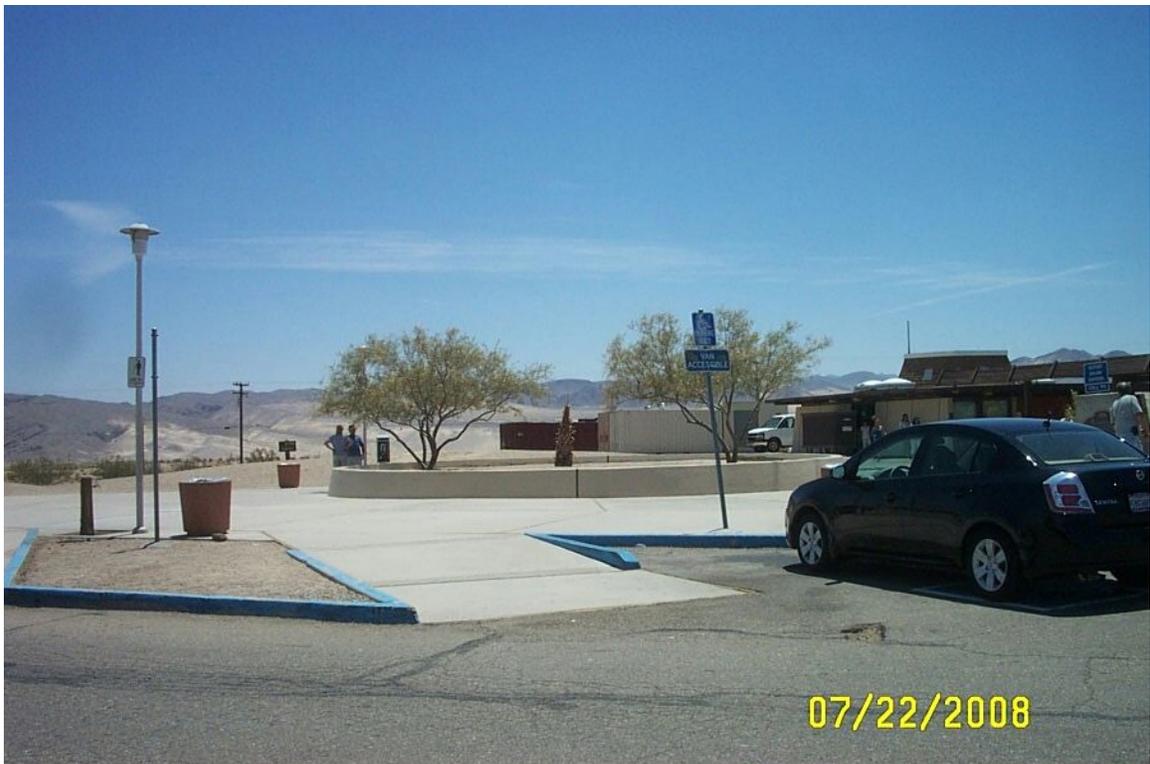
Photograph No. 12
Representative view of Southbound Facility Parking Lot.
