ASBESTOS AND DETERIORATED LEAD-CONTAINING PAINT SURVEY

**Bishop Maintenance Station
Bishop, California**

**GEOCON PROJECT NO. S9200-06-52
CALTRANS CONTRACT 06A1141
TASK ORDER NO. 52, EA NO. 09-310601**

Subject: BISHOP MAINTENANCE STATION (SHOP 29)
500 MAIN STREET IN BISHOP, INYO COUNTY, CALIFORNIA
CONTRACT NO. 06A1141
TASK ORDER NO. 52, EA NO. 09-310601
ASBESTOS AND DETERIORATED LEAD-CONTAINING PAINT SURVEY

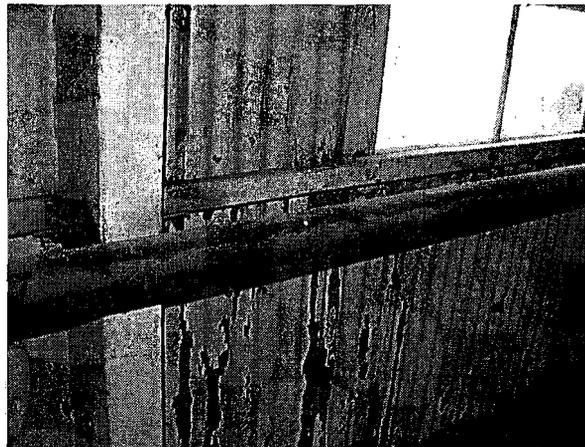
Photo 6 – Tire shed interior

A sample representing approximately 25 square feet of deteriorated white interior paint used in the tire shed exhibited a total lead concentration of 260 mg/kg and a soluble (WET) lead concentration of 1.9 mg/l.

Deteriorated lead-containing white interior paint in the tire shed would not be classified as a California or Federal hazardous waste based on lead content.

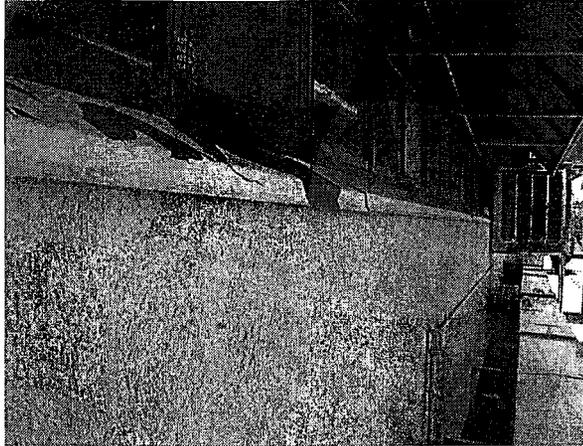
Photo 16 – Main shop exterior

A sample representing approximately 50 square feet of deteriorated beige exterior paint used on the main shop exhibited a total lead concentration of 2,000 mg/kg and a soluble (TCLP) lead concentration of 3.0 mg/l.

We recommend that peeling/flaking beige exterior paint on the main shop (a California hazardous waste based on total lead content) be removed and disposed of prior to renovation, demolition, or other activities that would disturb the material. The contractor should be required to use personnel who have lead-related construction certification as supervisors or workers, as appropriate, from the California DHS for LCP removal work. Loose and peeling/flaking LCP require removal prior to demolition for
