FOUNDATION REPORT AND SUPPLEMENTAL FOUNDATION REPORT

ROUTE: 10-Tuo-108-58.8

Subject: Supplemental Foundation Report

Geotechnical Recommendations
September 5, 2006
State Route 108 Slope Repair
EA 10-0M2401
10-TUO-108 PM 58.8

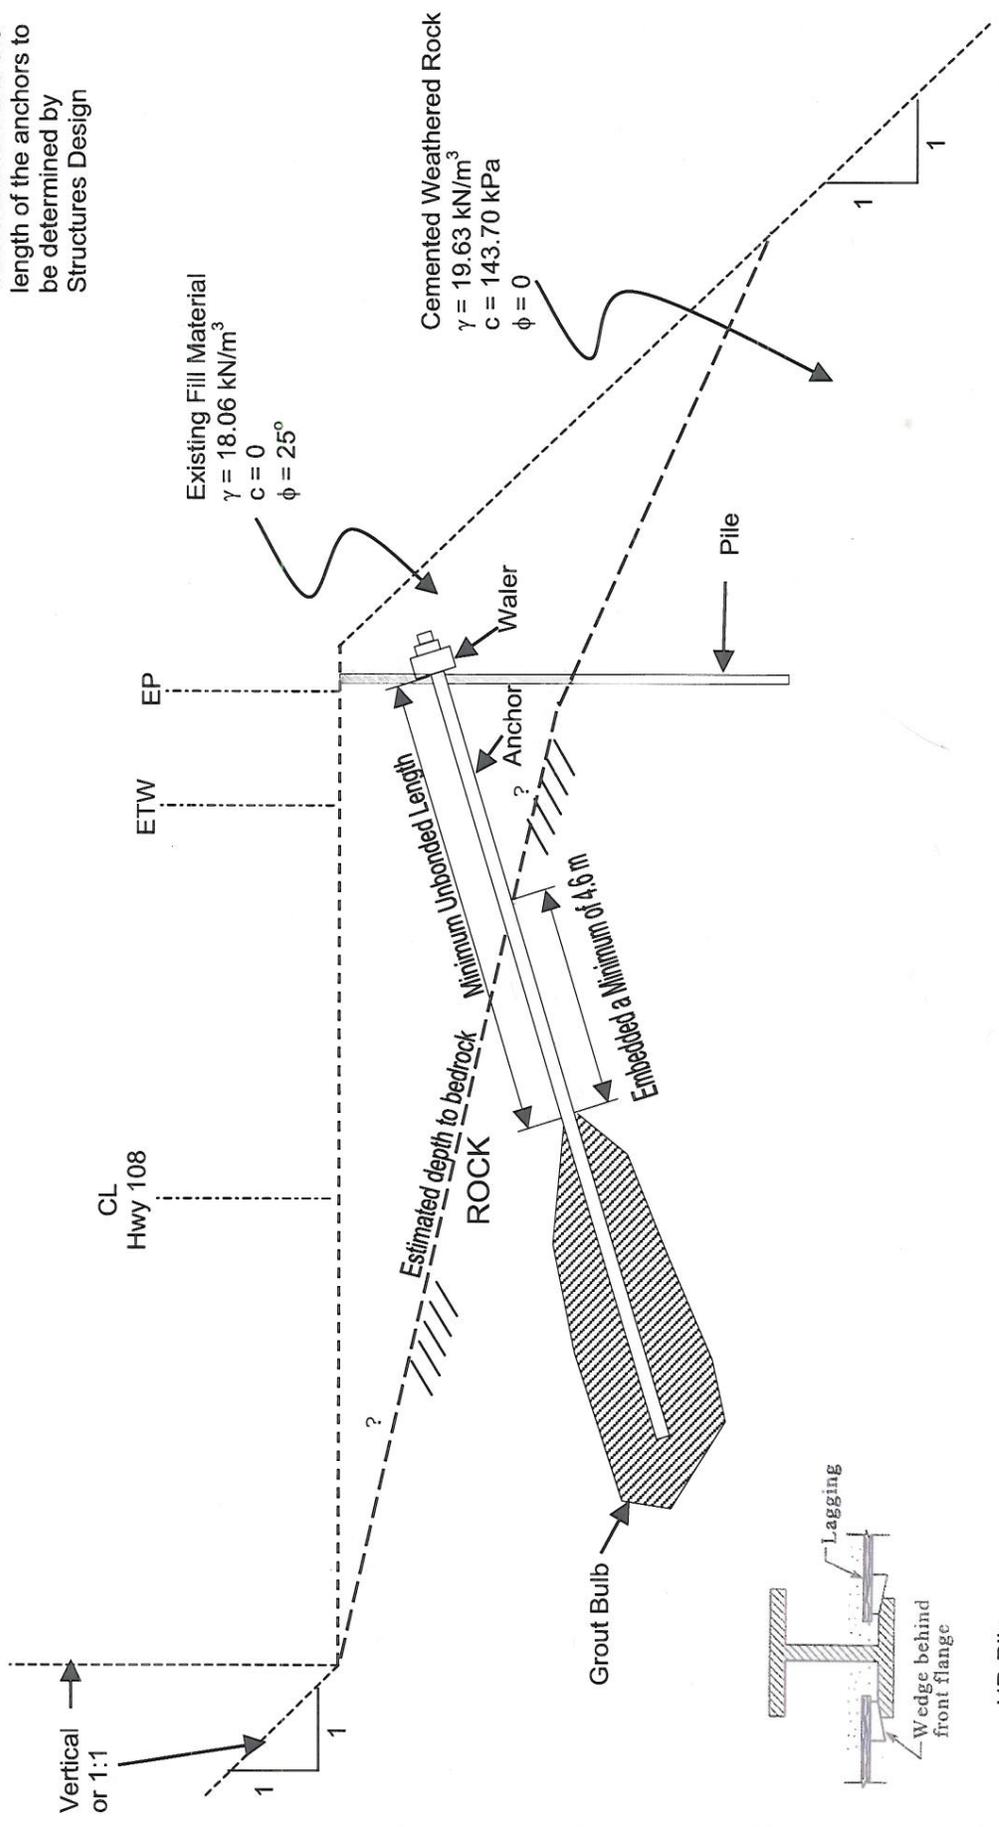
Figure No. 1

A soldier pile wall consists of piles typically set at 1.8 to 3 meter spacing and lagging which spans the distance between the piles. The lagging is used to retain the soil and transmit the lateral earth pressure to the piles. The most common pile used is the HP-pile or a pile with wide flange sections. The lagging is typically timber or prefabricated concrete. The piles would be installed and concreted into pre-drilled holes. The wall is built from the top down where the soil is excavated one level at a time, placing the lagging as the excavation proceeds. A waler, if necessary, is then attached to the piles and tie back anchors are installed and attached to the waler. Typically a waler and anchors are used for wall heights greater than 4 meters. This sequence is continued until the desired height of the wall is reached. A cross section of a soldier pile wall is presented as Figure No. 1.

Note: The number of
 walers/anchors and the
 length of the anchors to
 be determined by
 Structures Design

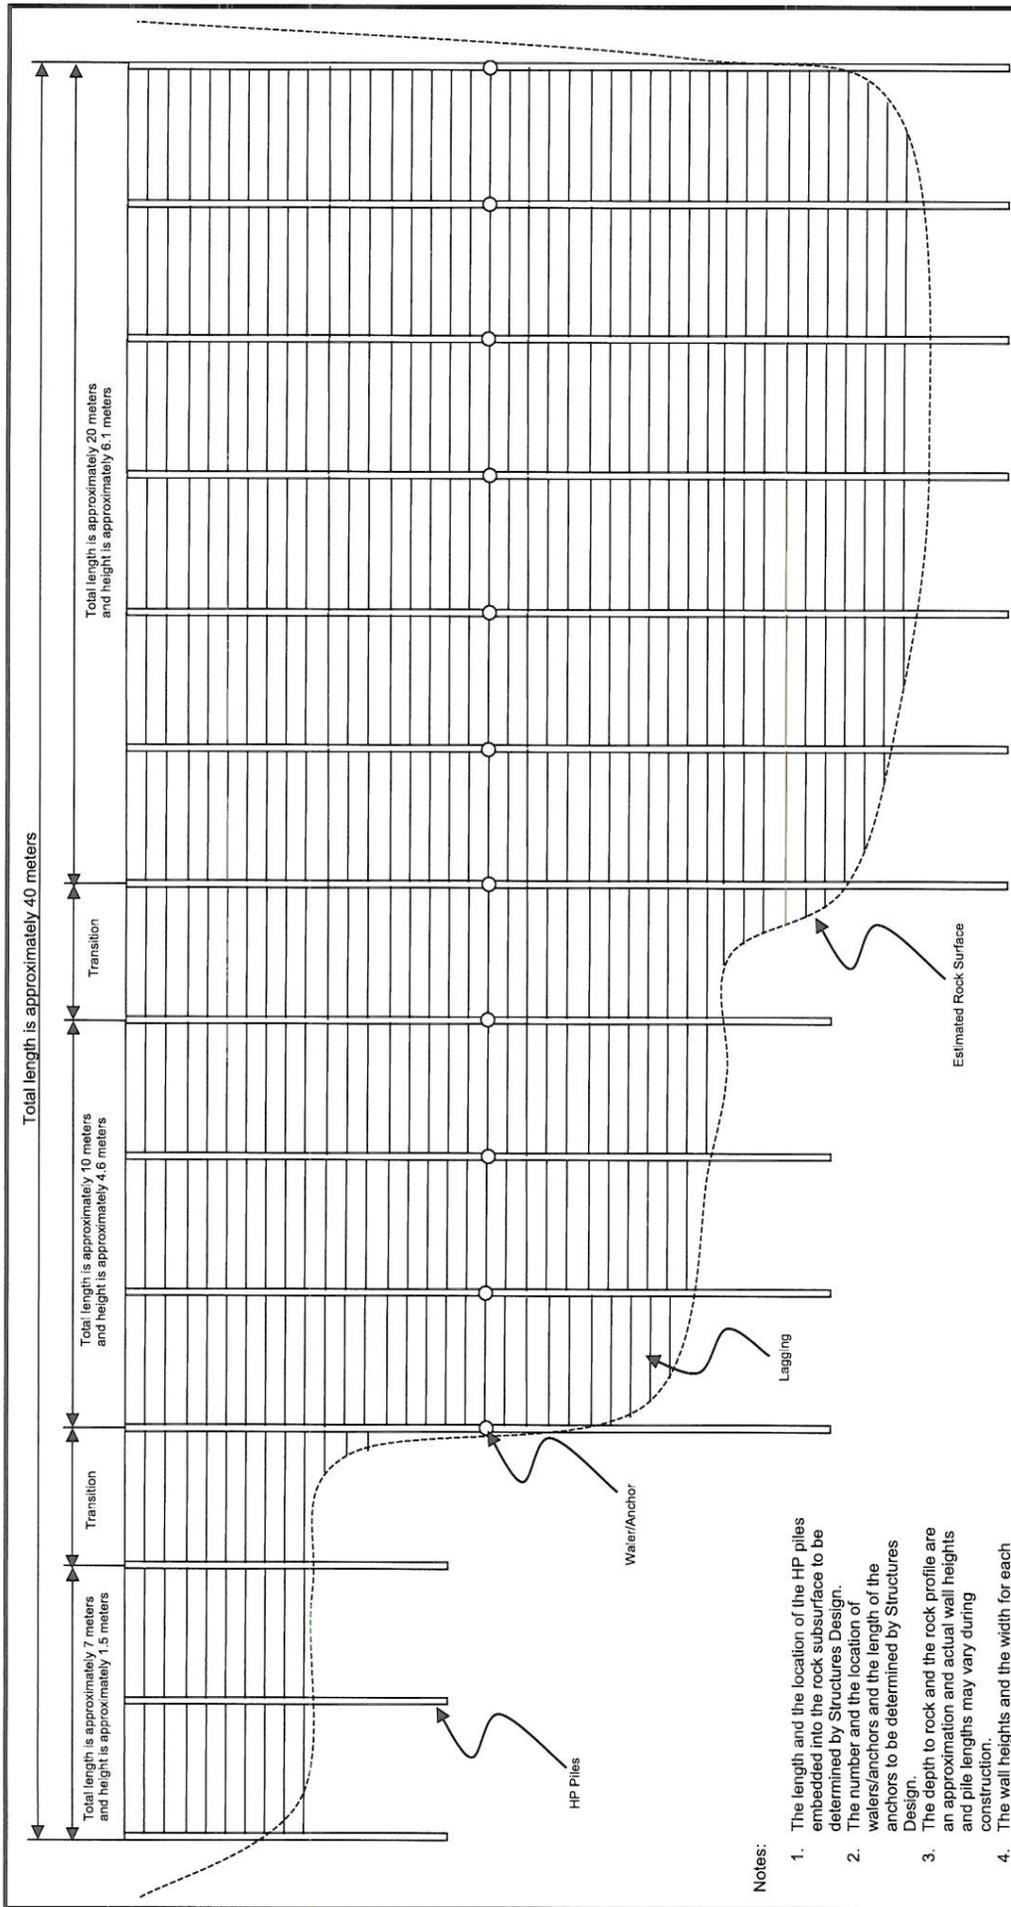
Figure No. 2

Total length is approximately 20 meters and height is approximately 6.1 meters

Total length is approximately 10 meters and height is approximately 4.6 meters

Total length is approximately 7 meters and height is approximately 1.5 meters

Estimated Rock Surface

1. The length and the location of the HP piles embedded into the rock subsurface to be determined by Structures Design.
2. The number and the location of the walers/anchors and the length of the anchors to be determined by Structures Design.
3. The depth to rock and the rock profile are an approximation and actual wall heights and pile lengths may vary during construction.
4. The wall heights and the width for each height are approximations.
5. The transition zone is changing from one pile length and wall height to another length and height. The location of transition will be determined during construction.

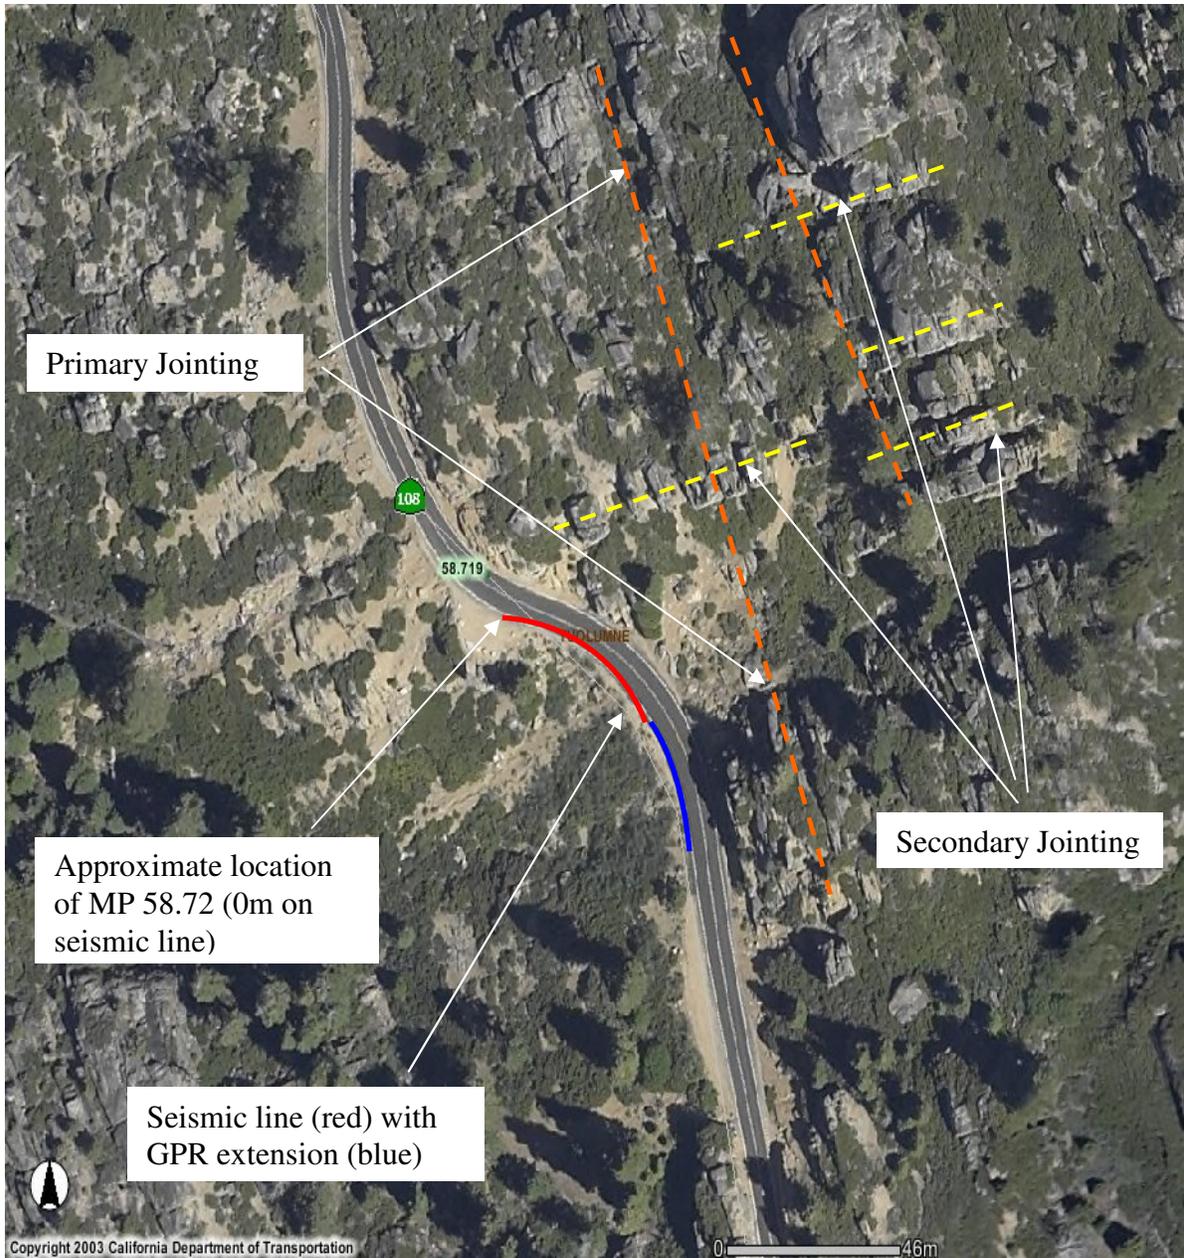
Field data were acquired on August 12, 2010. The geometry of the site limited our options for investigation (Figure 1). We ran a seismic refraction line and a GPR profile along the southwestern (eastbound) edge of the existing roadway in an attempt to differentiate between loose slide material and bedrock below it (Figure 2, Plates 1 and 2). Bedrock is visible below and above the roadway. The roadway itself appears to be constructed within several active and inactive debris chutes bounded by granitic bedrock.

Figure 1. Aerial photo showing location of the site on Highway 108, regional geologic trend of granitic outcrop and its jointing, and location of the seismic line.

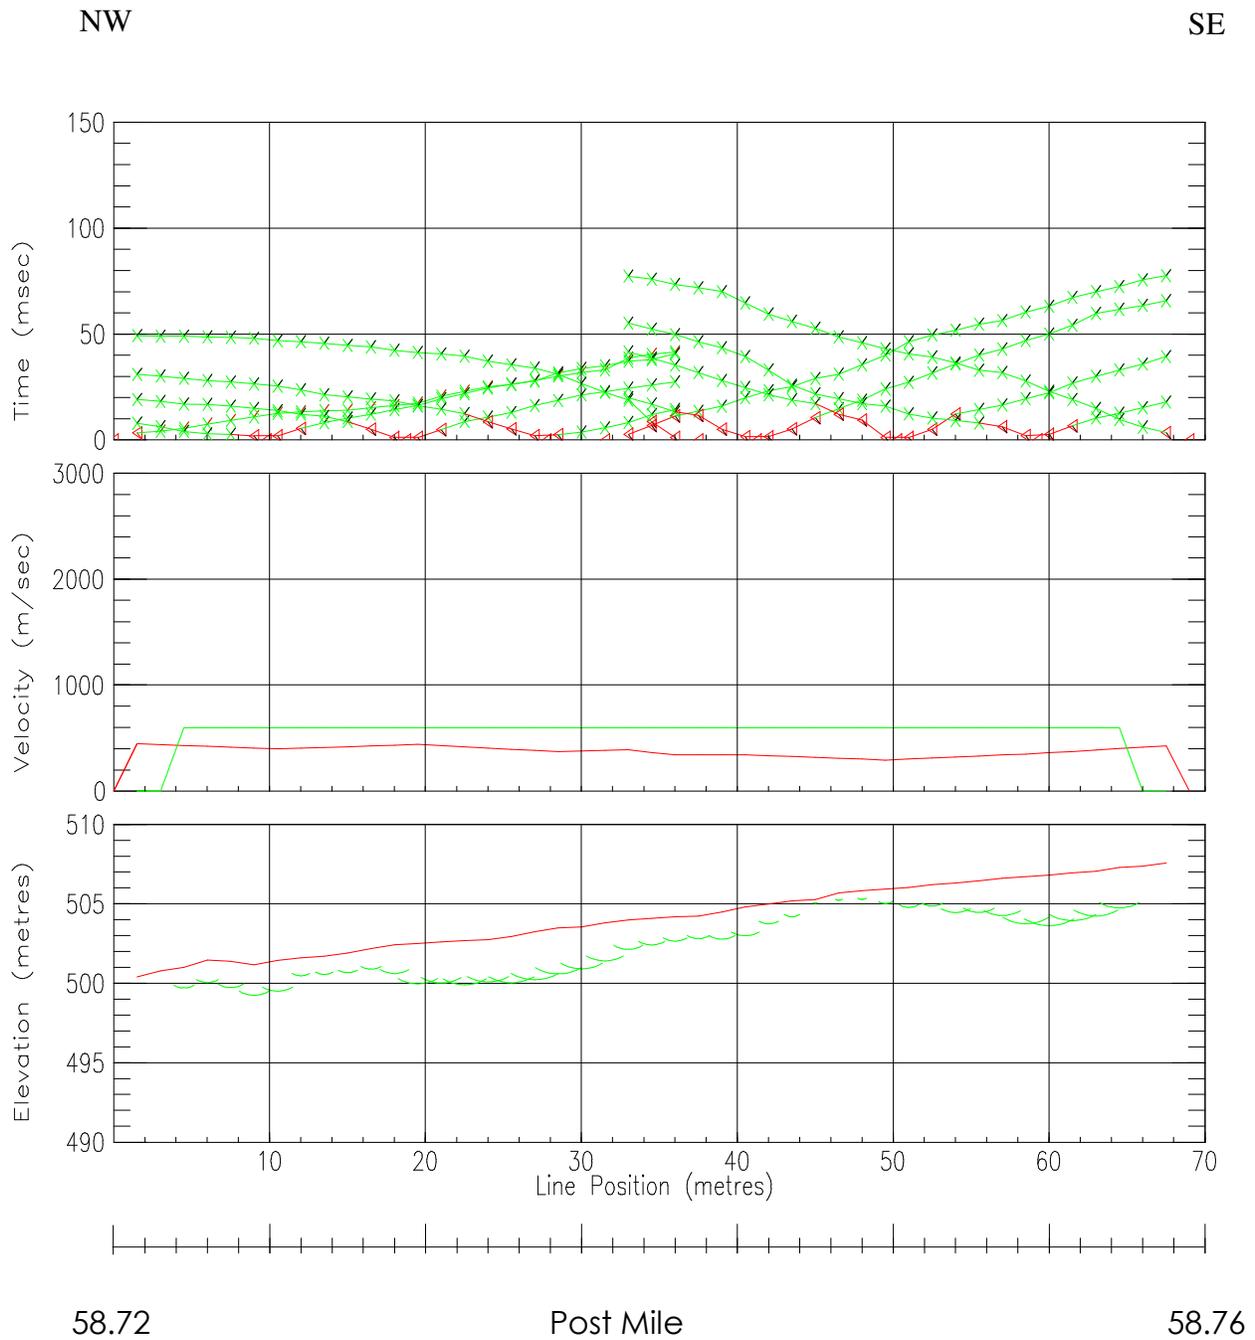
We anticipated bedrock seismic velocity should be much faster than loose slide debris lying above it. However, results revealed only a single, shallow refractor with velocity of about 600 m/sec. (1970 ft/sec., see Figure 2). Velocity of the fill and colluvial material overlying the refractor was measured at 320m/sec., (1050 ft/sec.). From observations of rock exposures, the measured seismic velocity for the refractor, if associated with granitic bedrock under the profile, appears to be anomalously slow. Correlation of the seismic profile with the GPR data does not lead to the conclusion of a spurious model, but neither can this velocity zone be interpreted as consisting of intact rock. It is highly likely that the velocity unit identified by the refractor does not represent homogeneous bedrock and is instead originating from a heterogeneous surface comprised of granitic bedrock, compacted fill or colluvium, and possibly even buried pavement.

Figure 2. Travel time curve, velocity model and depth section for the seismic line. Model does not support the existence of bedrock as large intact blocks below the refractor. Post mile stationing is approximate. See text for discussion.

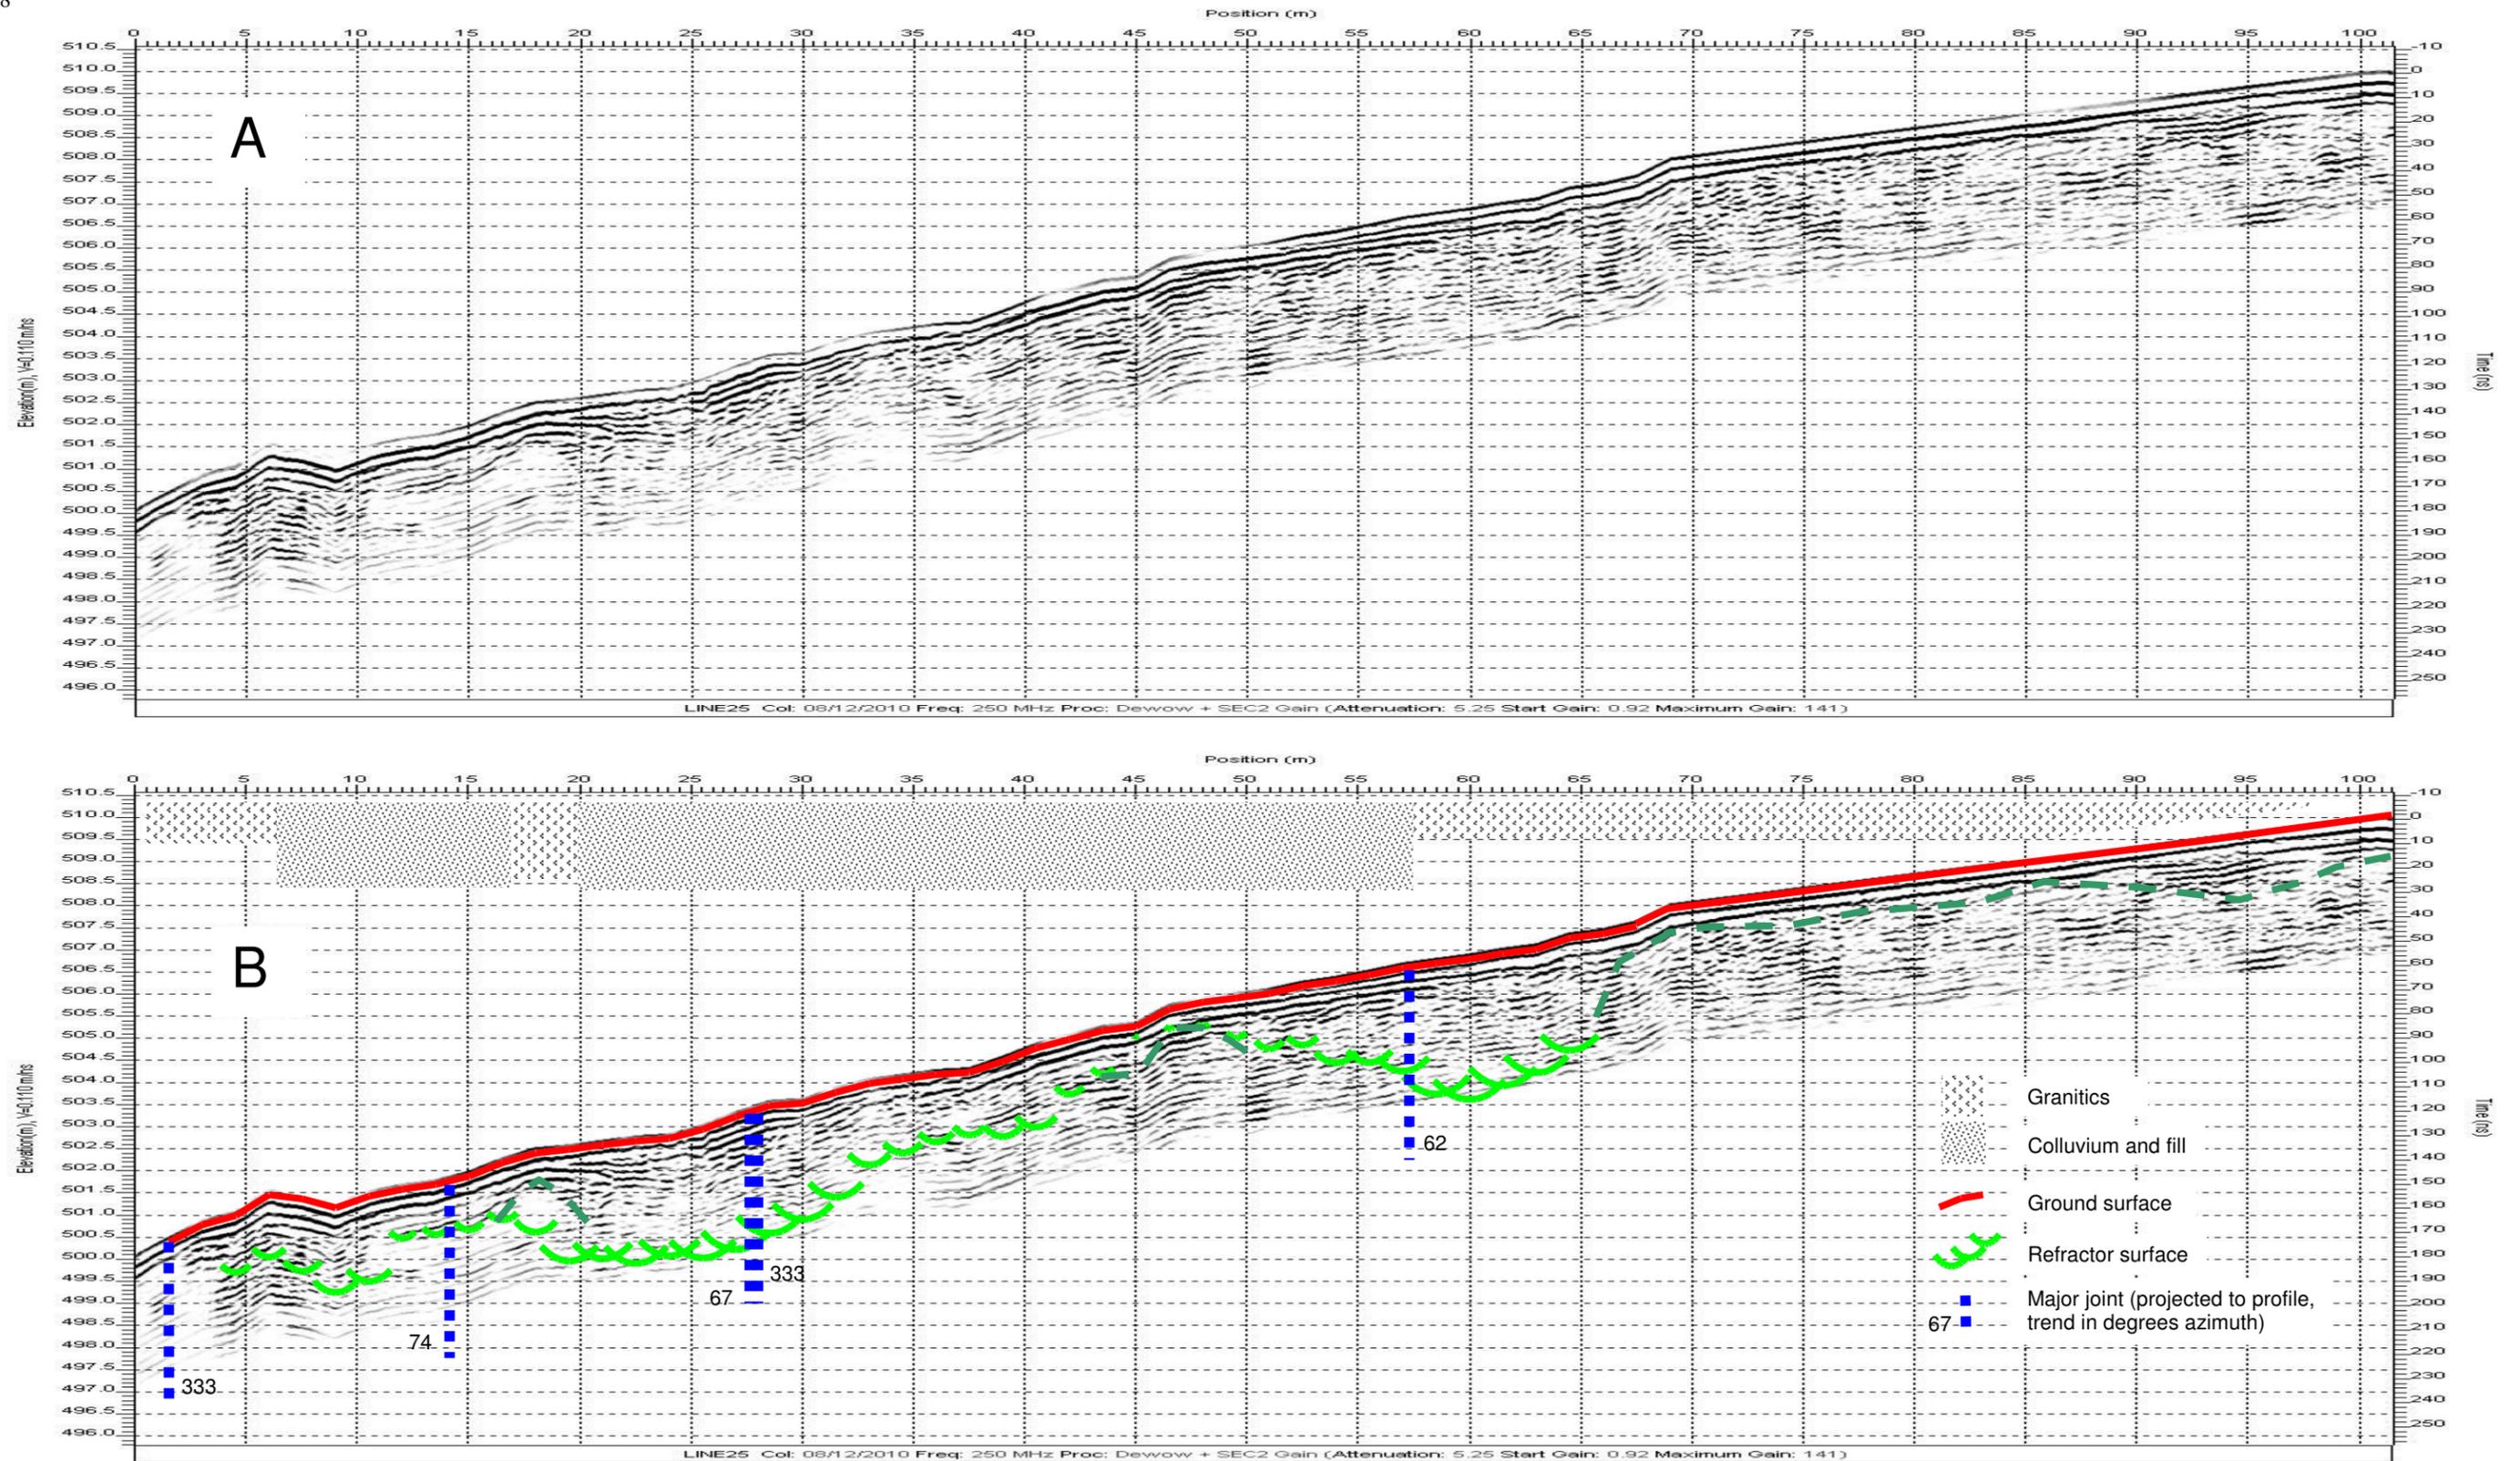
Comparison of the refraction seismic data to the collinear GPR profiles (Plates 1 and 2) reveals surprising agreement within the upper 2 meters (6.5 feet). The GPR signal attenuates to background below 2 m due to the lossy nature of the fill, so total thickness of the fill prism is not completely defined by GPR. At various locations above the refractor, GPR reflections demonstrate characteristics associated with repaired fill prisms, such as boulders or rubble and buried pavement. In addition, the GPR data reveal some shallow bedrock contacts not defined by the refraction model.

Plate 1. Correlation of GRM seismic and 250 MHz radar profiles. A) Original and B) interpreted sections. Material composition at top of (B) projected from observations of outcrop along the cut (westbound shoulder) and embankment (eastbound shoulder). GRM data terminates at 65 meters; dashed green lines represent interpreted base of colluvium and fill from GPR data.

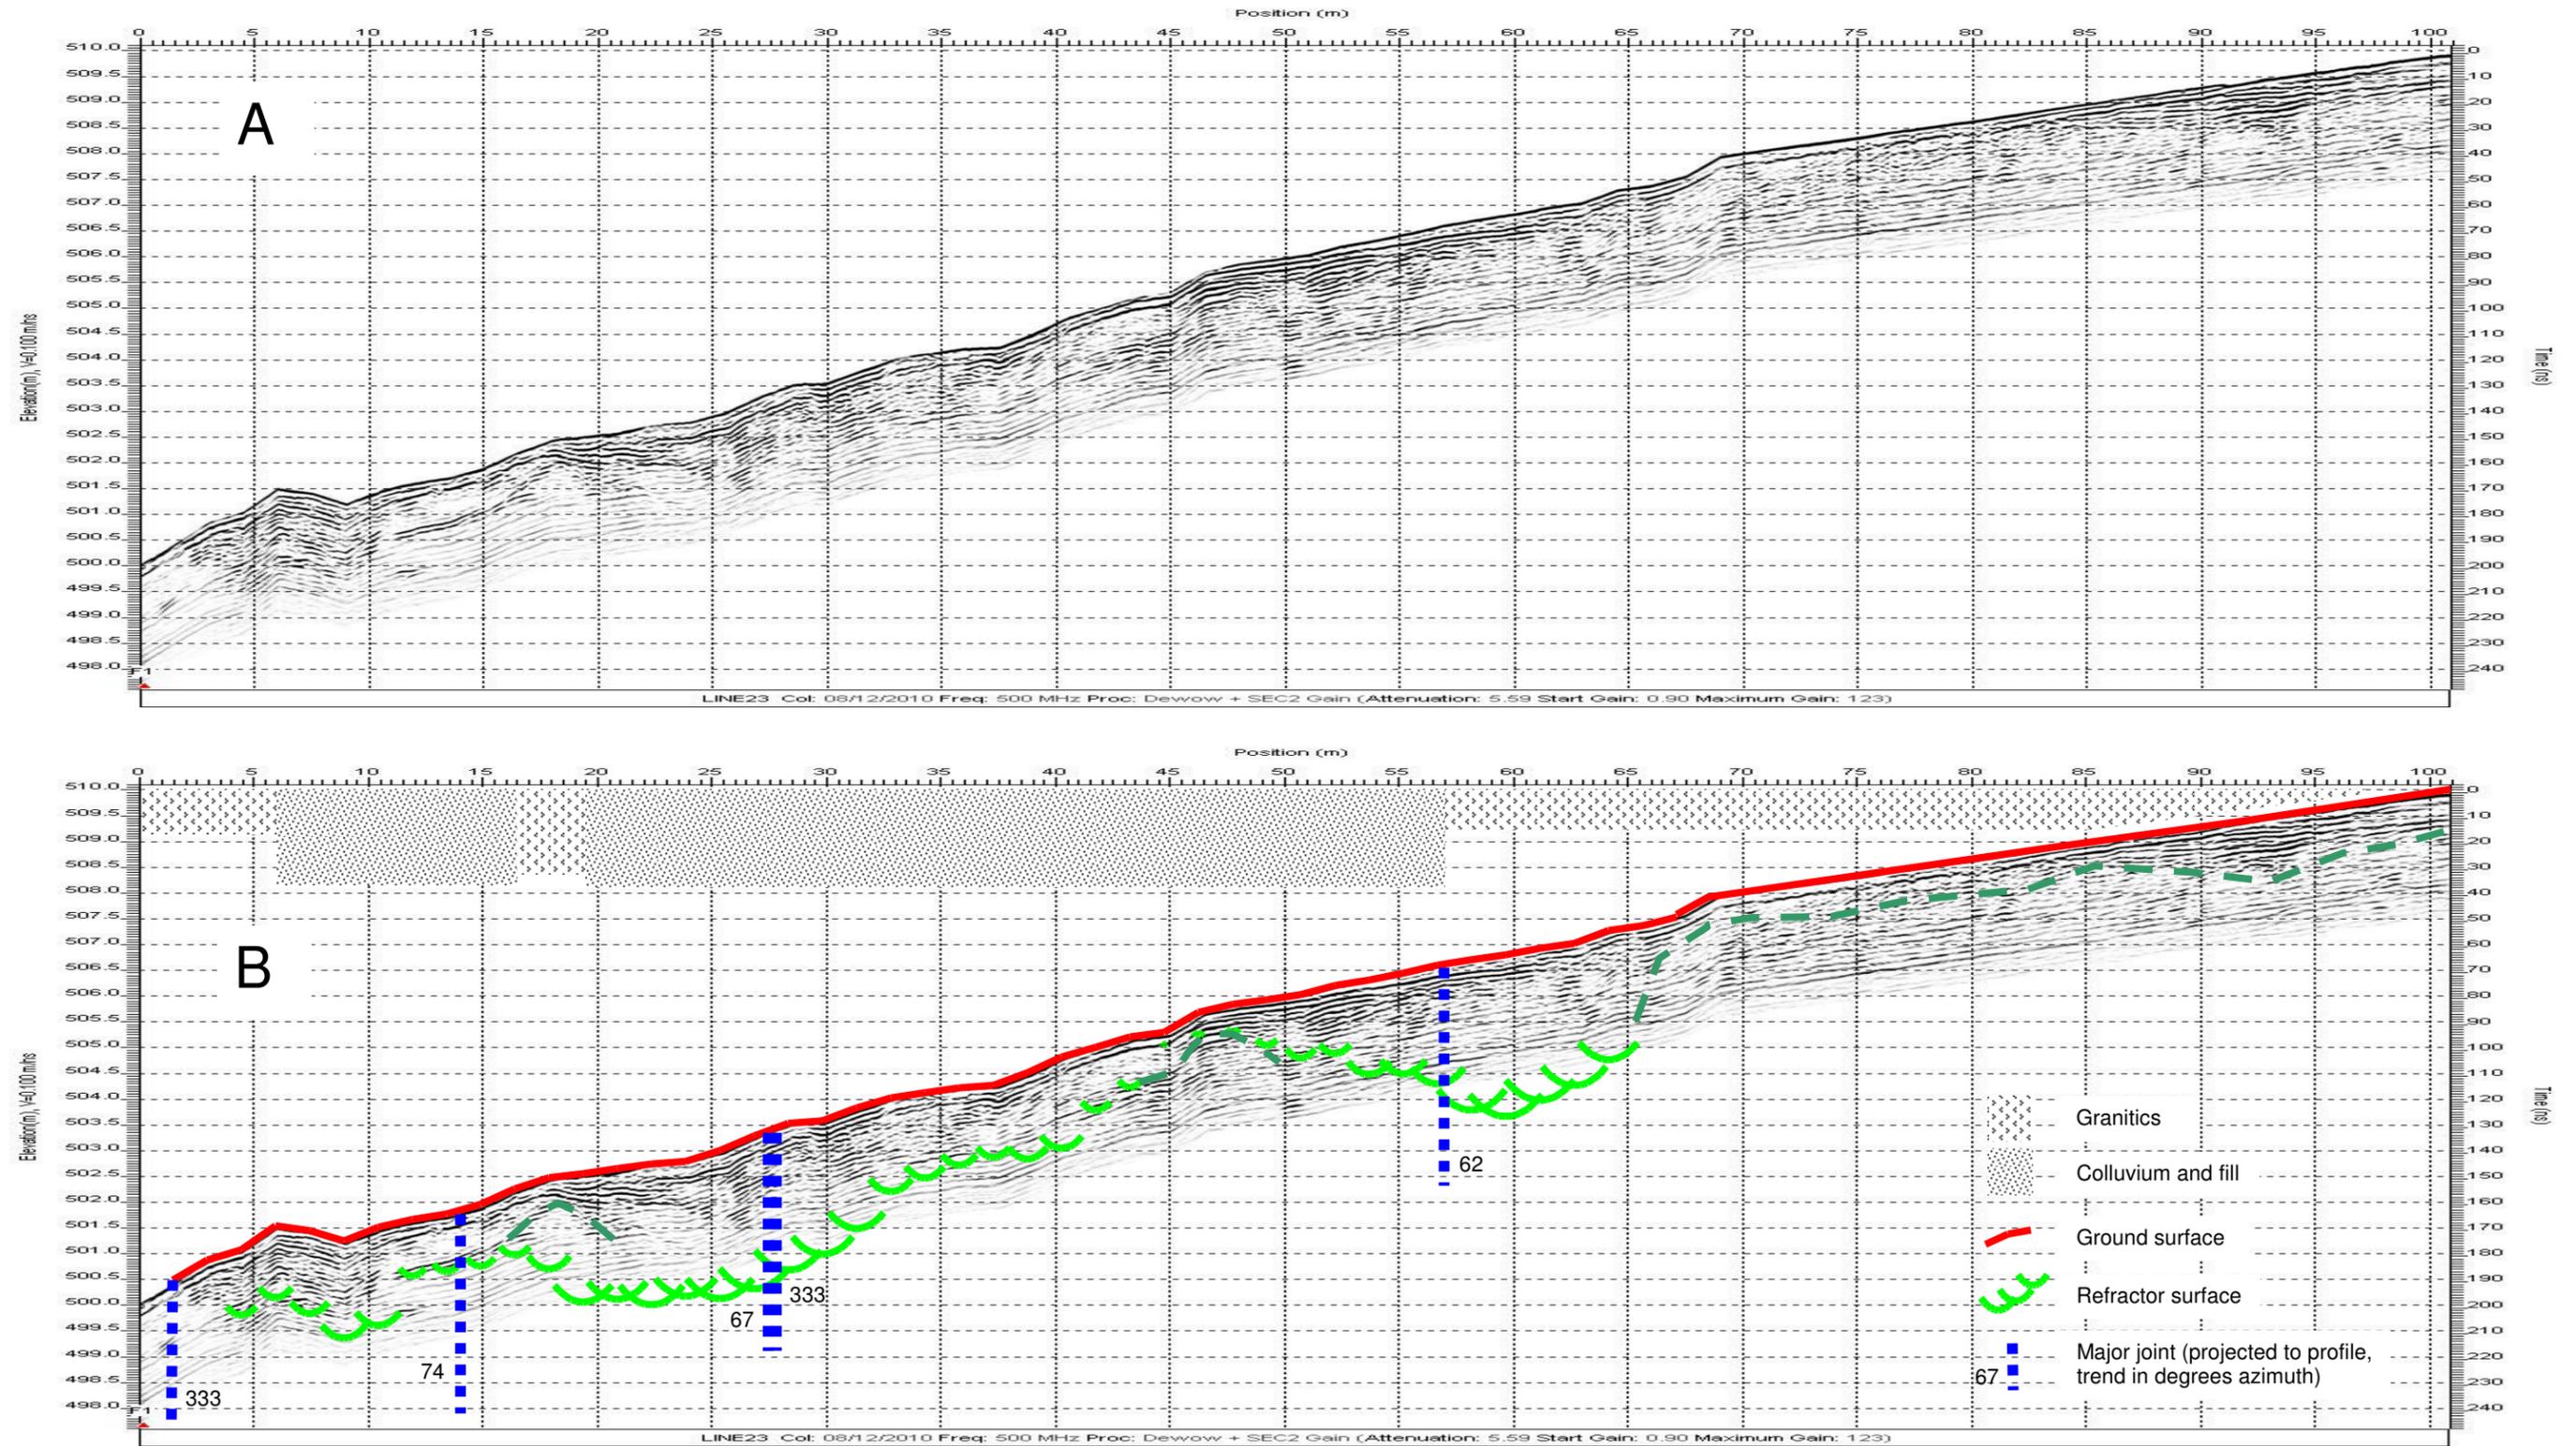
Plate 2. Correlation of GRM seismic and 500 MHz radar profiles. A) Original and B) interpreted sections. Material composition at top of (B) projected from observations of outcrop along the cut (westbound shoulder) and embankment (eastbound shoulder). GRM data terminates at 65 meters; dashed green lines represent interpreted base of colluvium and fill from GPR data.
