INFORMATION HANDOUT

For Contract No. 07-295704

Fiber Optics Asbuilt drawings

Aerially Deposited Lead Site Investigation Report. Site investigation for LA 605 CAPM project between I-10/605 junction and Los Angeles/Orange County line, Los Angeles County, California.

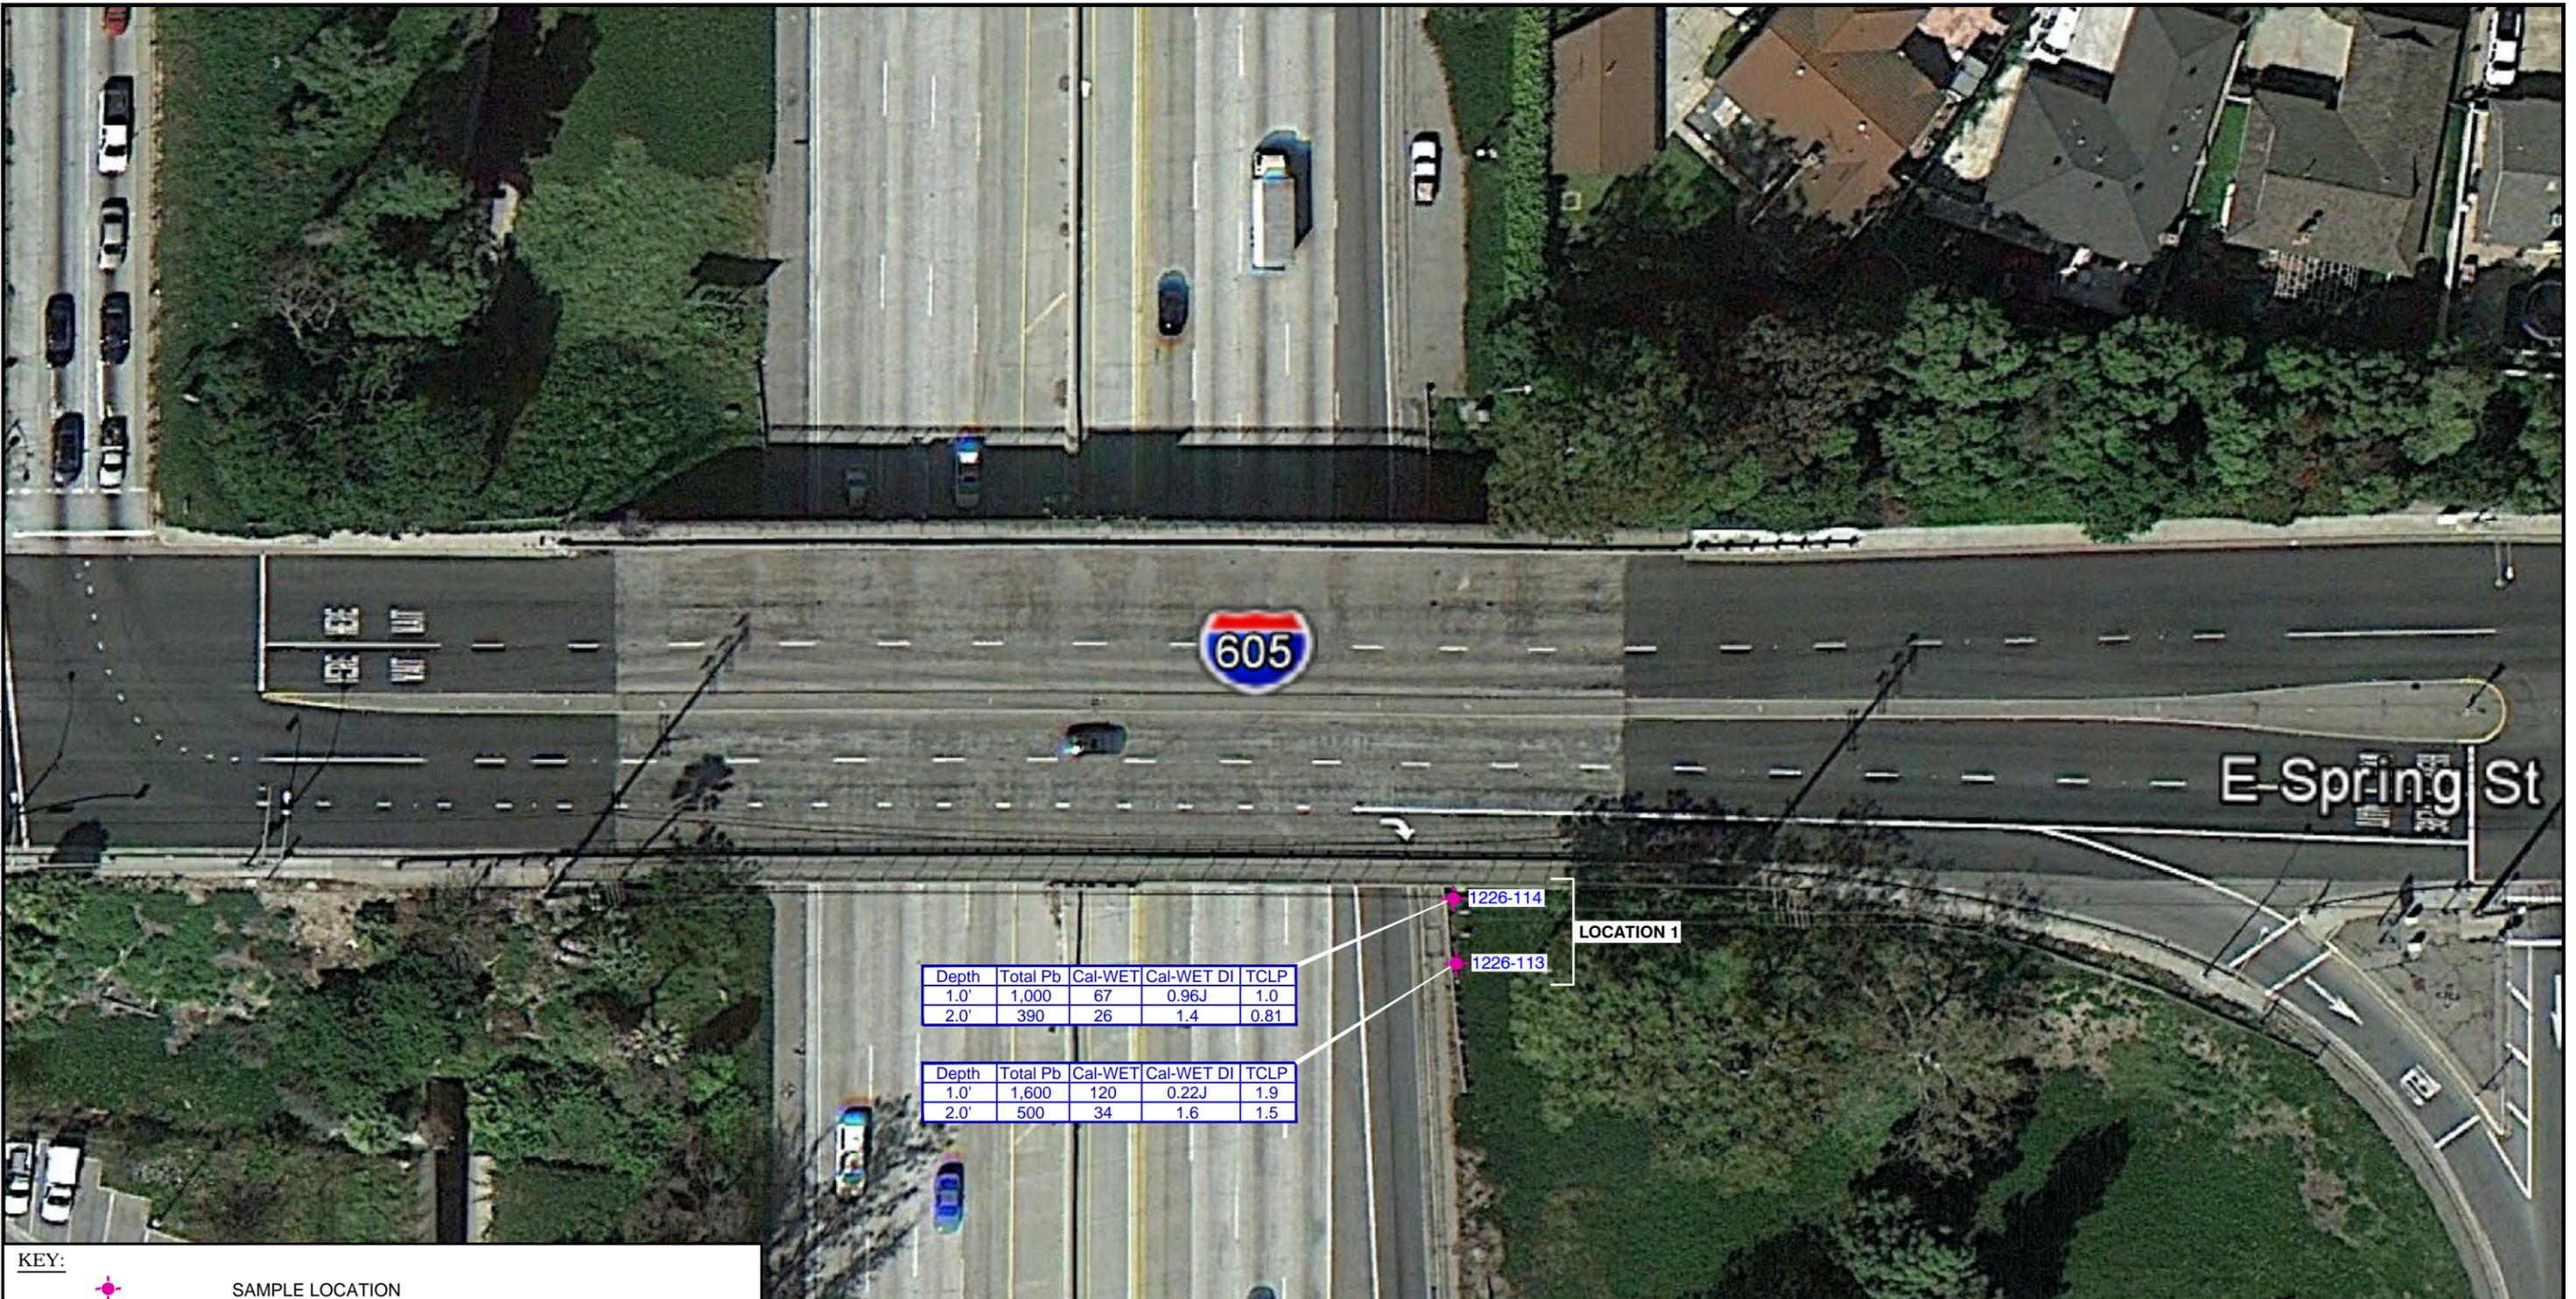
FILEPATH:M:\00 OTHER OFFICES\04-REDLANDS\CAL-TRANS\ADL\TO-6\FIG 2_LOCATION 1_11-05-2013.dwg[saguinaldo]Nov 14, 2013 at 14:07 | Layout: L1

Depth	Total Pb	Cal-WET	Cal-WET DI	TCLP
1.0'	1,000	67	0.96J	1.0
2.0'	390	26	1.4	0.81

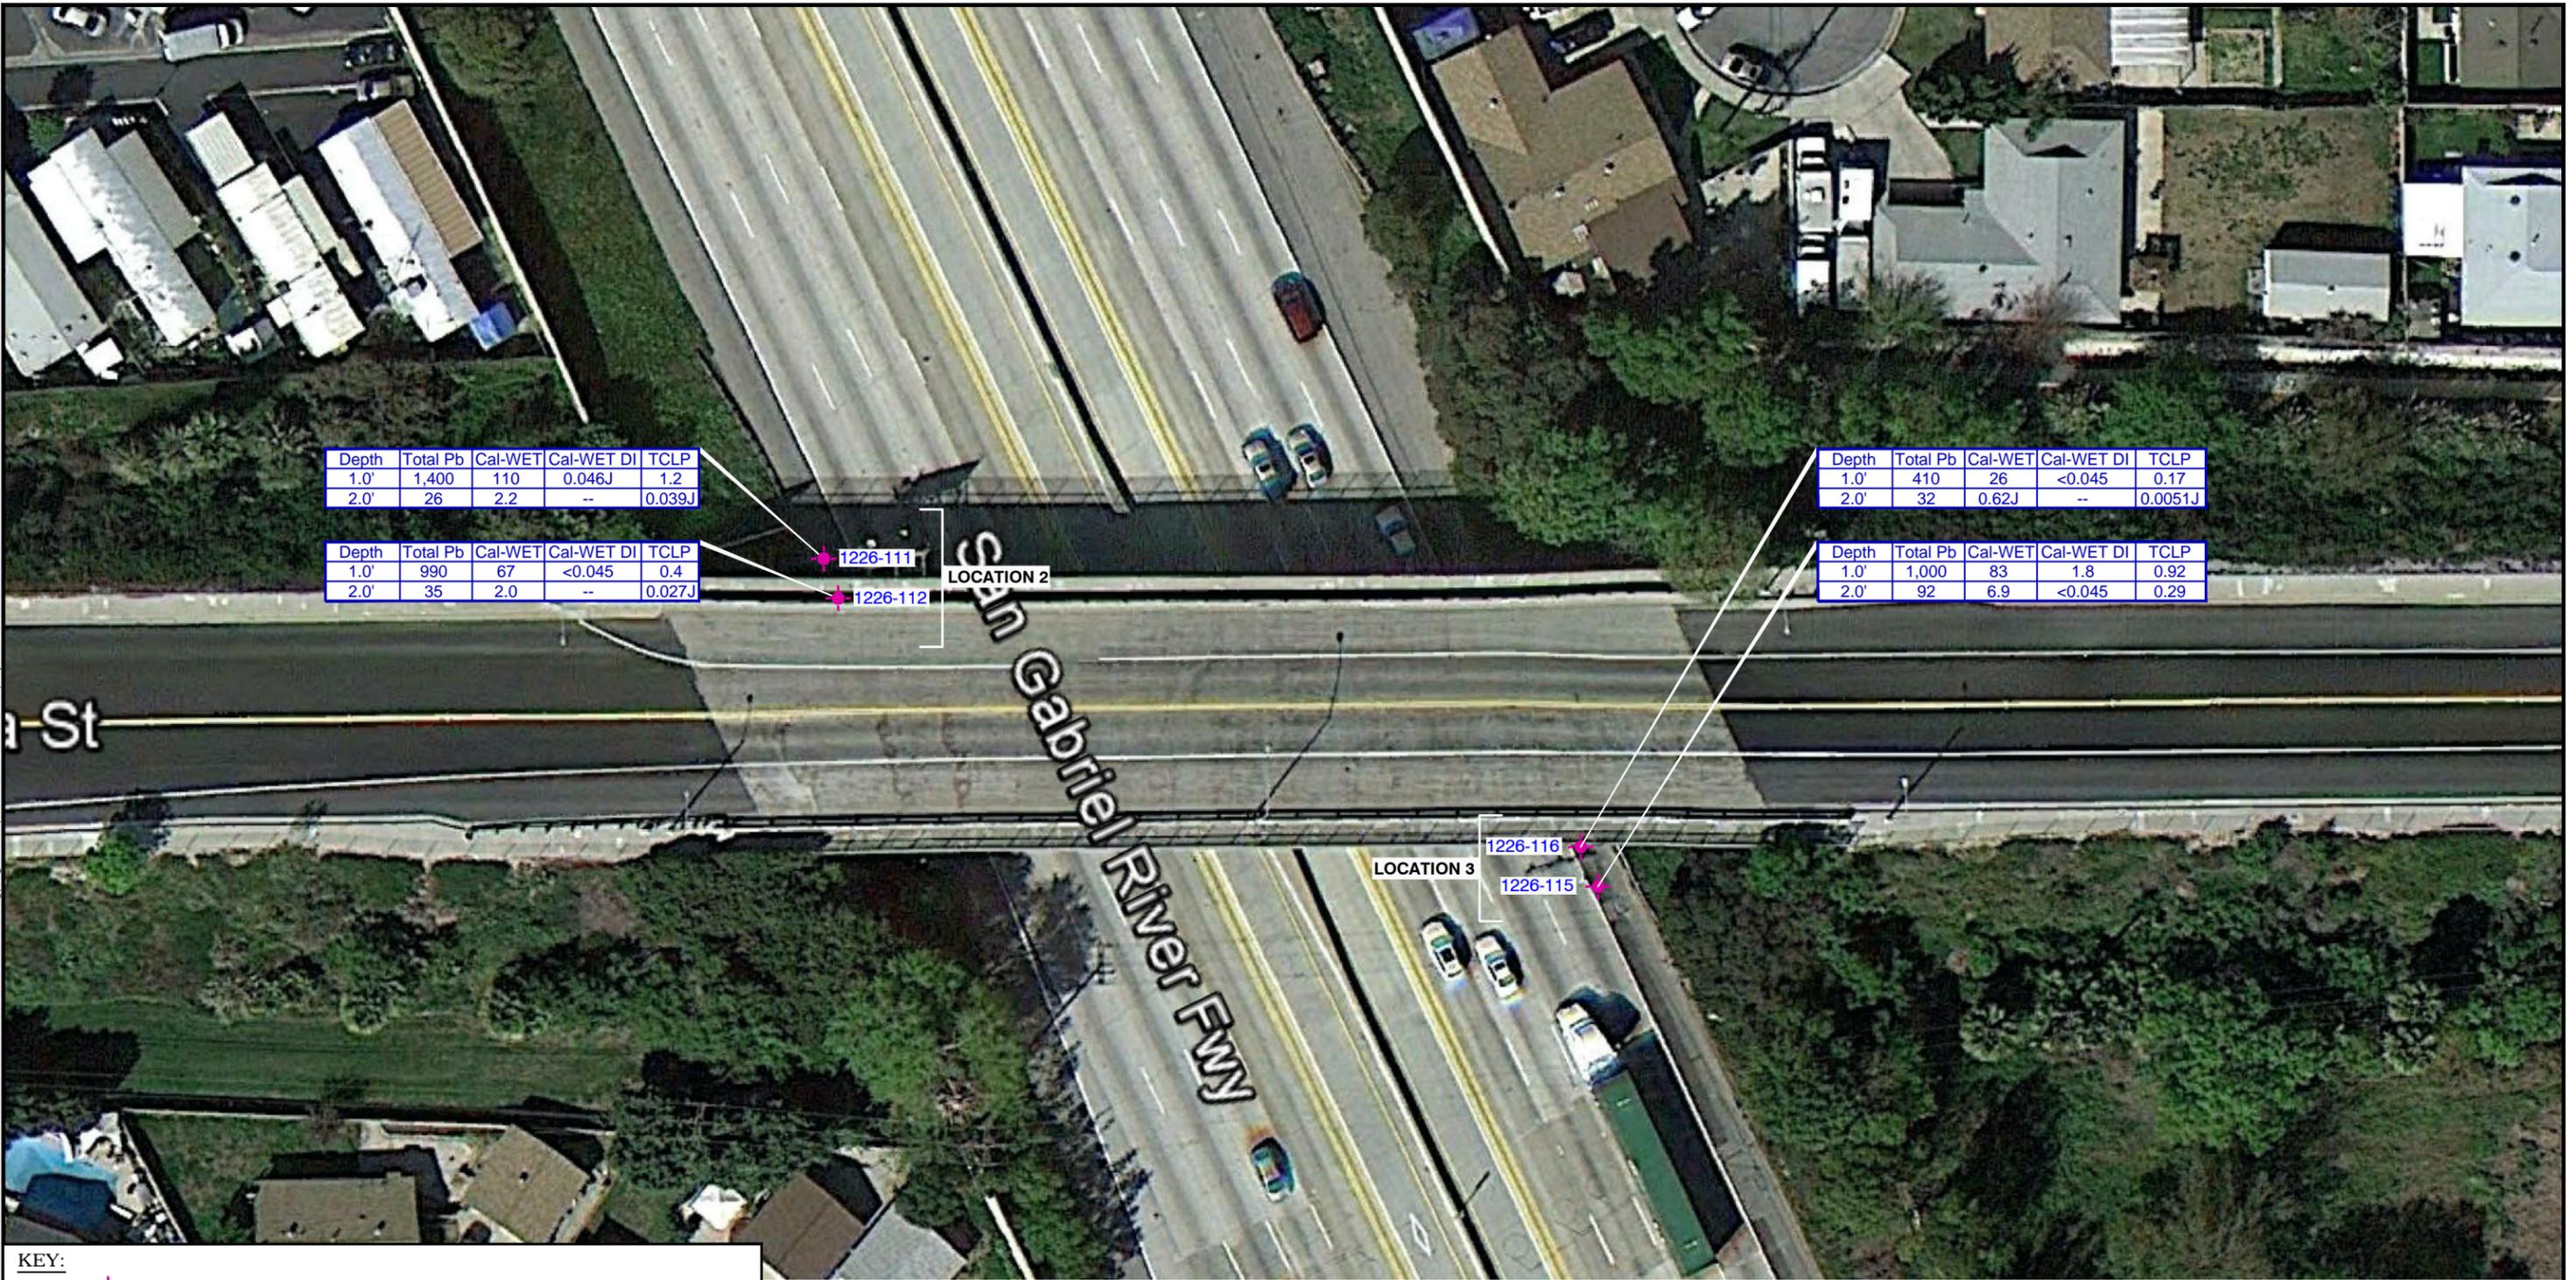
FILEPATH:M:\00 OTHER OFFICES\04-REDLANDS\CAL-TRANS\ADL\TO-6\ FIG 3_LOCATION 2 AND 3_11-05-2013.dwg\isagunaido\Nov 14, 2013 at 14:55\Layout: L2 AND 3

Depth	Total Pb	Cal-WET	Cal-WET DI	TCLP
1.0'	1,400	110	0.046J	1.2
2.0'	26	2.2	--	0.039J

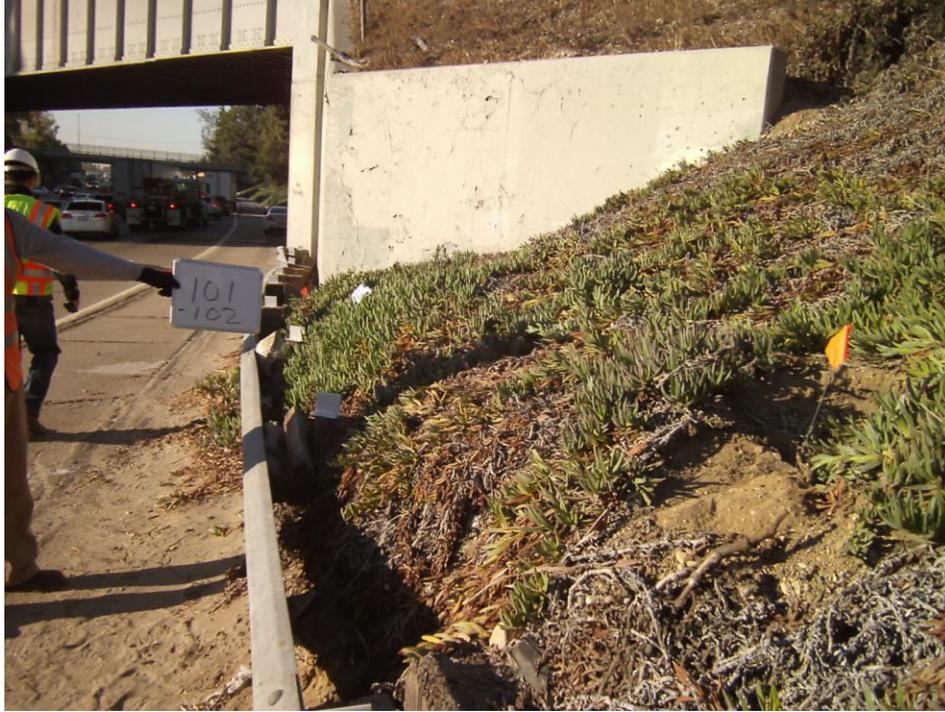
Photograph No. 1

WHITTIER UPRR OH (SOUTHBOUND I-605), BORINGS 1226-101 AND 1226-102.

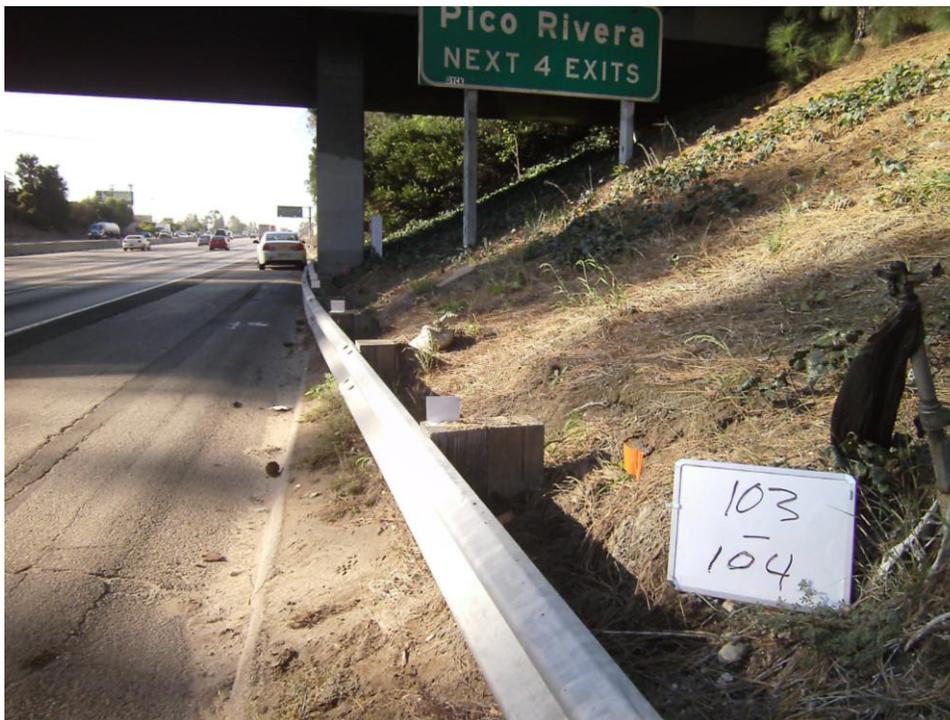
Photograph No. 2

OBREGON ST OC (SOUTHBOUND I-605), BORINGS 1226-103 AND 1226-104.

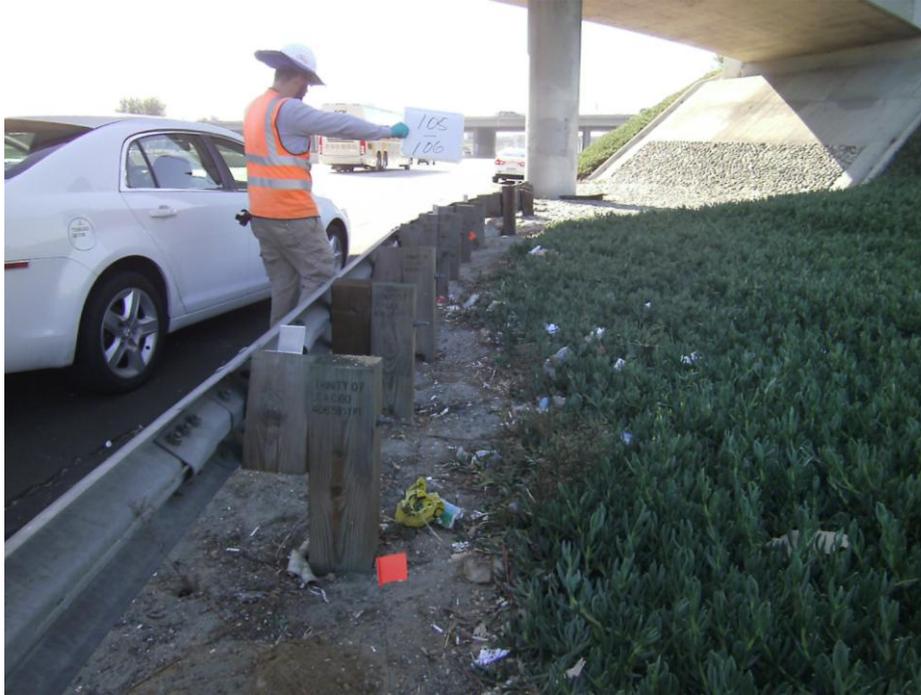
Photograph No. 3

91 WB CONNECTOR TO 605 SB CONNECTOR (SOUTHBOUND I-605), BORINGS 1226-105 AND 1226-106.

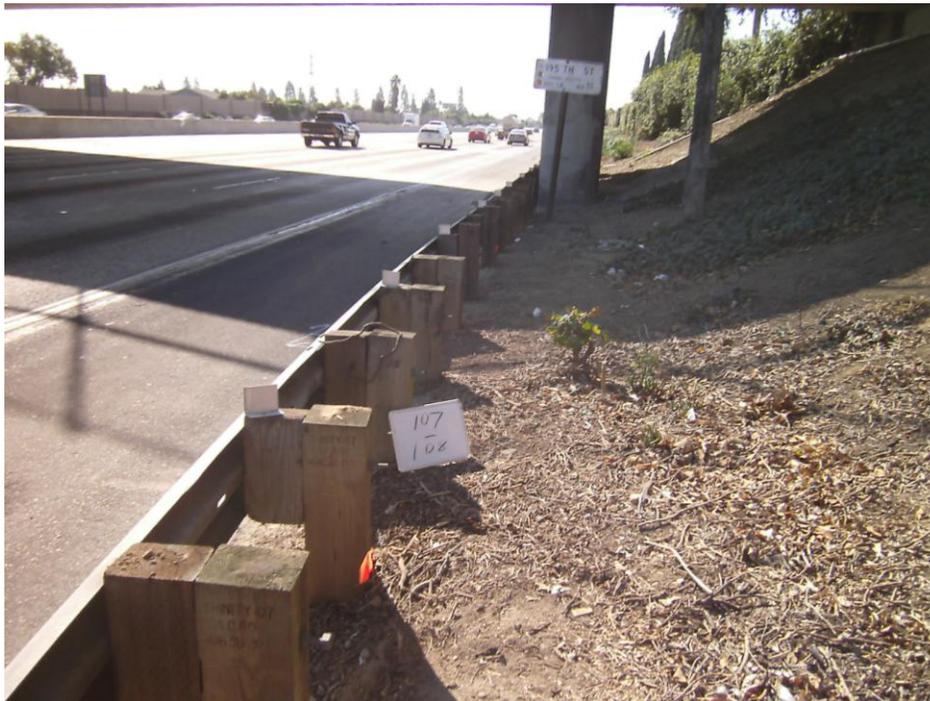
Photograph No. 4

195TH ST OC (SOUTHBOUND I-605), BORINGS 1226-107 AND 1226-108.

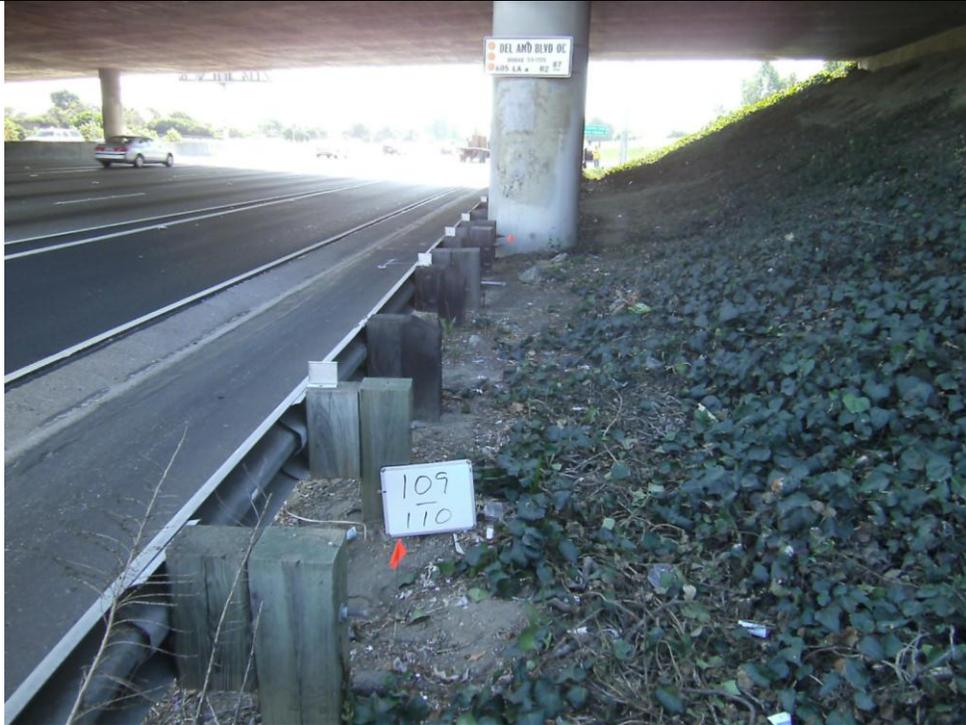
Photograph No. 5

DEL AMO BLVD OC (SOUTHBOUND I-605), BORINGS 1226-109 AND 1226-110.

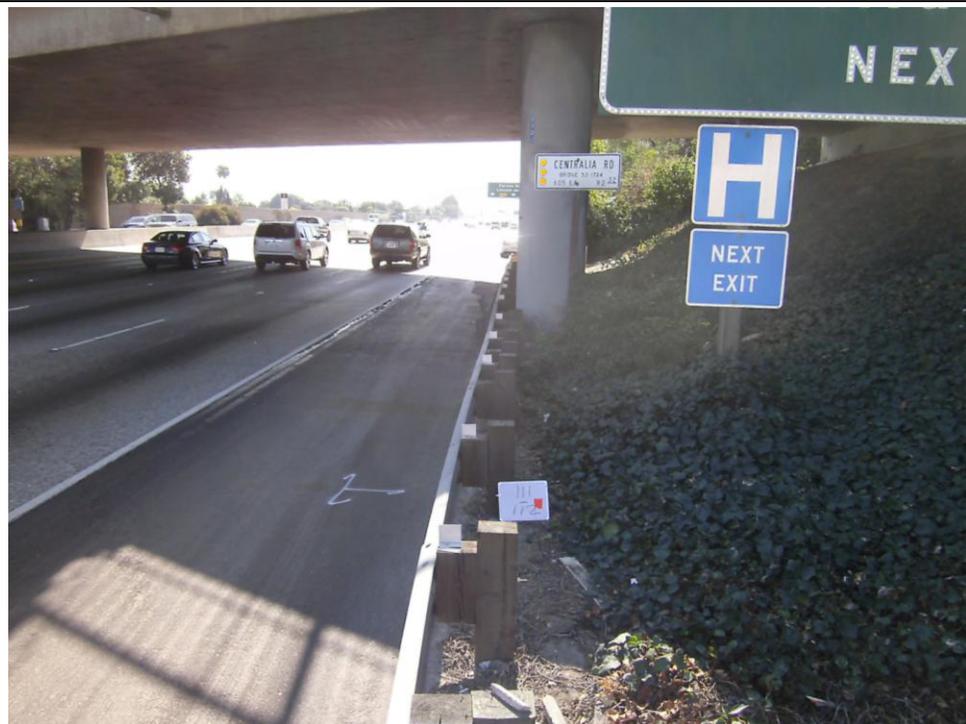
Photograph No. 6

CENTRALIA RD OC (SOUTHBOUND I-605), BORINGS 1226-111 AND 1226-112.

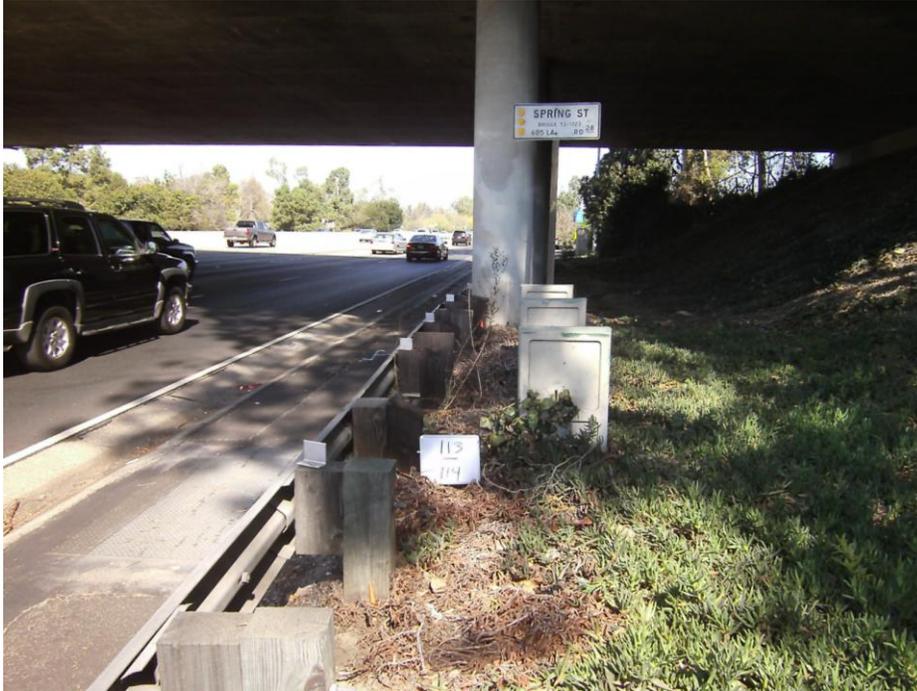
Photograph No. 7

SPRING ST OC (NORTHBOUND I-605), BORINGS 1226-113 AND 1226-114.

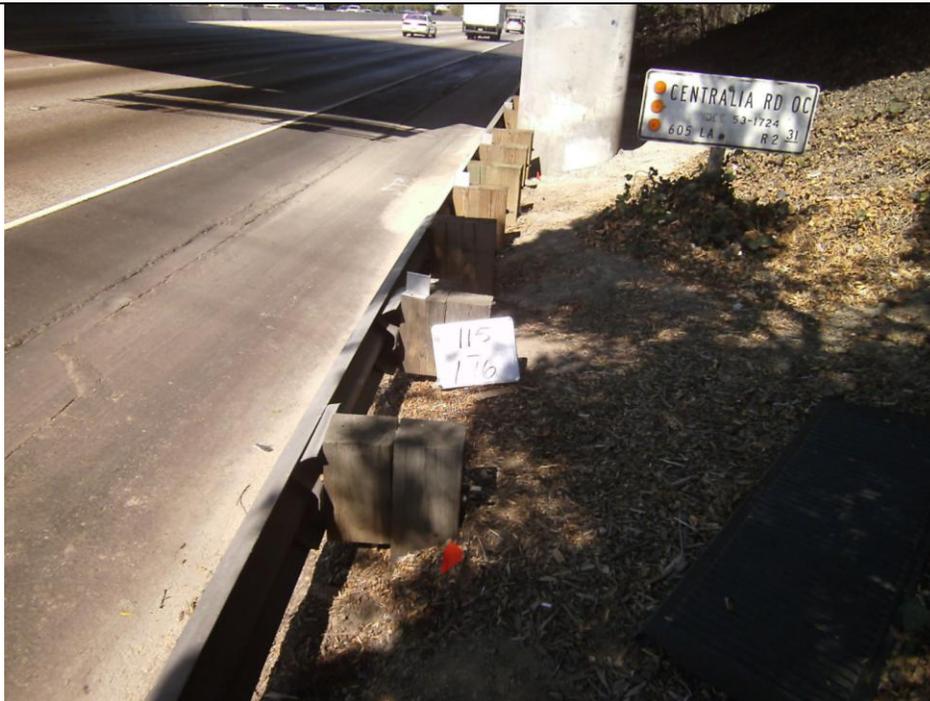
Photograph No. 8

CENTRALIA RD OC (NORTHBOUND I-605), BORINGS 1226-115 AND 1226-116.

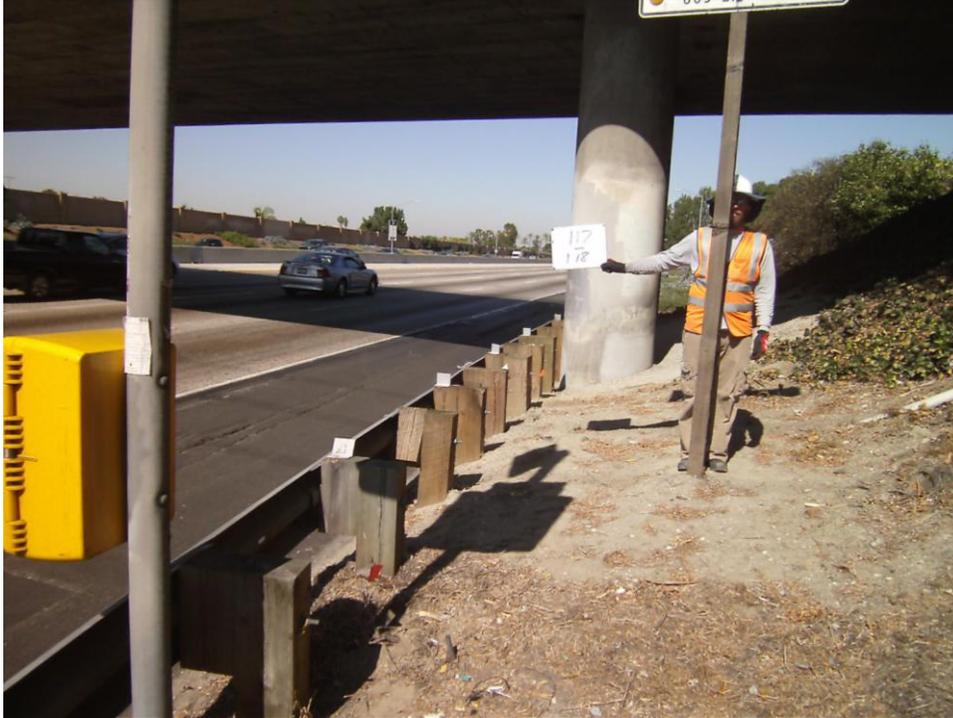
Photograph No. 9

195TH ST OC (NORTHBOUND I-605), BORINGS 1226-117 AND 1226-118.

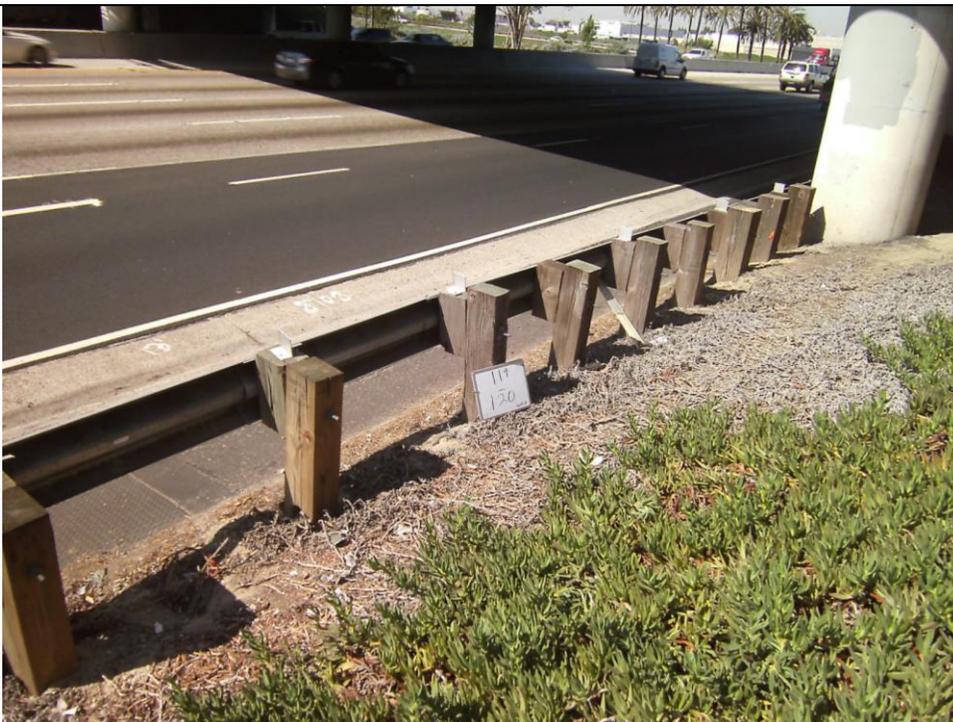
Photograph No. 10

SOUTH ST OC (NORTHBOUND I-605), BORINGS 1226-119 AND 1226-120.

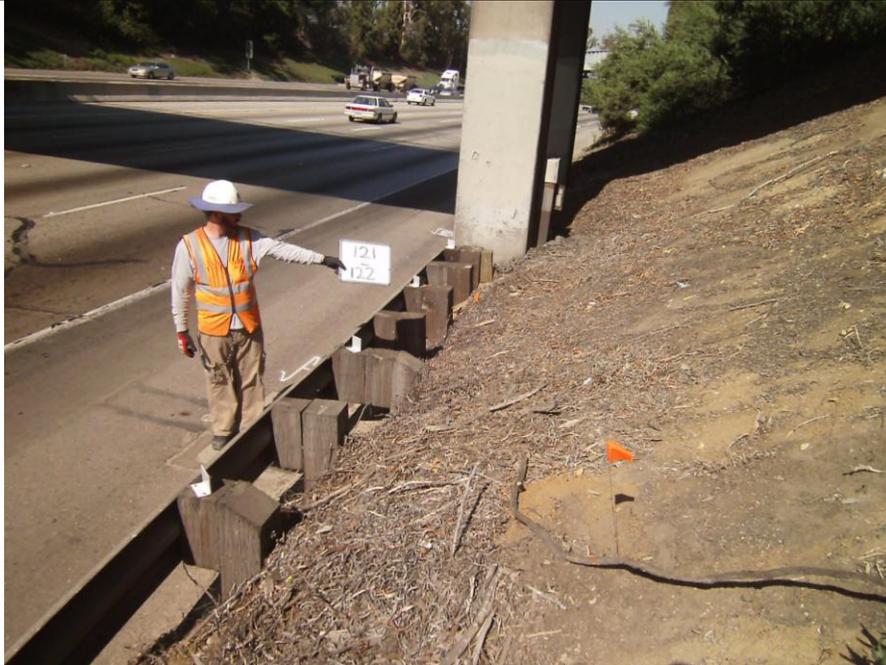
Photograph No. 11

OBREGON ST OC (NORTHBOUND I-605), BORINGS 1226-121 AND 1226-122.

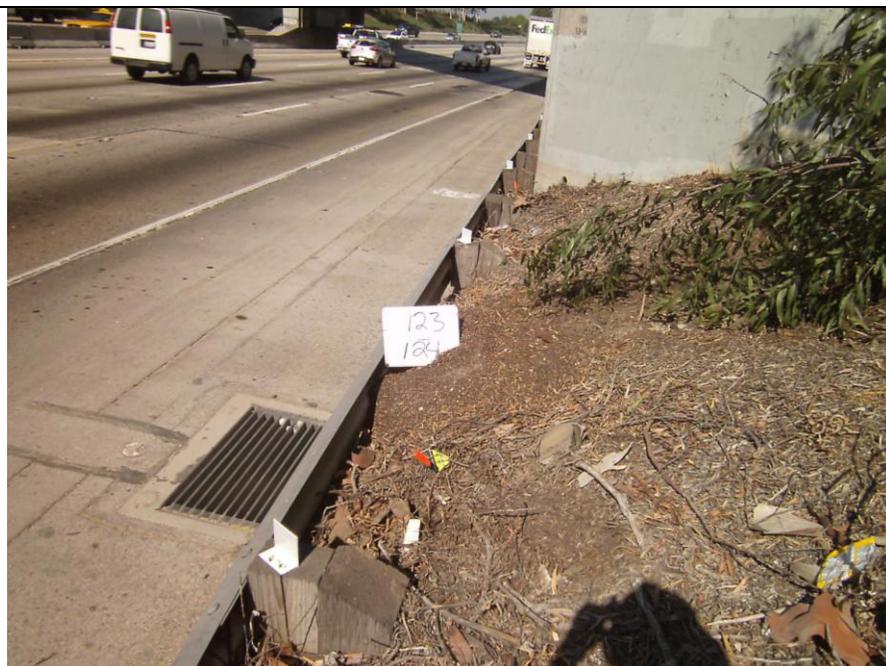
Photograph No. 12

WHITTIER UPRR OH (NORTHBOUND I-605), BORINGS 1226-123 AND 1226-124.

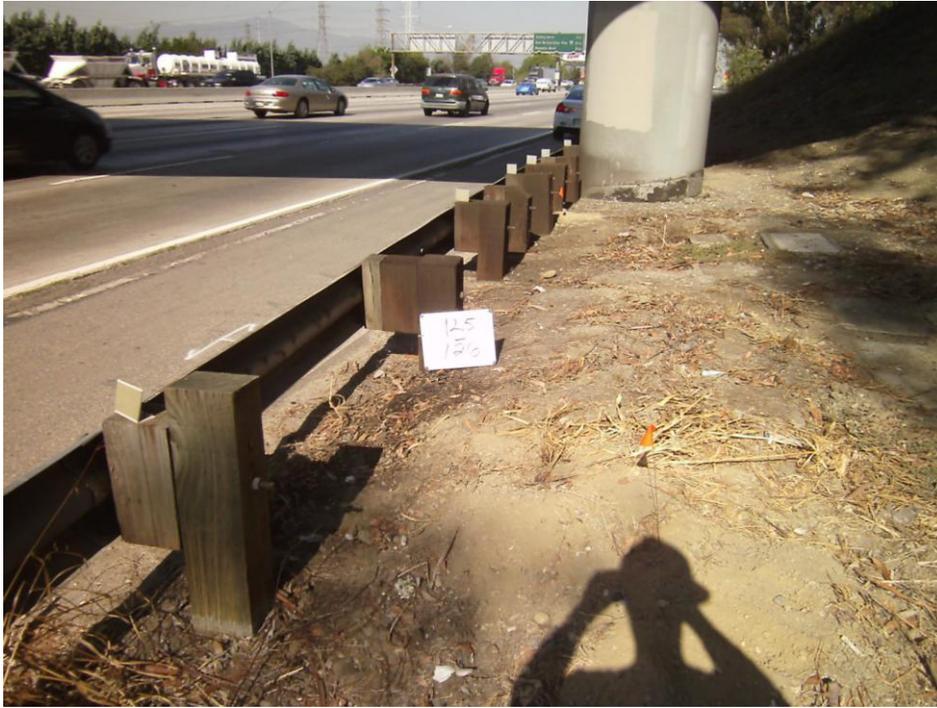
Photograph No. 13

RTE 60 WB TO 605 SB COLUMN, NORTH OF SEPARATION (SOUTHBOUND I-605), BORINGS 1226-125 AND 1226-126.

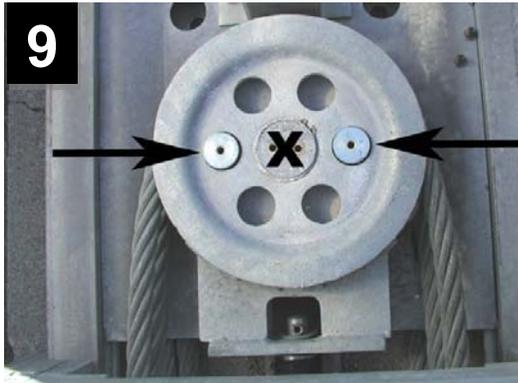
7. During frame pullout, inspect front part of the cable from the spelter socket, as it will be partially obscured after extension of the mobile frames and sheaves. See the cable inspection procedure.
8. Remove the front and rear sheave cover plates at each end of the cylinder by removing the two hex bolts that hold them down.

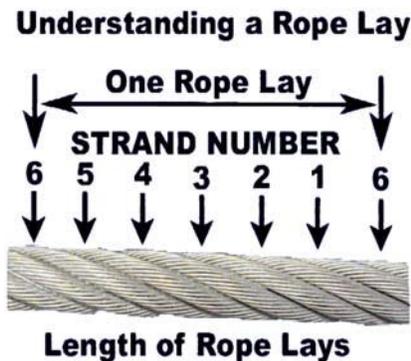
The cable should be visually inspected for damage. The most common sign of rope deterioration is broken wires. The wire must be clean and not under tension to perform a visual inspection. The visual inspection should include looking for broken wire strands, localized wear or crowns. A sharp awl or marlin spike can be used to separate wires to check if internal damage is present, indicated by loose wires or crowns. If internal inspection shows any damage to any core wires, the cable should be replaced. If there are more than six random broken wires in one rope lay or three broken wires in one strand in one rope lay, the wire rope should be replaced. A rope lay is the length along the rope in which one strand makes a complete revolution around the rope.

Inspect the spelter socket for broken wires, damaged eyes or other fatigue. Any signs of broken wires at the spelter socket will require a new cable.

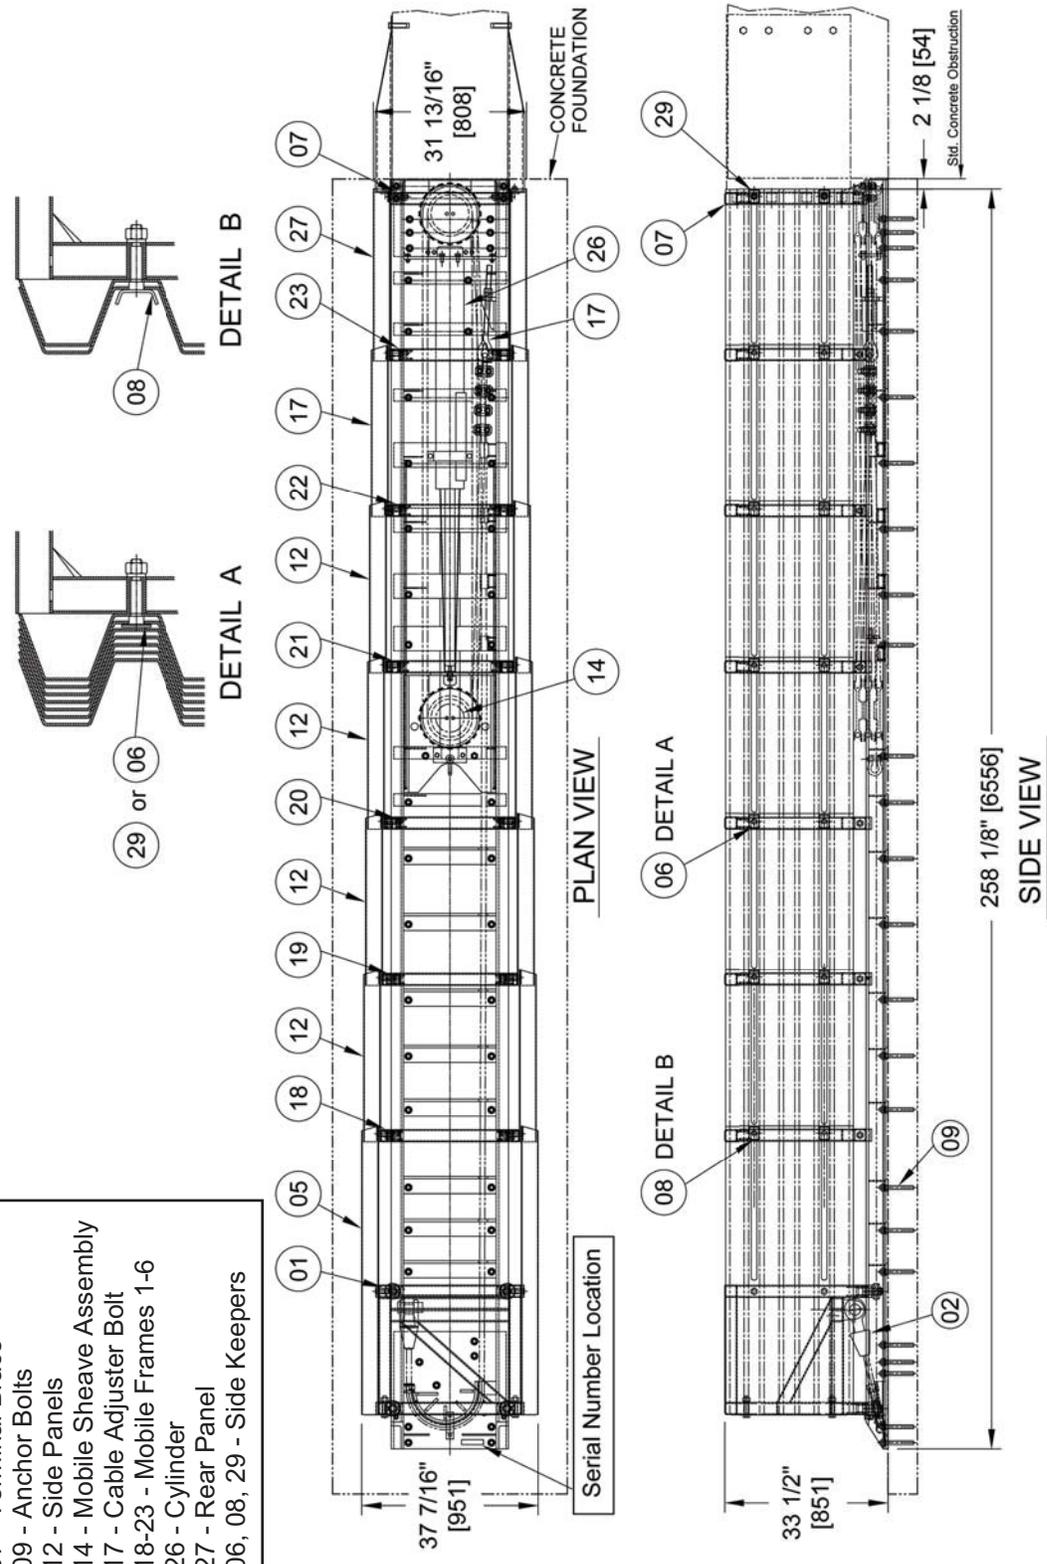
PARTS LIST	
01	- Front Sled
02	- Cable Assembly
05	- Sled Panel
07	- Terminal Brace
09	- Anchor Bolts
12	- Side Panels
14	- Mobile Sheave Assembly
17	- Cable Adjuster Bolt
18-23	- Mobile Frames 1-6
26	- Cylinder
27	- Rear Panel
06, 08, 29	- Side Keepers

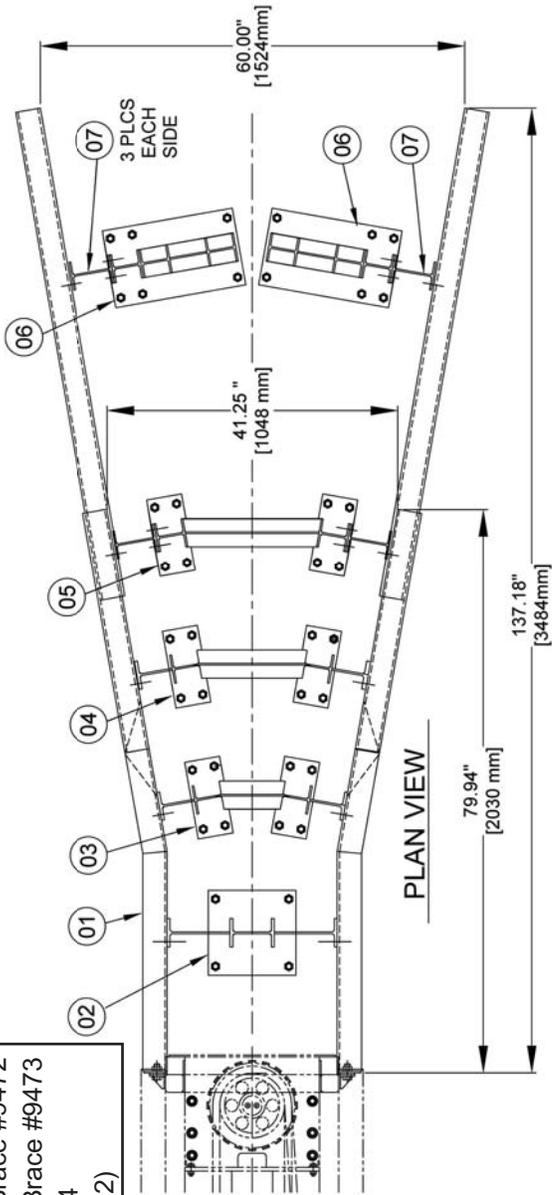
APPENDIX F - TRANSITION, GORE ASSEMBLY

***** SPLICE BOLTS AND GUARDRAIL SUPPLIED BY OTHERS*****
