INFORMATION HANDOUT

FINAL FOUNDATION REPORT

Subject: Final Foundation Report

ASBESTOS AND LEAD-CONTAINING PAINT SURVEY

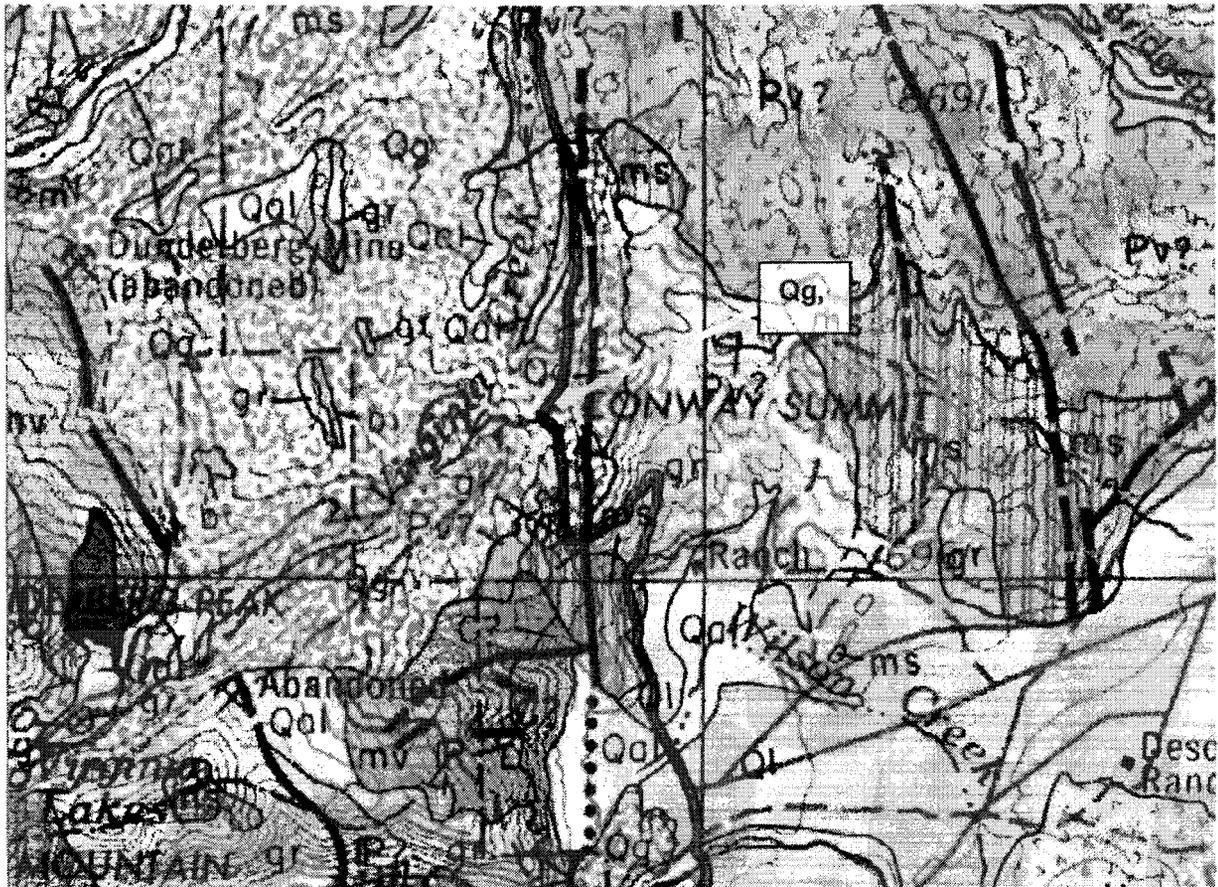
Plate
 No. 2

Geology base map from California Division of Mines and Geology – Geologic Map of California, Walker Lake Sheet, dated 1963

Explanation of Relevant Formations:

Qg – Quaternary Glacial Deposits - Glacial moraines and till of the Toiga, Tahoe, and Sherwin Stages.

Qal – Recent Alluvium - Stream and river alluvium; glacial outwash; Recent fan deposits.

gr – Undifferentiated - Mesozoic granitic rock, Ranging in composition from granite to diorite, probably representing several plutons (in part sheared and metamorphosed)

GEOLOGY MAP

The California Department of Conservation, Division of Mines and Geology Geologic Map of California, Walker Lake Sheet, 1963 was used to determine the geologic formations in the project location. A section from these maps showing the project location is attached as Plate No. 2, Geology Map. The project location is mapped as being in an area of sedimentary deposits (Qg and Qal) formed during the Quaternary Period of the Cenozoic Era, between 10 thousand and 1.6 million years ago.

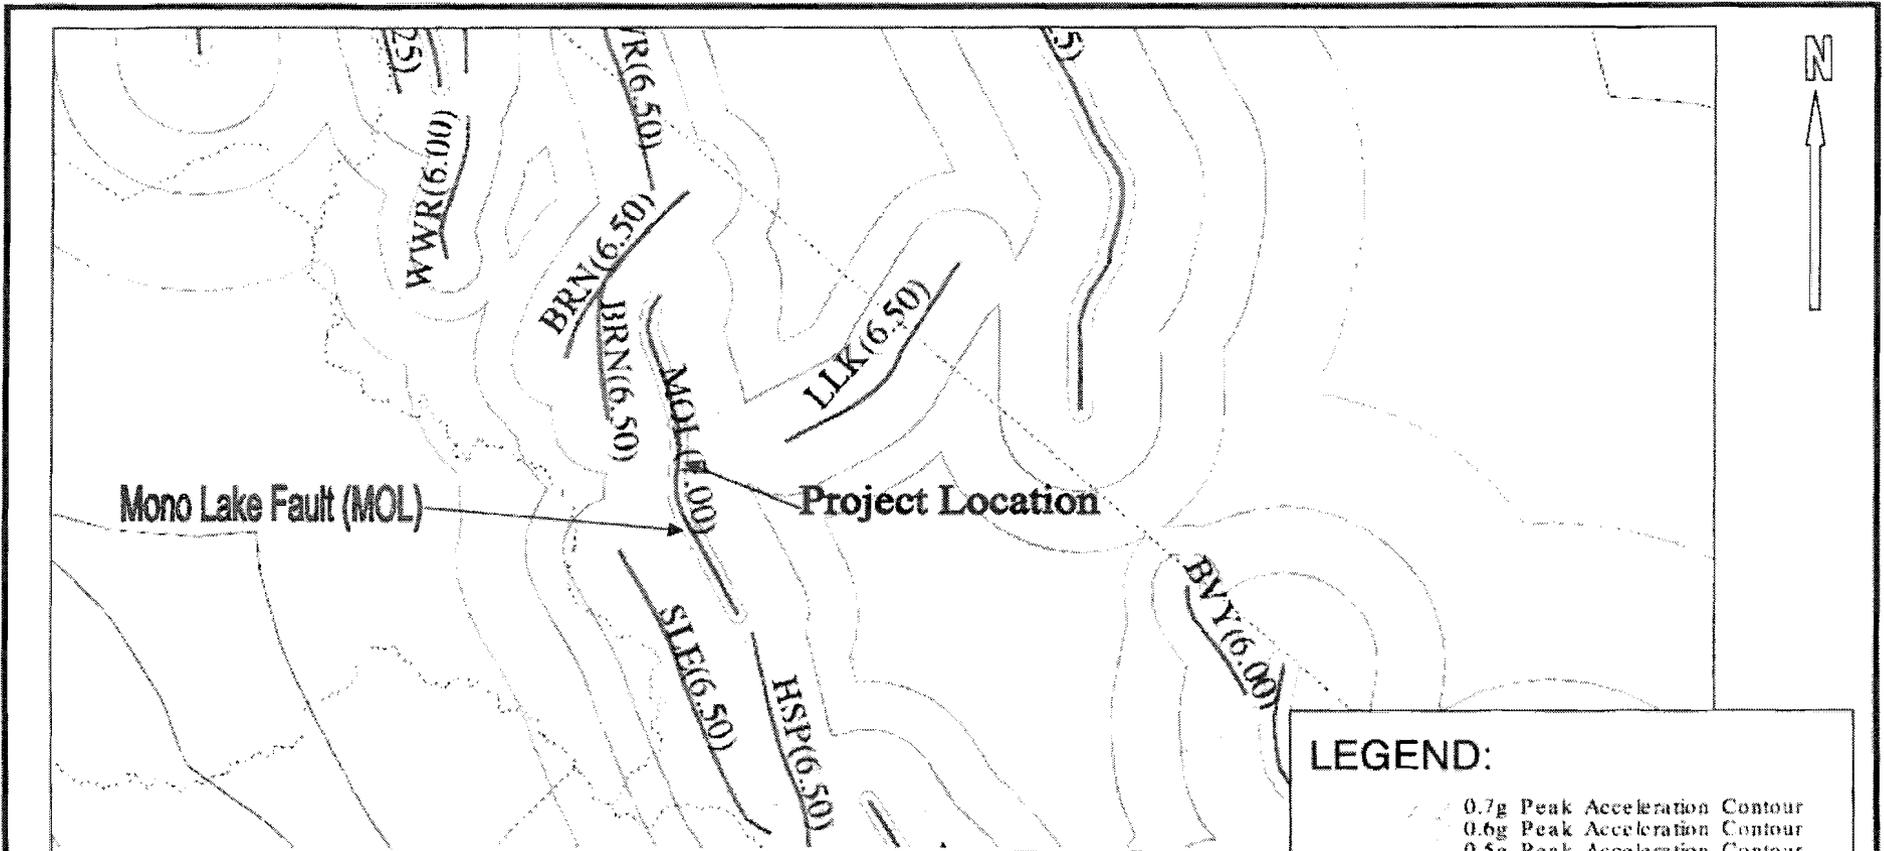
09-MNO-5704 (Rte 395 PM 63.7) FOUNDATION REPORT	Plate No. 3
--	-------------

California Seismic Hazard Map, 1996, by Lalliana Mualchin

EA: 09-334201	SEISMIC HAZARD MAP
July 2008

The Department's California Seismic Hazard Map, dated 1996, was also reviewed. The map indicates that the controlling fault is the Mono Lake Fault. See Plate No. 3, Seismic Hazard Map. This is a normal fault which is located approximately 0.2 mile (0.4 km) east of the project location. The fault is expected to be capable of producing a Maximum Credible Earthquake (MCE) of magnitude $M_w=7.00$.

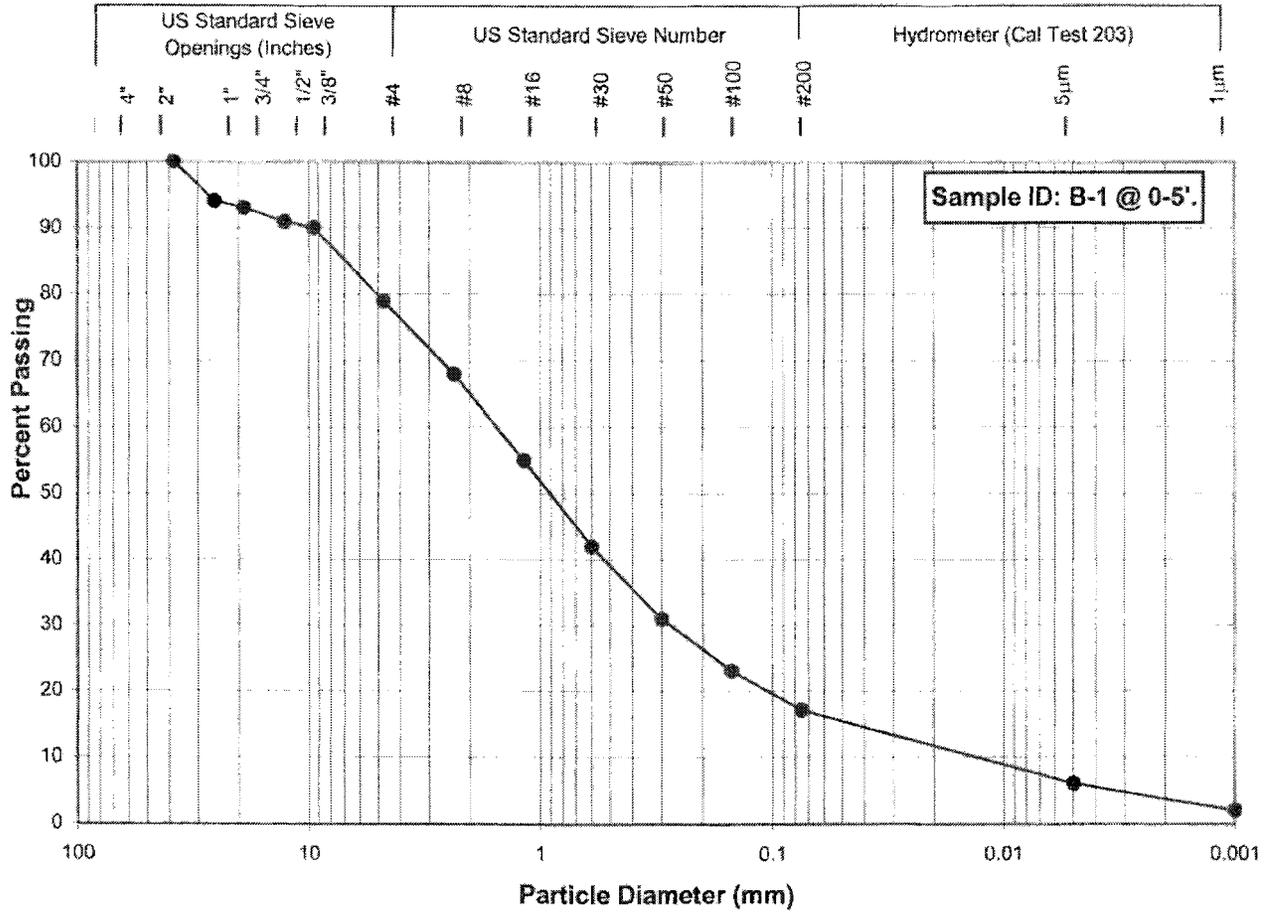
Gradation Analysis Test Results

Project: Conway Summit M. S.
EA: 09-334201
D.-Co.-Rt.-: 09-MNO-5704 (395 PM63.7)
Sample ID: B-1 @ 0-5'
Test Date: Jun. 16, 2008

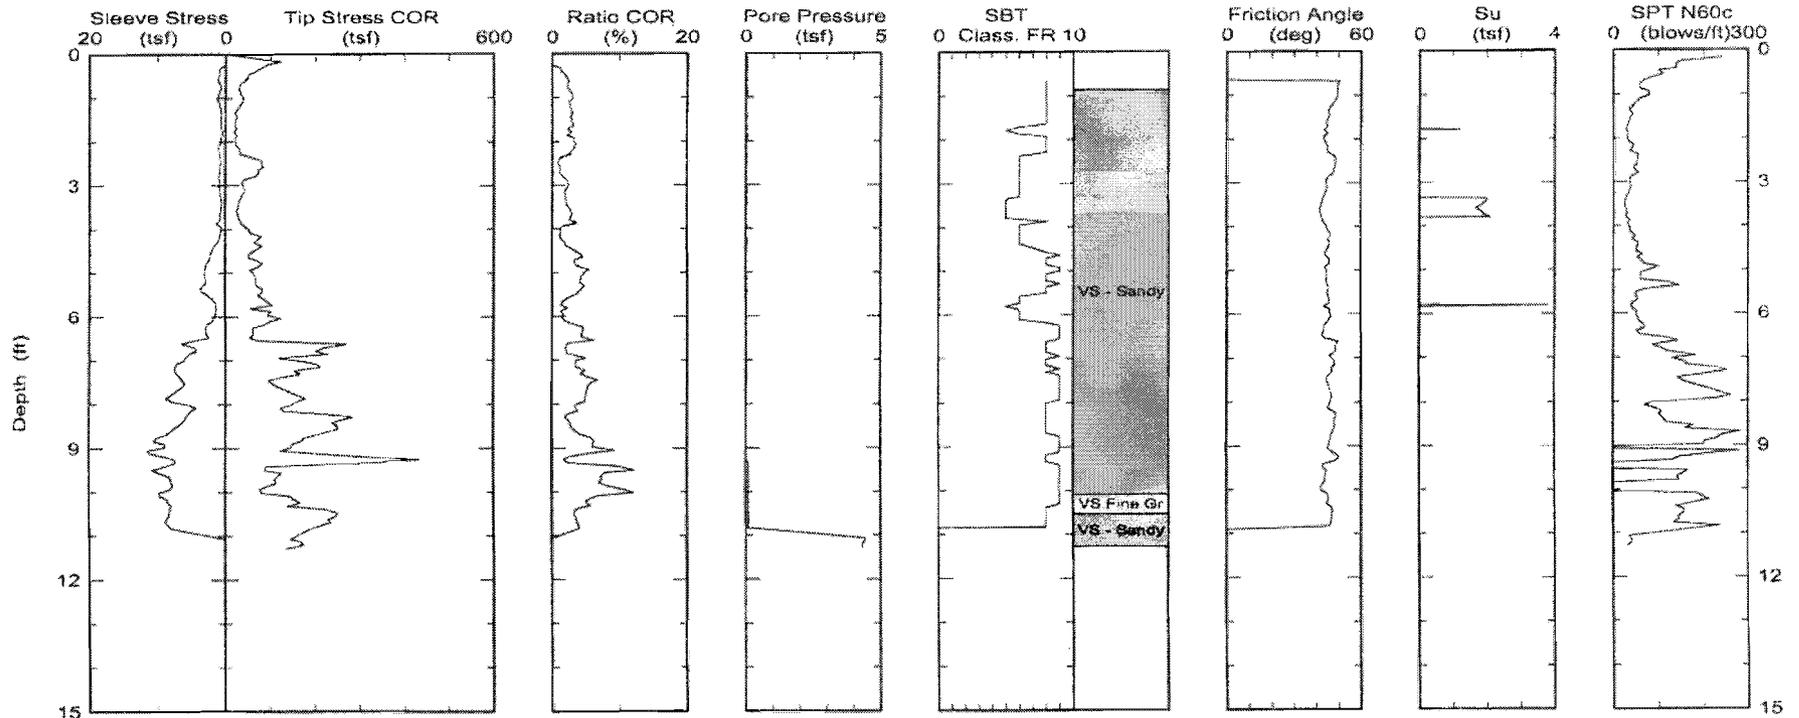
Date: 06/May/2008
Test ID: 106801-01
Project: 09-334201

Maximum depth: 11.28 (ft)

Class FR: Friction Ratio Classification (Ref: Robertson 1990)

According to CPT Soundings and a site visit on April 23, 2008, the site is underlain by sedimentary deposits which consist of fine to coarse grained, medium dense to very dense silt, sand, gravels, and mixtures thereof. For the preparation of this report, we have assumed similar soil conditions in the vicinity of the proposed construction.
