FOR CONTRACT NO.: 07-4L2204

ROUTE: 07-LA-1-KP 82.8/83.3 (PM 51.0/52.0)

File: 07-LA-01-PM51.6/KP83.07
EA 07-4L2201
Escondido Beach Landslide

Subject: Geotechnical Design Report

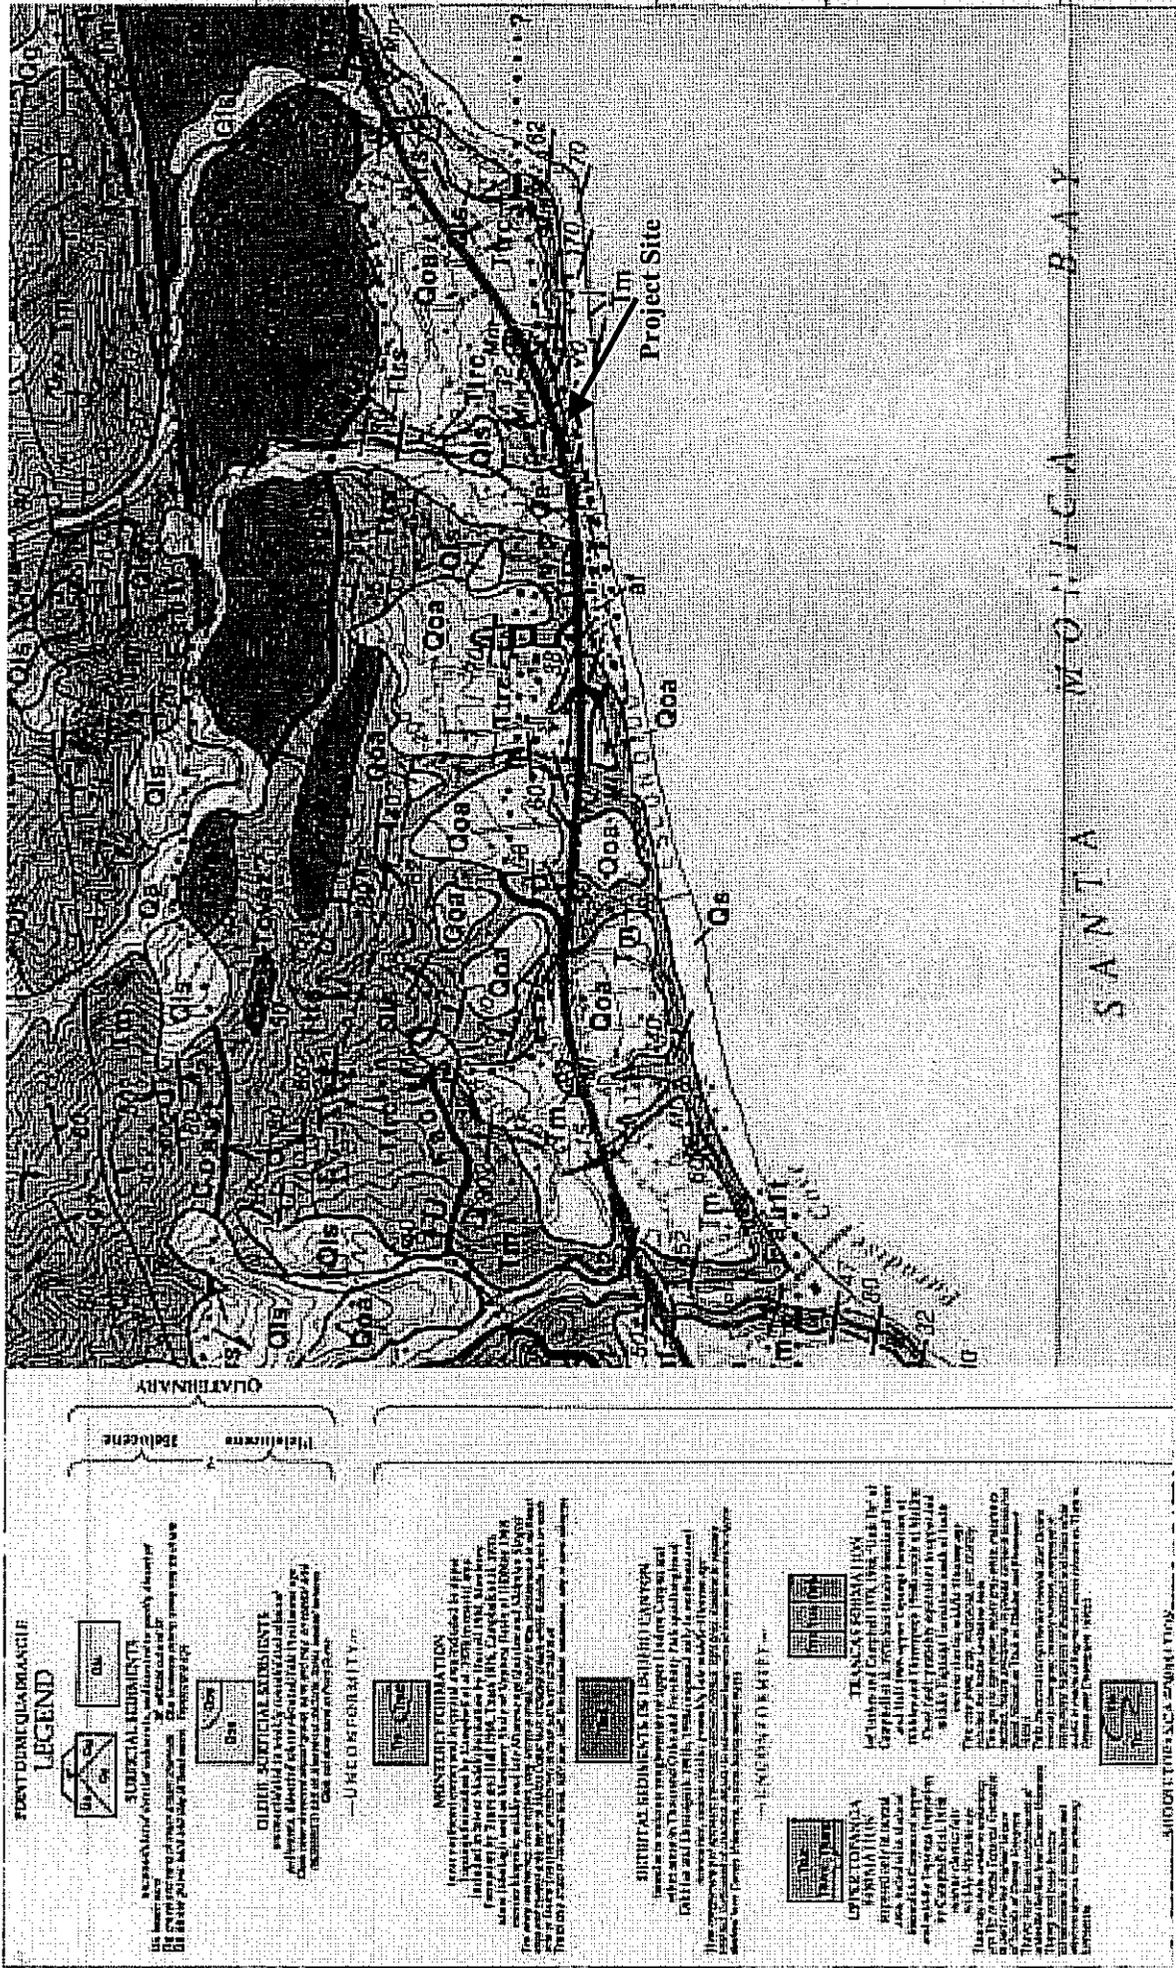
The geology in the area of the Escondido Beach Landslide consists of Late Pleistocene age landslide debris and Pleistocene age alluvium consisting of gravel sand and clay, overlying the Miocene age Trancas and Modelo Formations consisting primarily of siliceous and clay shales (Figure 4a). The alluvium is of high permeability and consists of all sizes from silty clay to cobbles. The shales of Trancas and Modelo Formations are characterized by stiff clay to silty clay interbedded with silty fine sands [4]. The clay and sands occur as separate thin laminae but at some locations the sands are massive enough to be distinguished as a separate unit. The materials are extensively folded and faulted. Numerous small slickensided fractures cut across the bedding. These structural imperfections are not revealed until the material is failed in shear tests [3]. The surface geology has been modified as a result of relocation of the Pacific Coast Highway in 1940-47 [3] and placement of fill whenever emergency repair work was done in the past. Probably the excavated, dried slide mass (landslide debris) was compacted and placed as fill during the past emergency repair work [2].

Figure 4a: Regional Geology

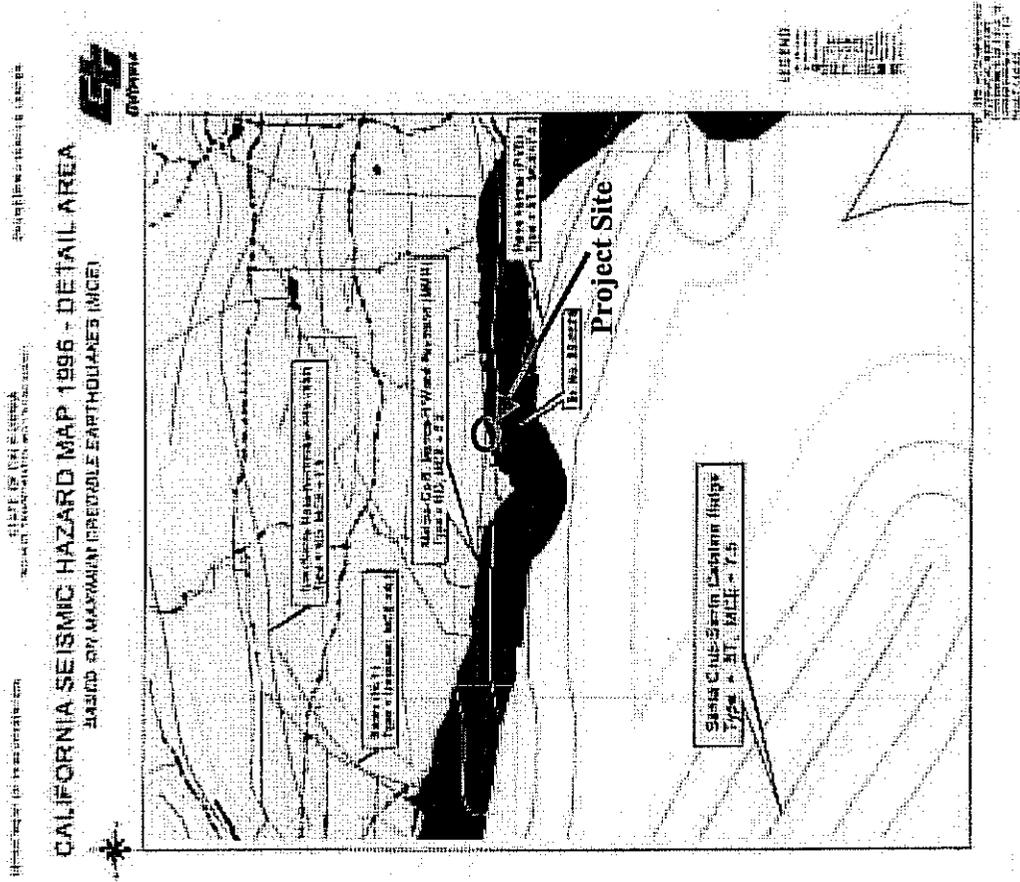
The nearest seismic source is Malibu Coast-Santa Monica-Hollywood-Raymond (MMR) Fault (Figure 4b). Based on the 1996 Caltrans Seismic Hazard Map (CSHM), this reverse/oblique fault is located about 0.7 km north from the project site. The Malibu Coast Fault is a reverse/oblique fault with probable magnitudes of 7.5 (Mw) and slip rate of 0.3 mm/y. Based on the Caltrans' current policy of taking the Peak Bedrock Acceleration (PBA) from Reverse/Oblique fault as equal to 110% of that from Strike Slip (ST) fault with the same MCE and distance, and in accordance with the attenuation by Sadigh et al (1997), the design PBA at the site should be taken as 0.8g.

Figure 4b: Faults in the Project Vicinity

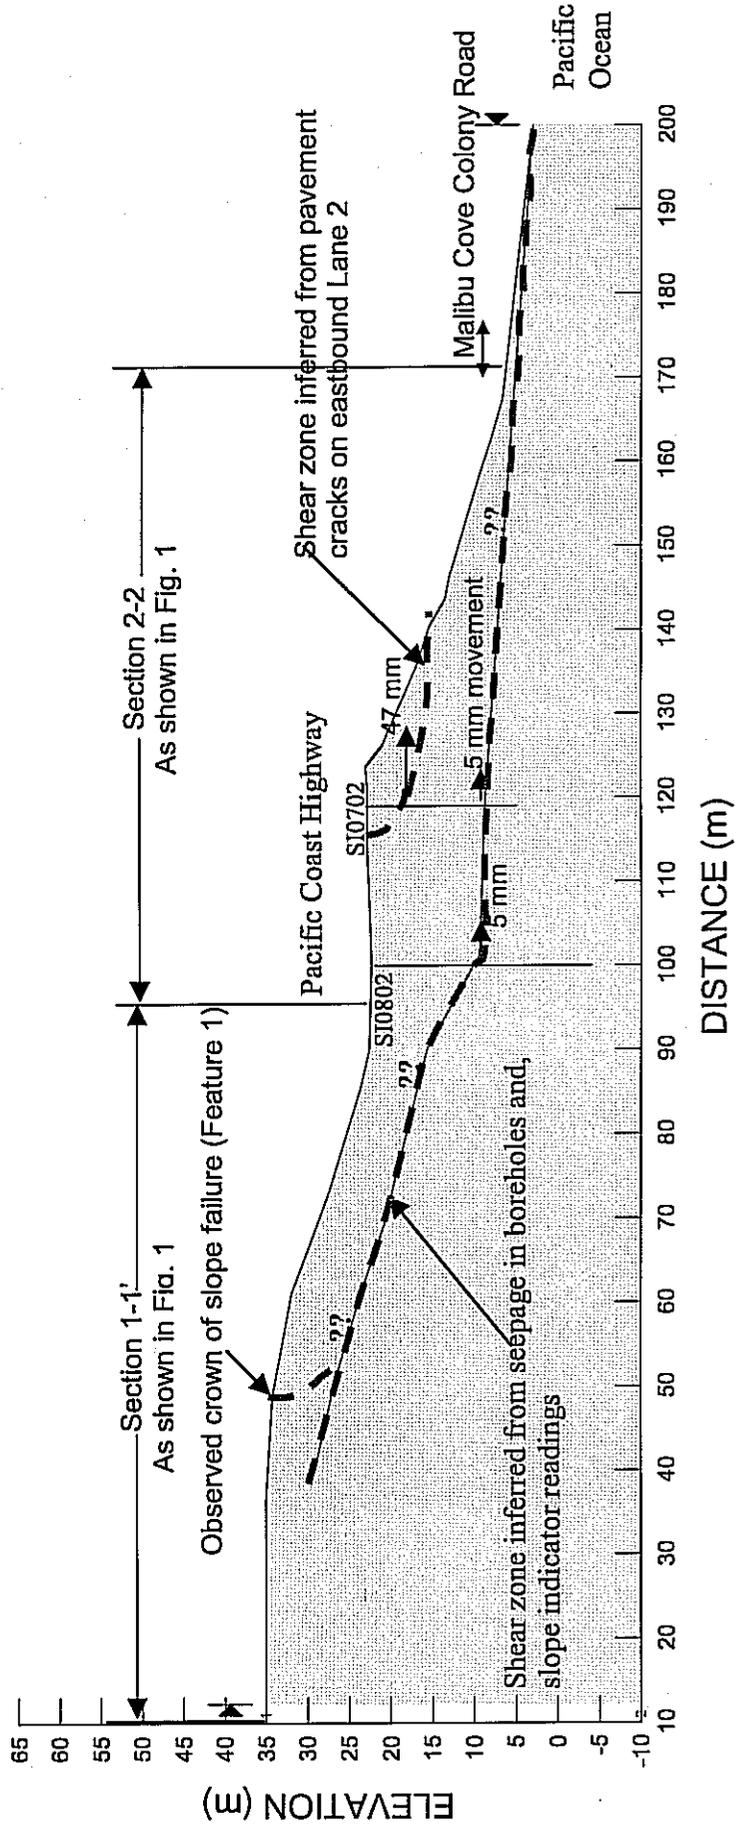
Water level in monitoring well W4_02 fluctuated between 14.8 m, and 11.4 m below pavement level between July 2002 and May 2005. A cross section and idealized soil profile prepared on the basis of the survey data and boring logs is shown in Figure 7a and 7b

Figure 7a: Cross Section

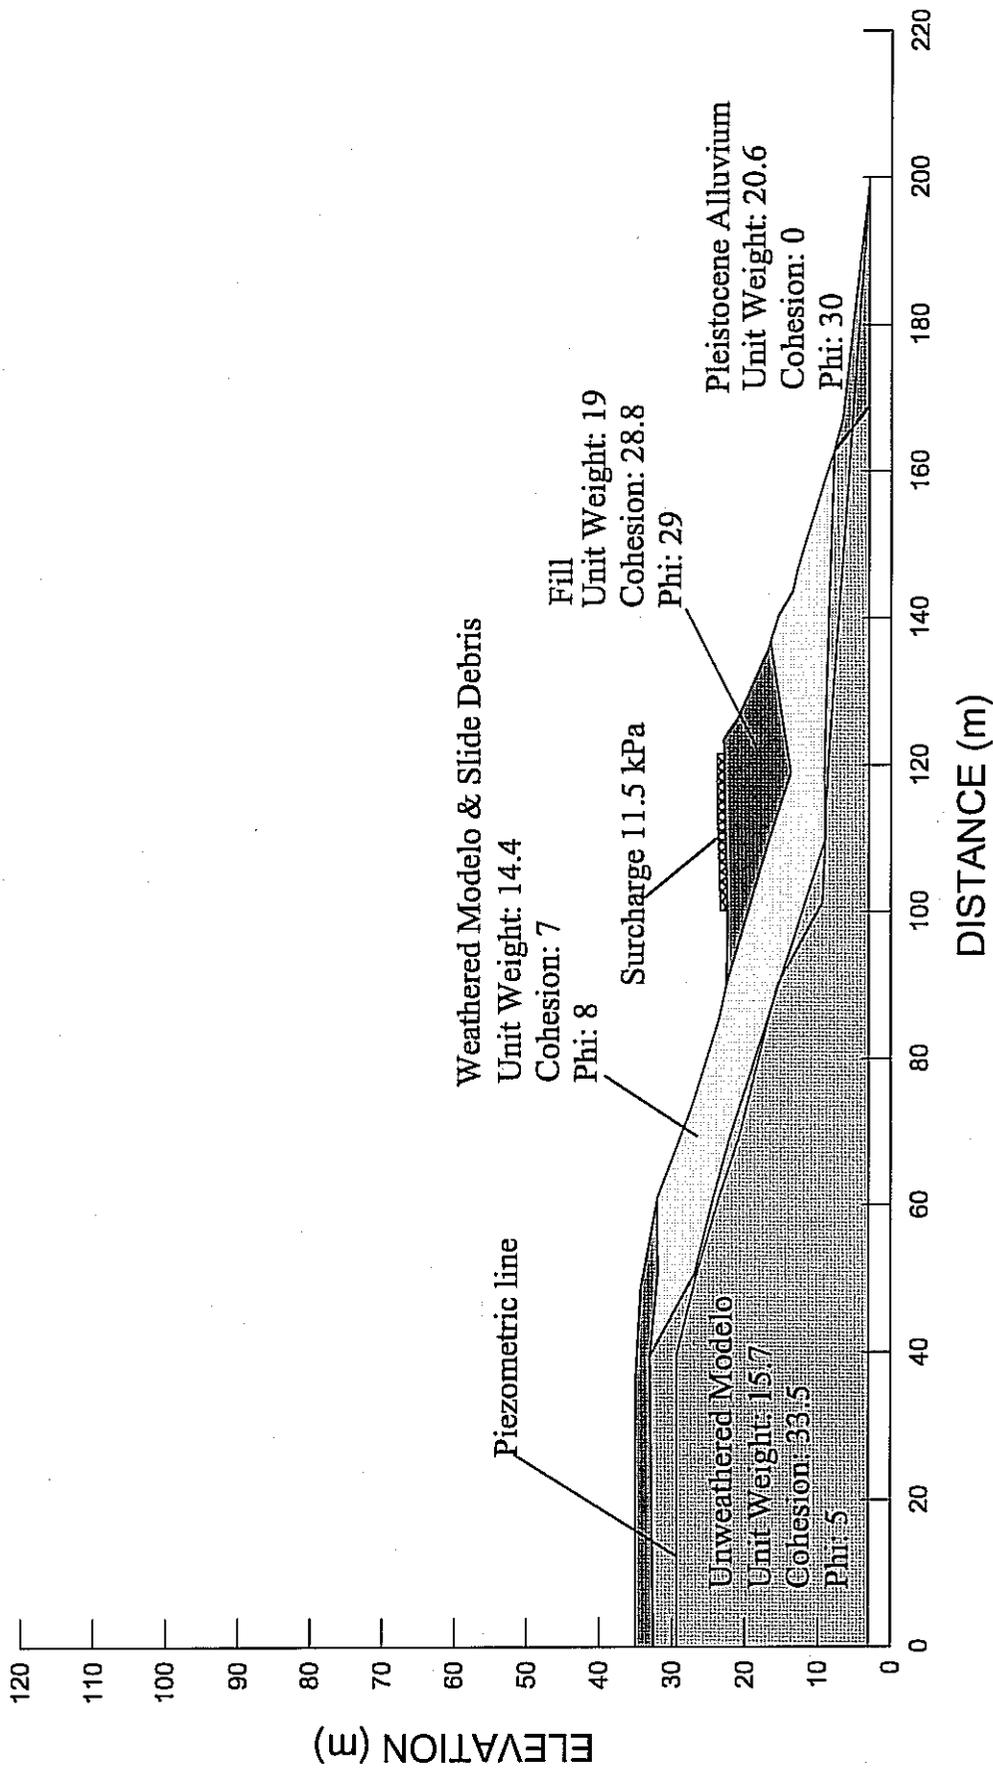
Figure 7b: Idealized Soil Profile

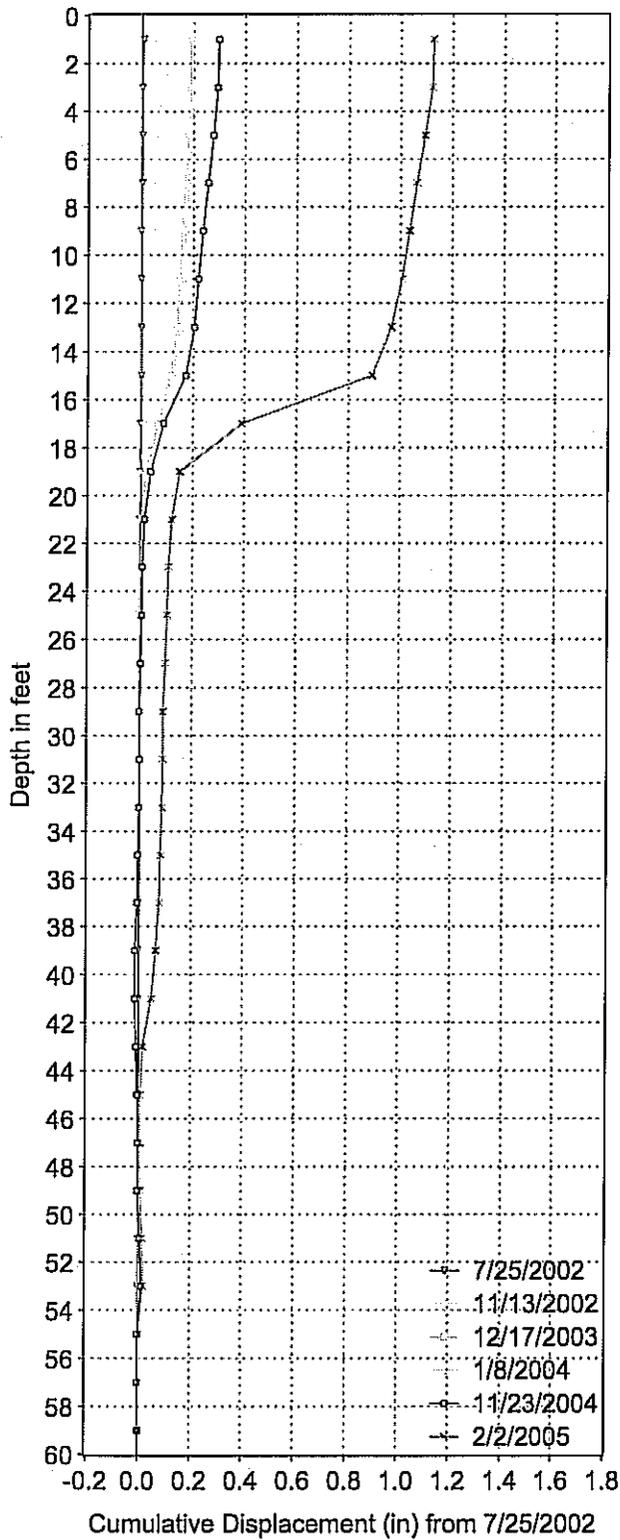
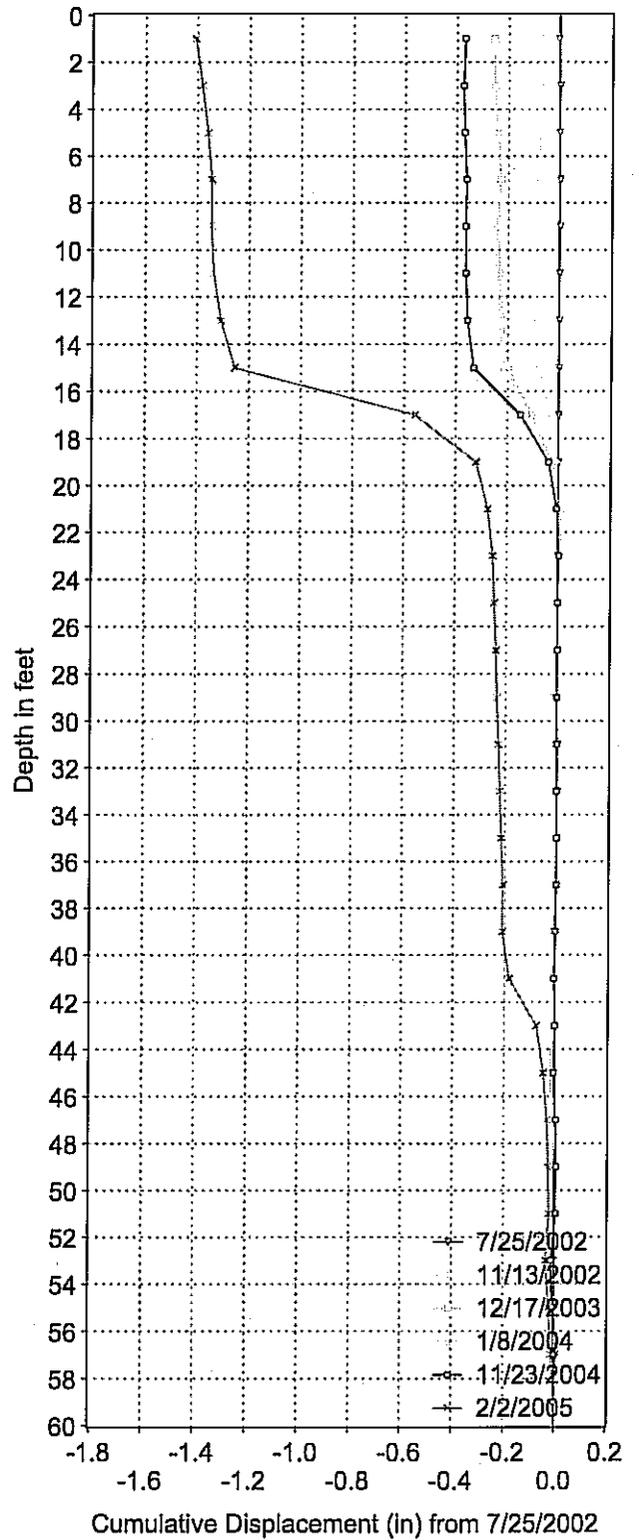
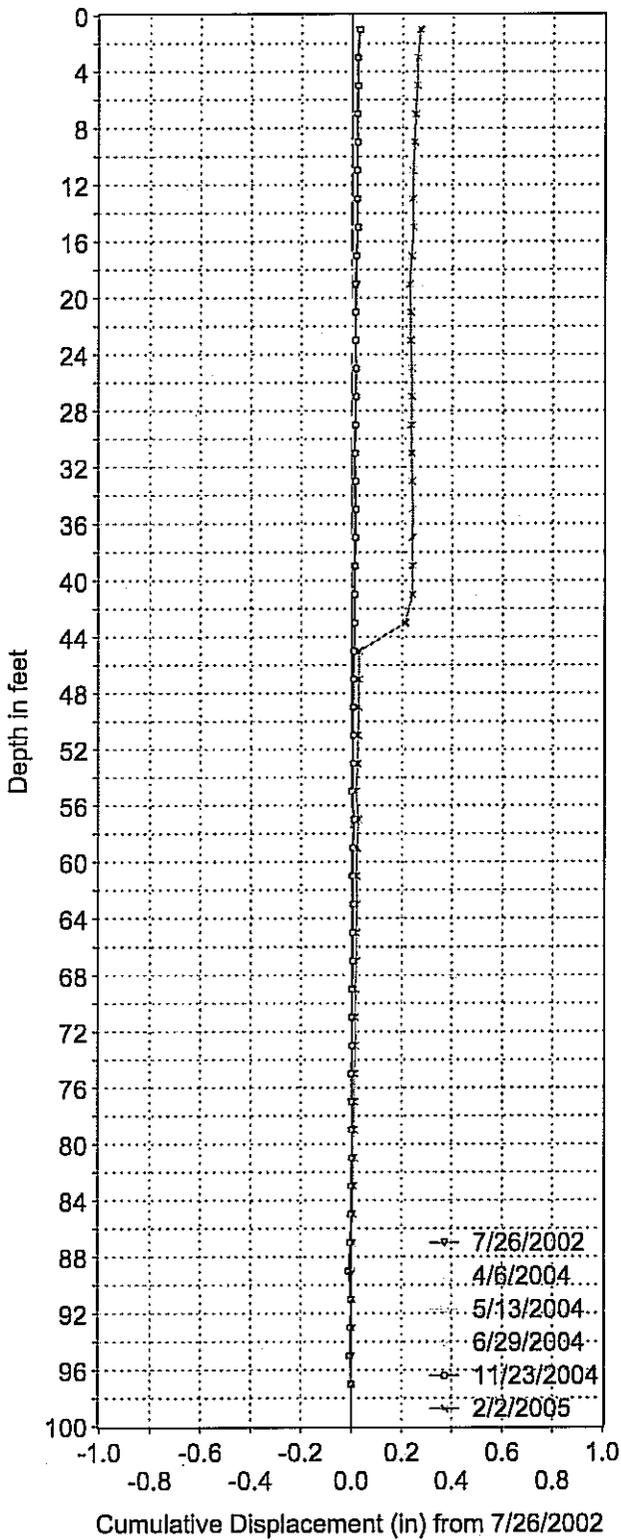
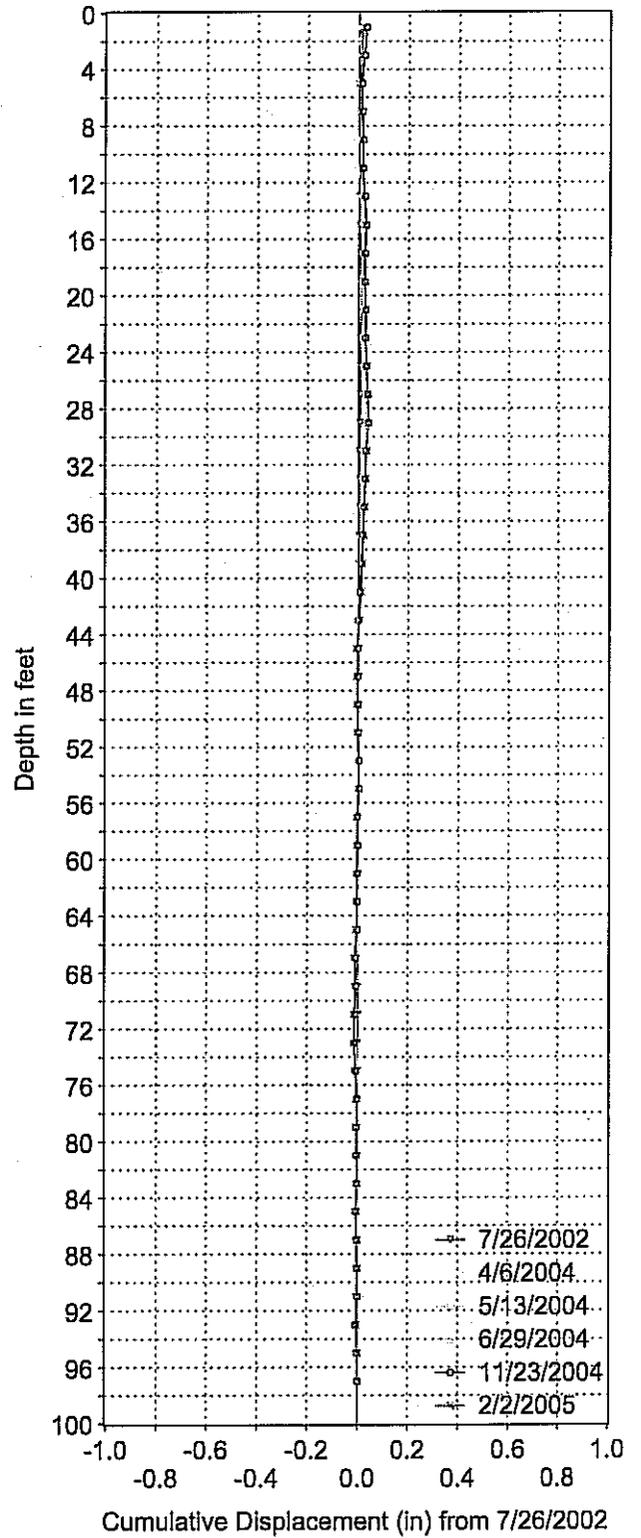
Slope Indicator Data Analysis after December 2004: Slope indicator data collected between December 2004 and March 2005 showed an increase in movement due to the winter storm (Figure 8). Readings of the two slope indicators, SI's 0702 and 0802, within the area of concern showed (1) significant increase of movement along the existing shallow shear zone at SI_0702, and (2) a newly detected deep-seated movement along a deeper shear zone at SI_0802 (Figures 9 and 10). According to the slope indicator readings, the shallow shear zone is about 5.2 m below the highway and the deep-seated shear zone is about 13.5 m below the highway

Approximately 20 mm additional movement along the shallow shear zone was observed due to the rainstorm, which resulted in a cumulative movement of 47 mm since the installation of the slope indicator. This shallow shear zone is affecting primarily the eastbound lanes and reflects the widening of the pre-existing pavement cracks (Figure 3a), and subsidence of eastbound lane No.2.

Figure 8: Time Series plot for Inclinometer SI_07_02
